LINCOLNVILLE COMMUNITY REDEVELOPMENT AREA

STREETSCAPE SURVEY & ANALYSIS

October 3, 2019

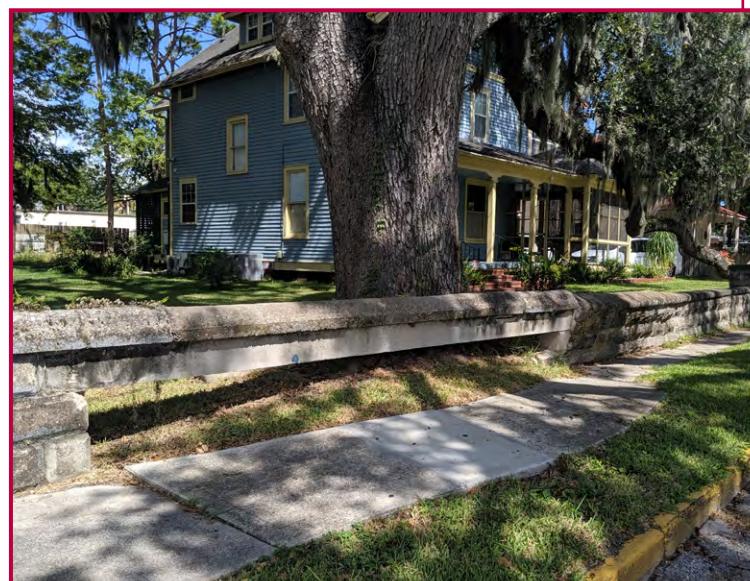
Previous sidewalk repair beginning to buckle/crack.

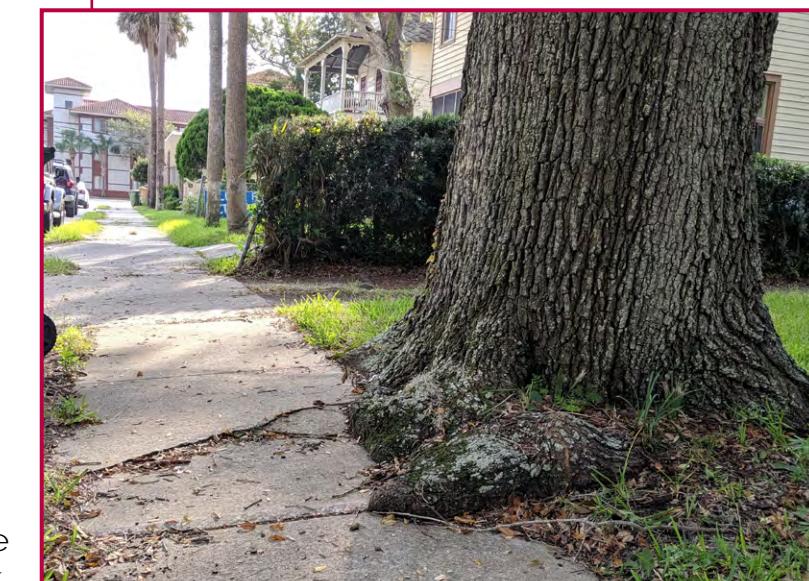
Large existing oak tree lifting/cracking sidewalk.

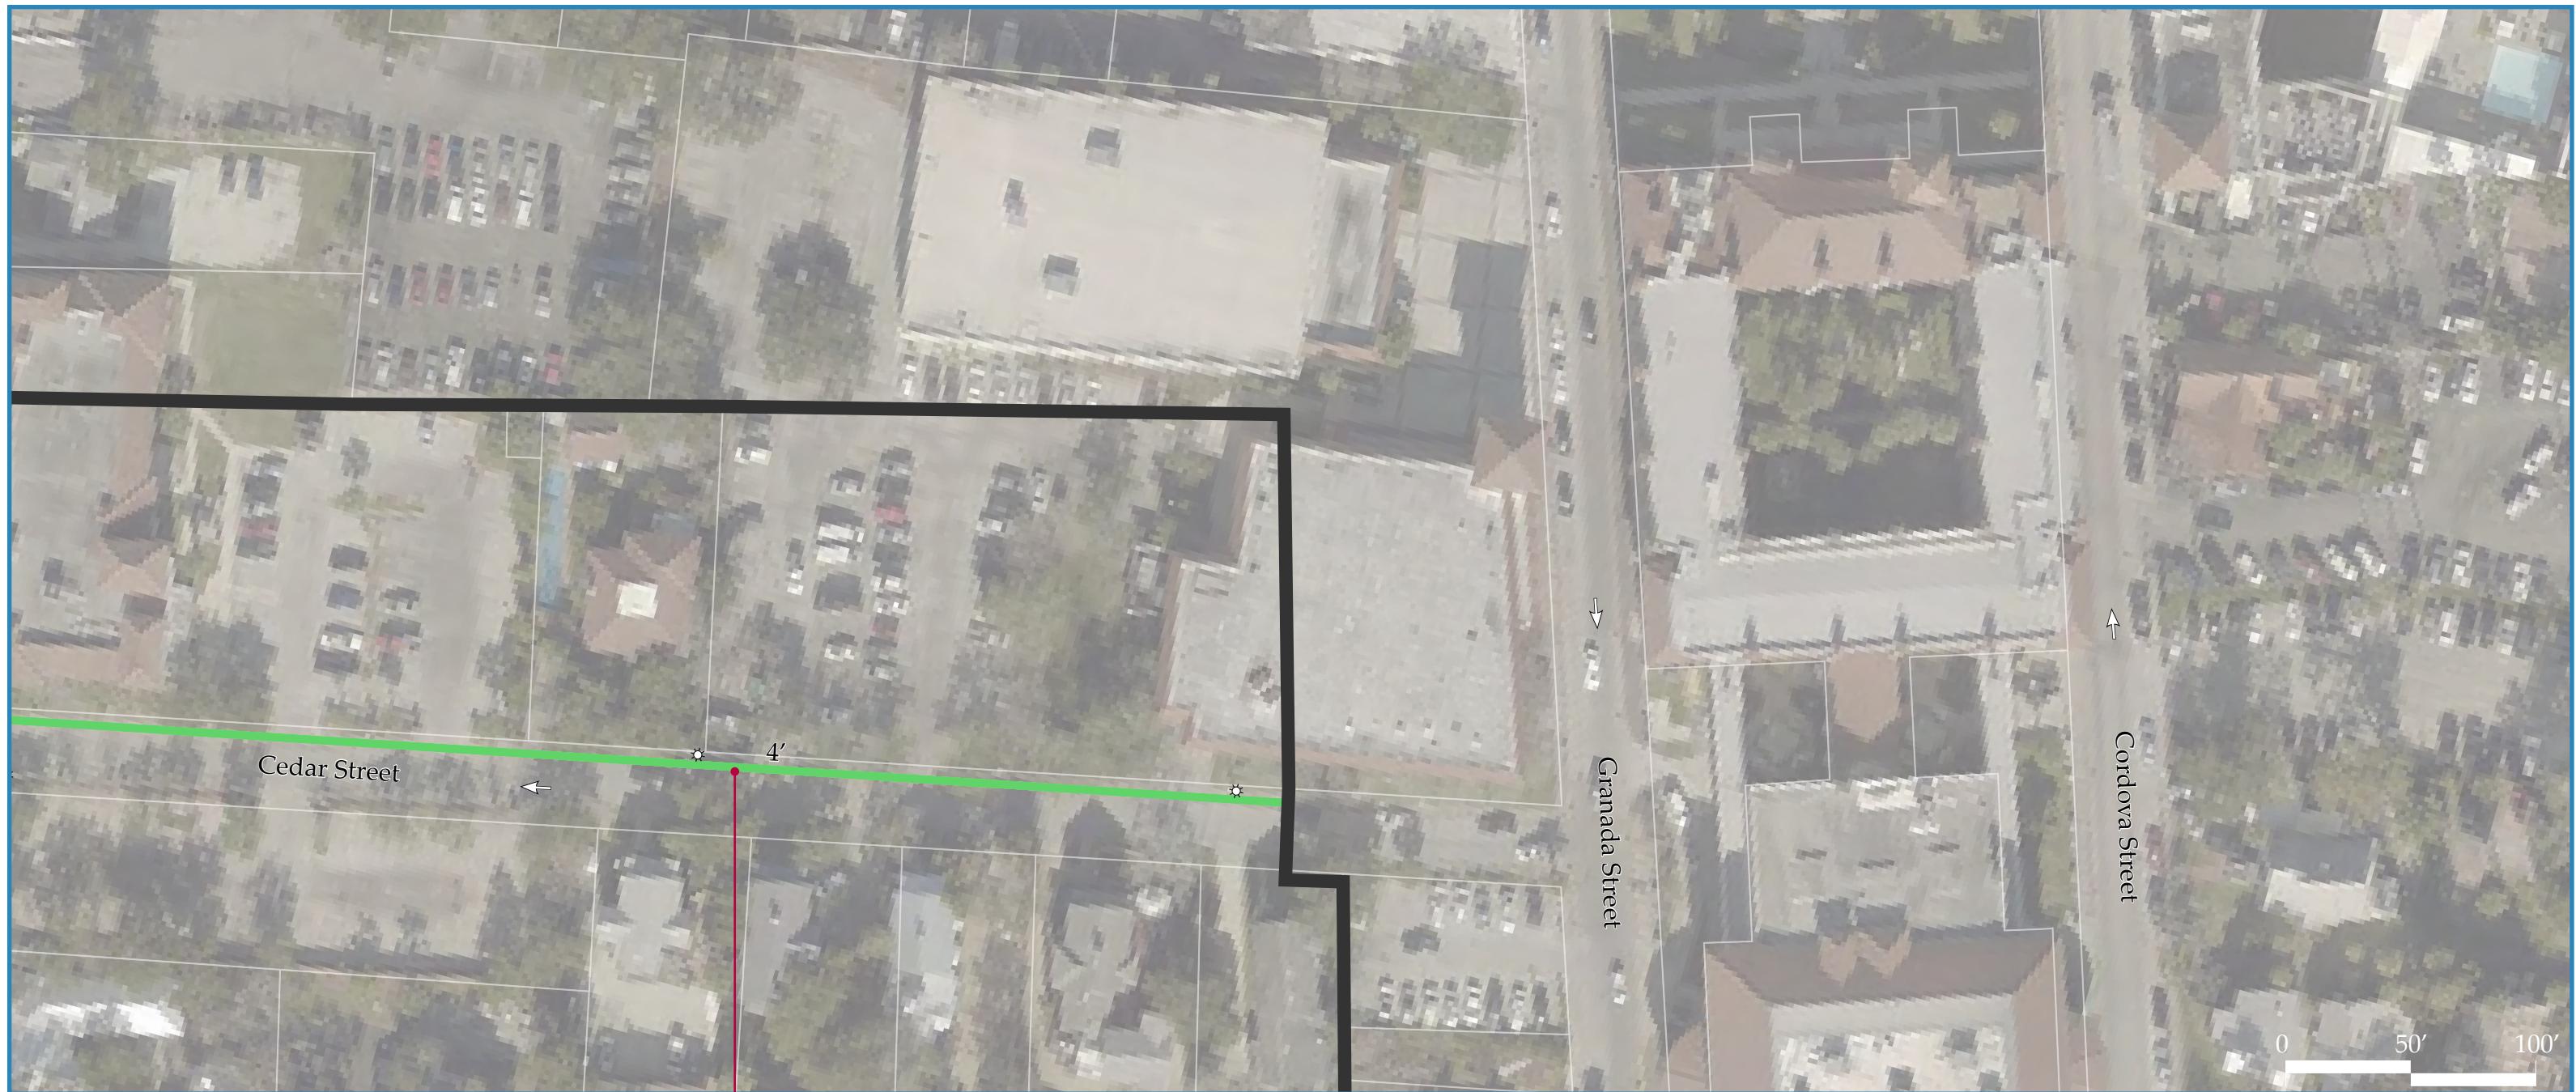
Good/continuous sidewalk along the north side of Cedar Street with minor obstructions.

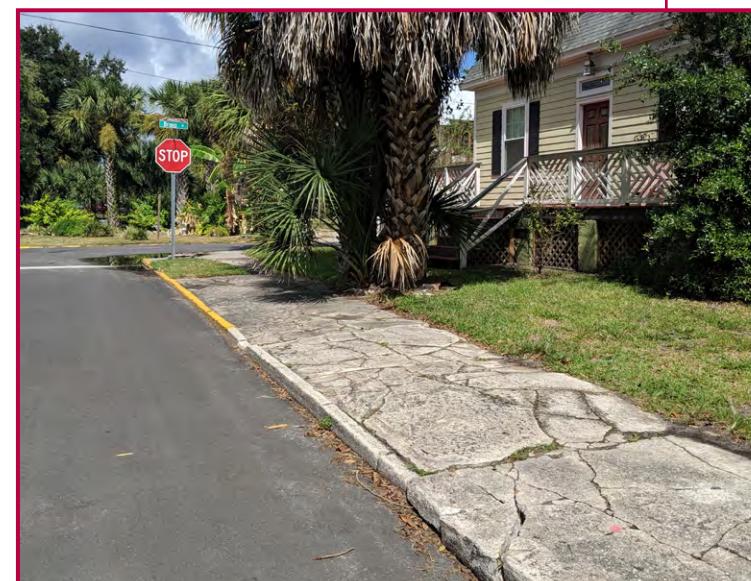
Heavily damaged sidewalk section.

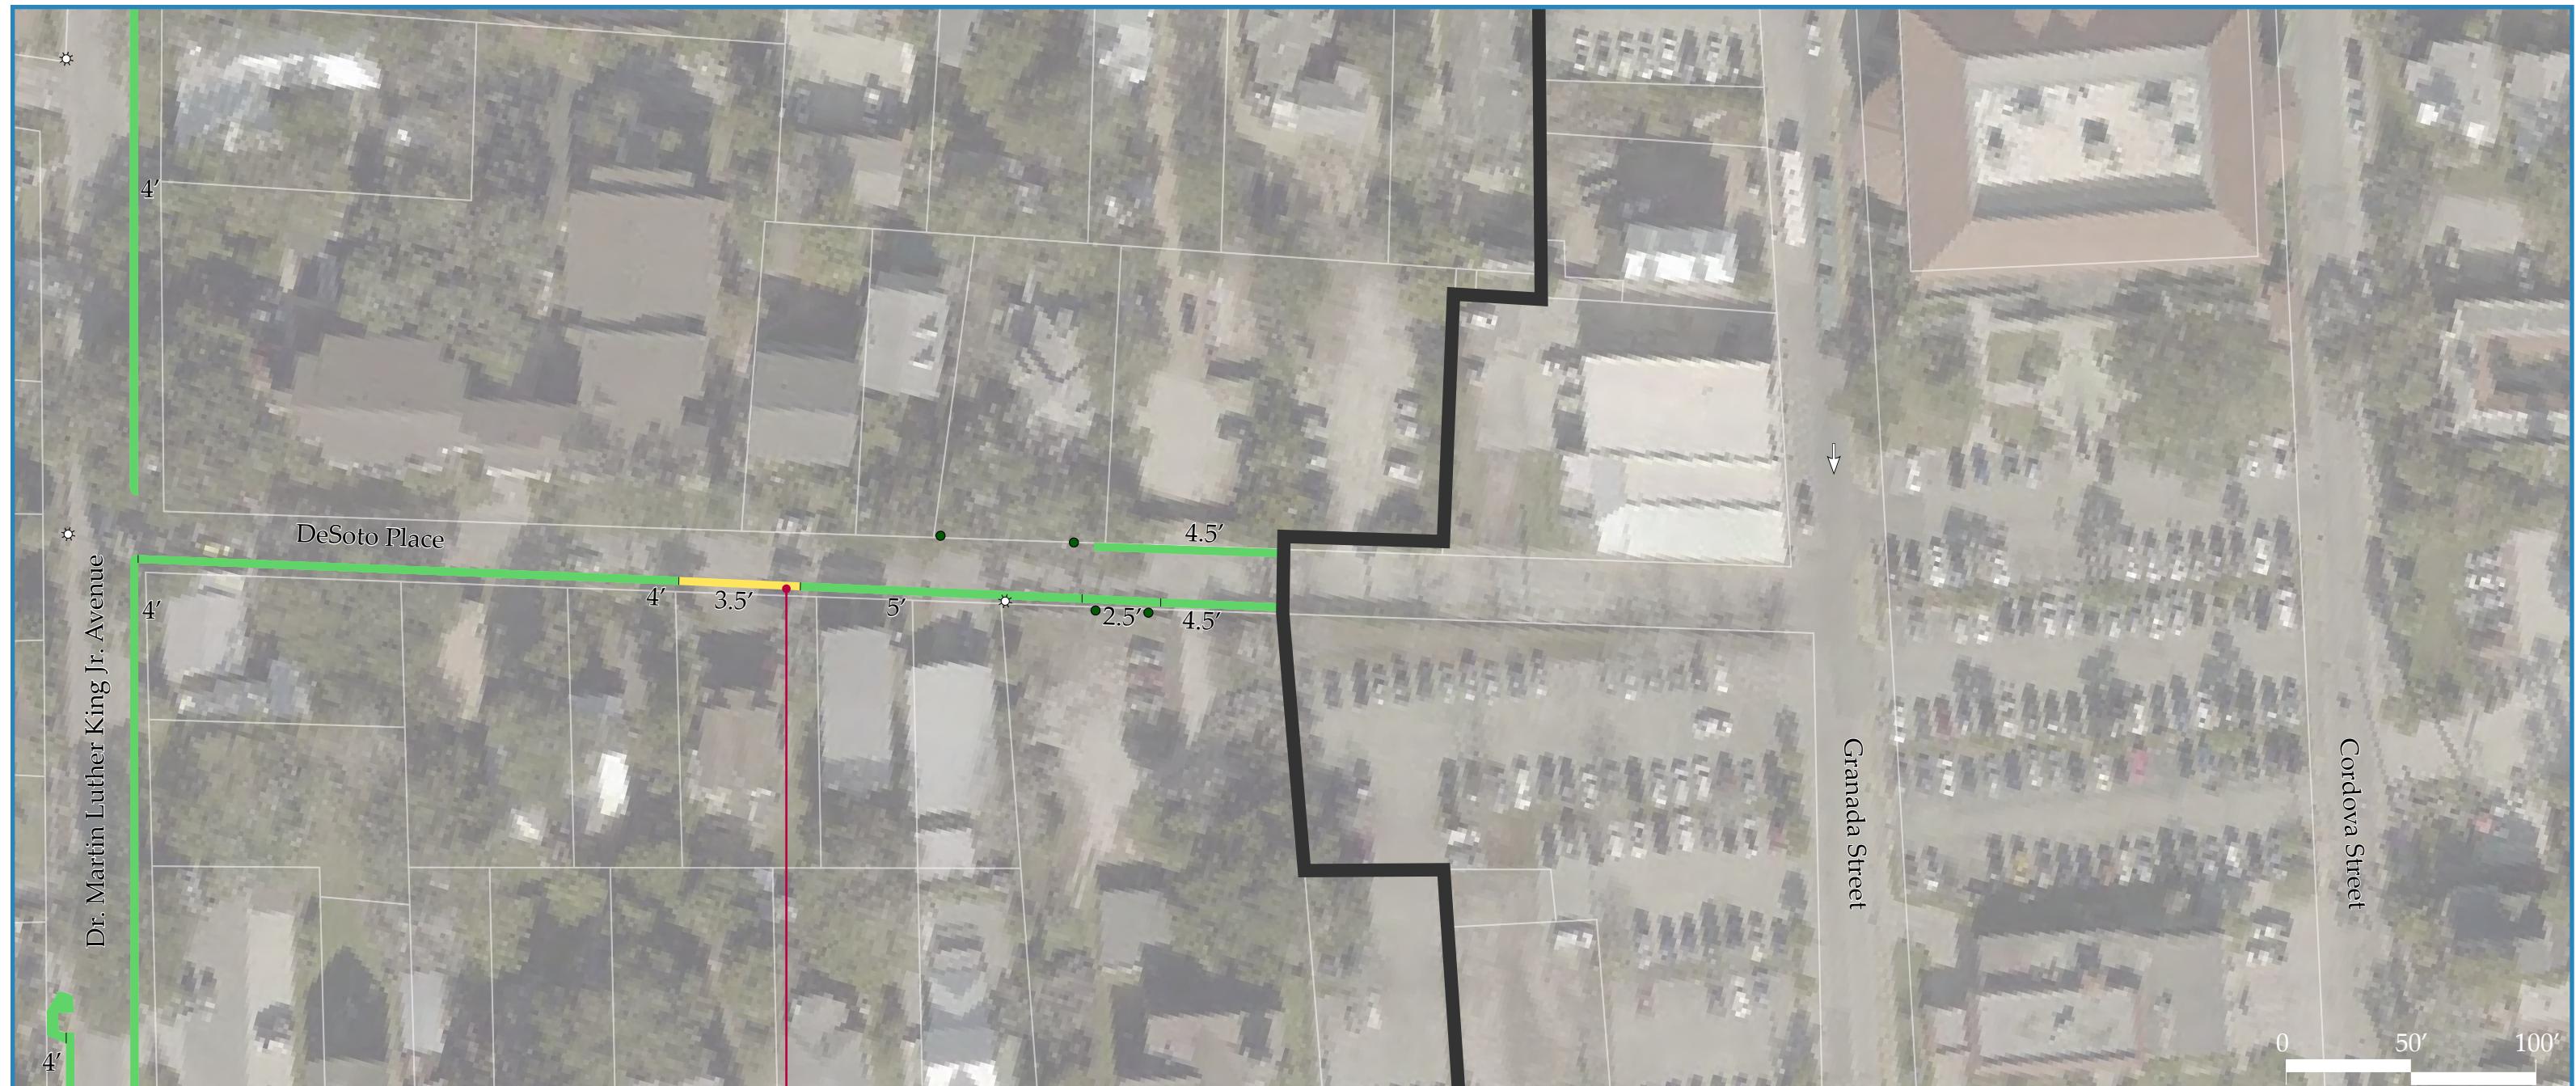
Utility poles within sidewalk/
damaged driveway apron.

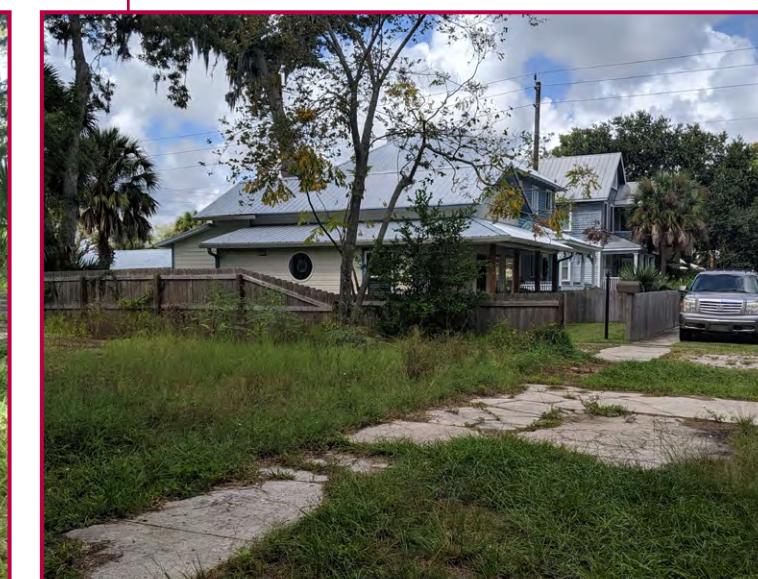
Existing tree lifting sidewalk with significant damage.

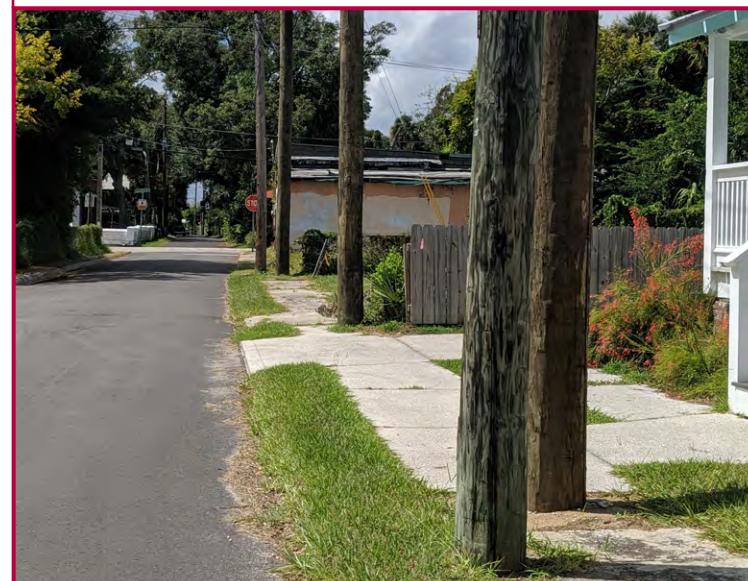
Sidewalk is in good condition. Existing trees beginning to lift sidewalk.

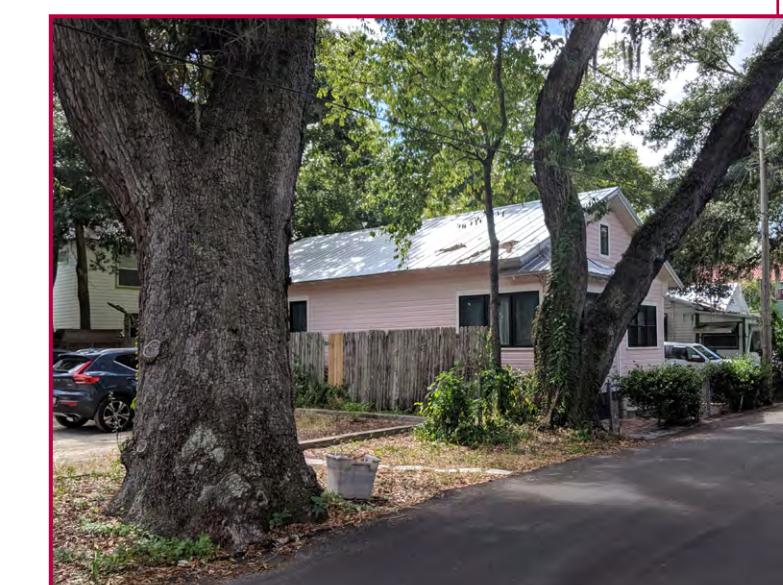
Large existing oak trees would be in conflict with future construction.

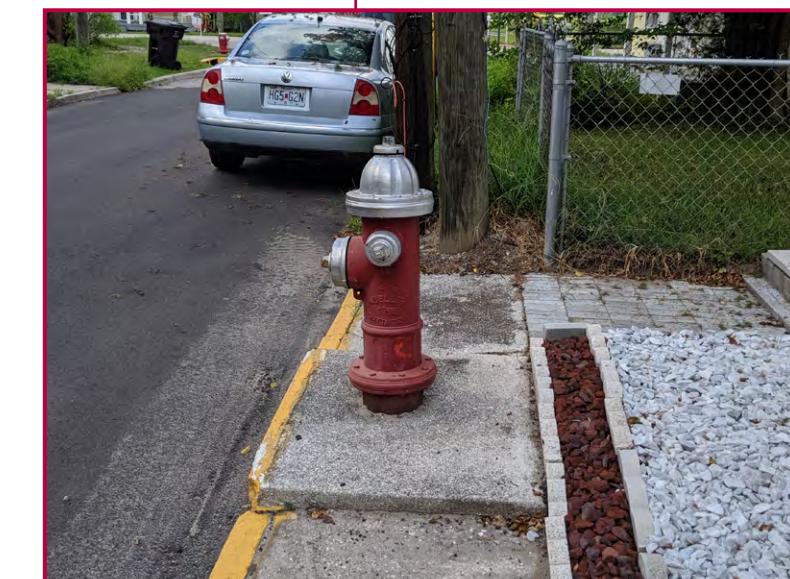
Existing utilities conflicting with sidewalk.

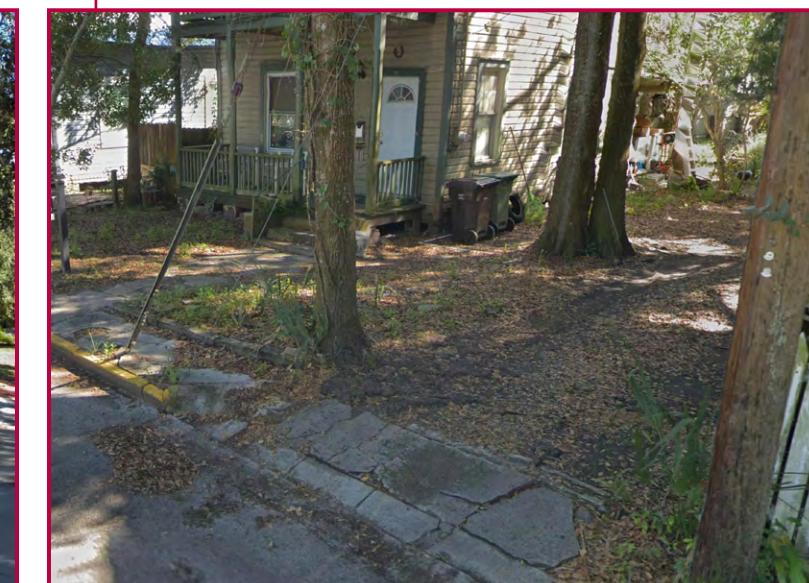
Analysis
Damaged sidewalk and utility conflict.

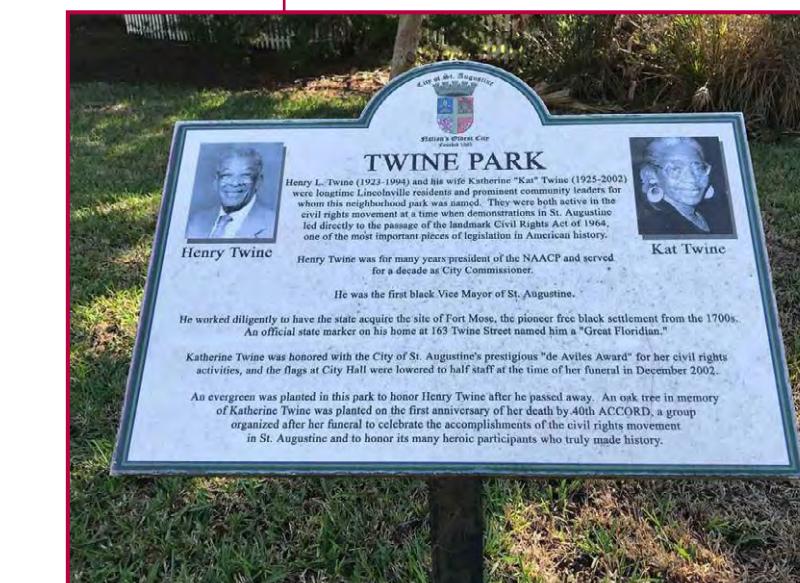
No sidewalk connection/accessible route to Twine Park.

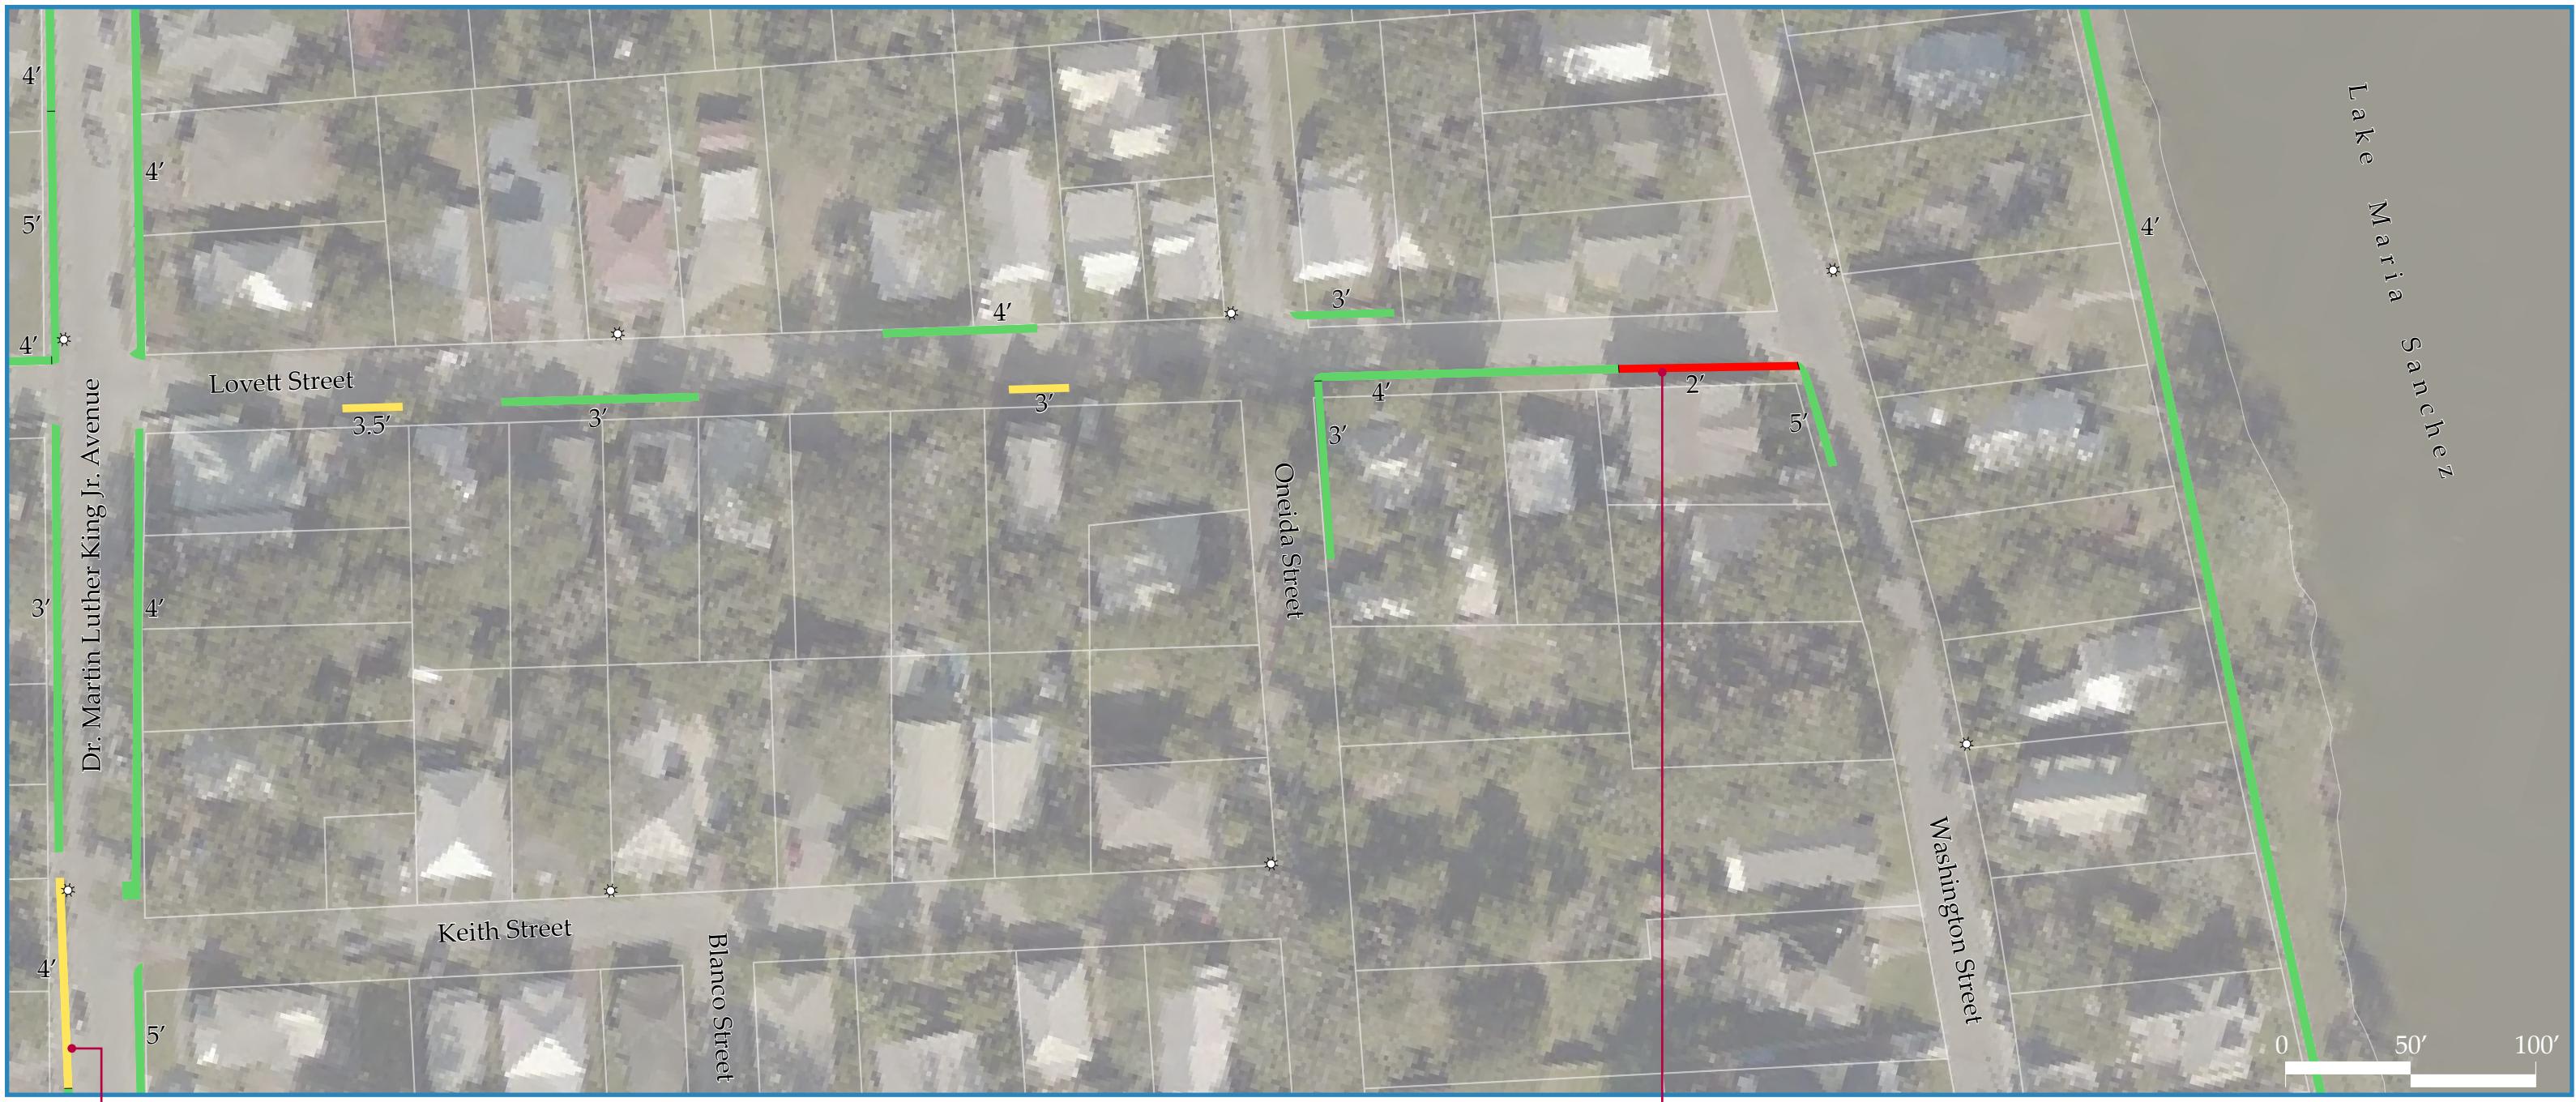
Non-ADA accessible transition.

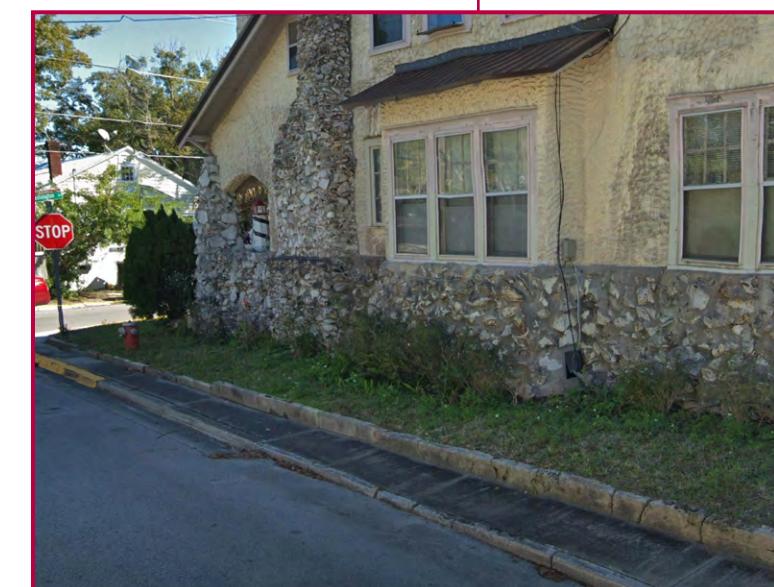
Non-ADA accessible section flanked by sections of good sidewalk.

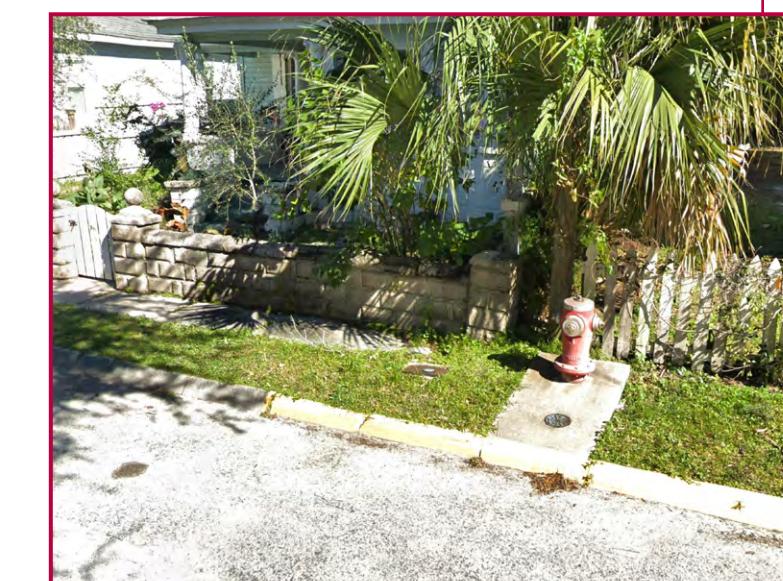
Existing utilities would be in conflict with future sidewalk construction.

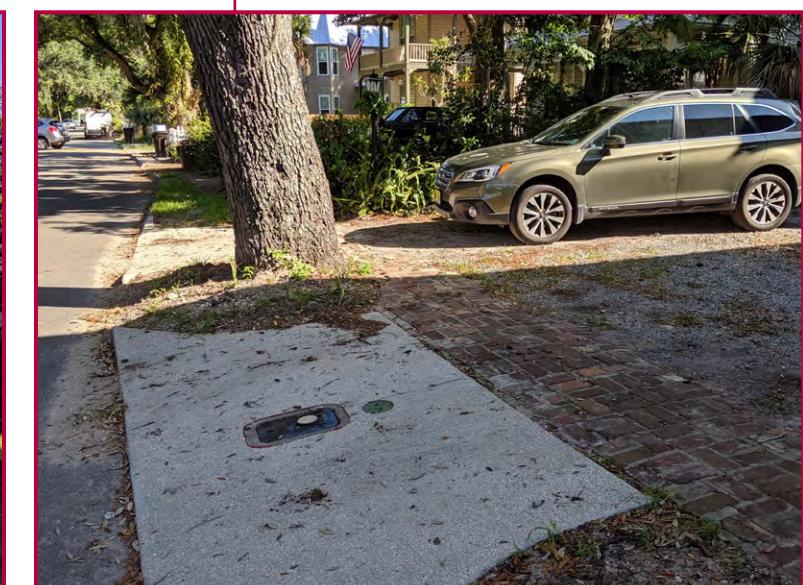
Large existing oak trees would be in conflict with future construction.

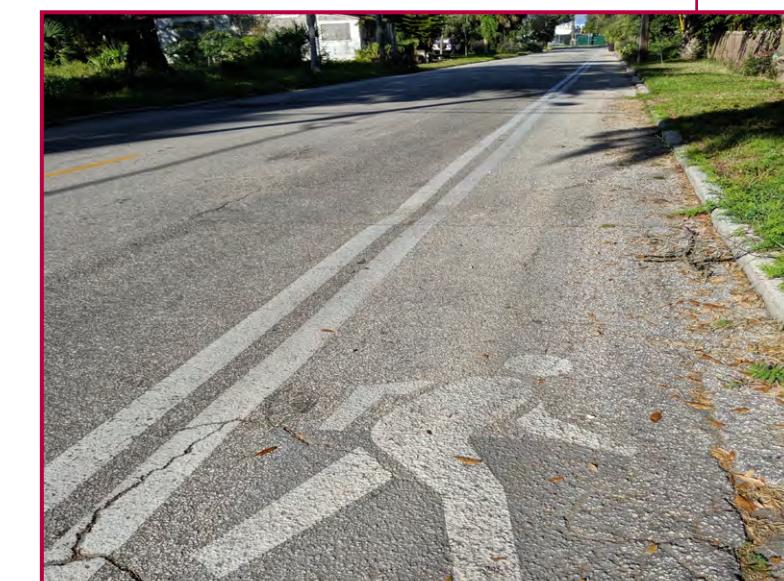
Existing on-street pedestrian path. East sections of South Street featuring quality, off-street sidewalk system.

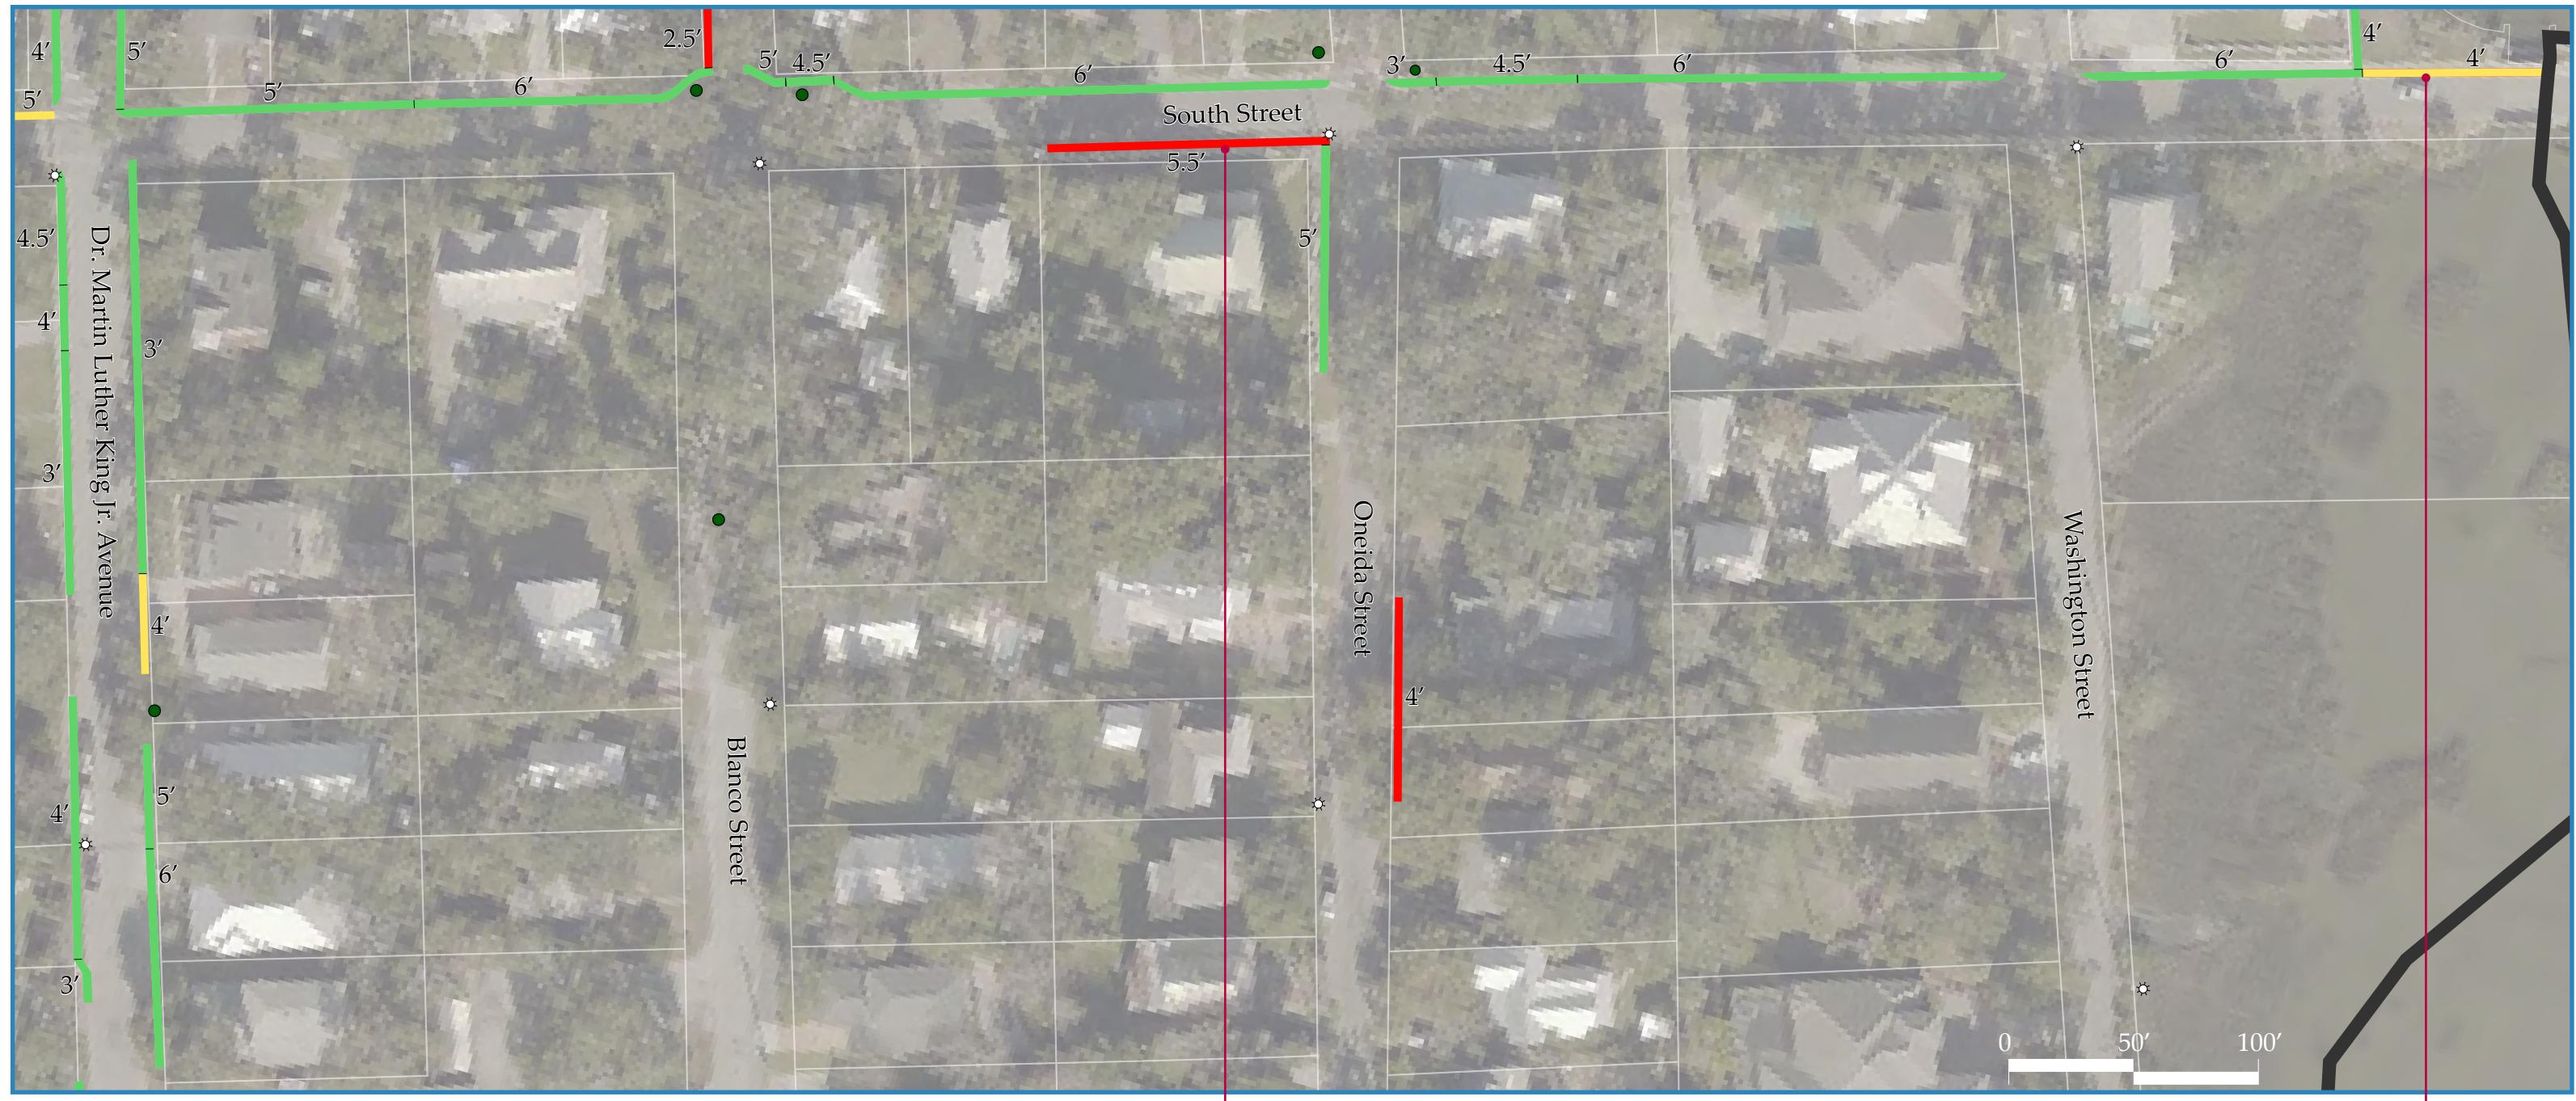
Existing slate sidewalk has
broken/missing sections.
Non-ADA accessible.

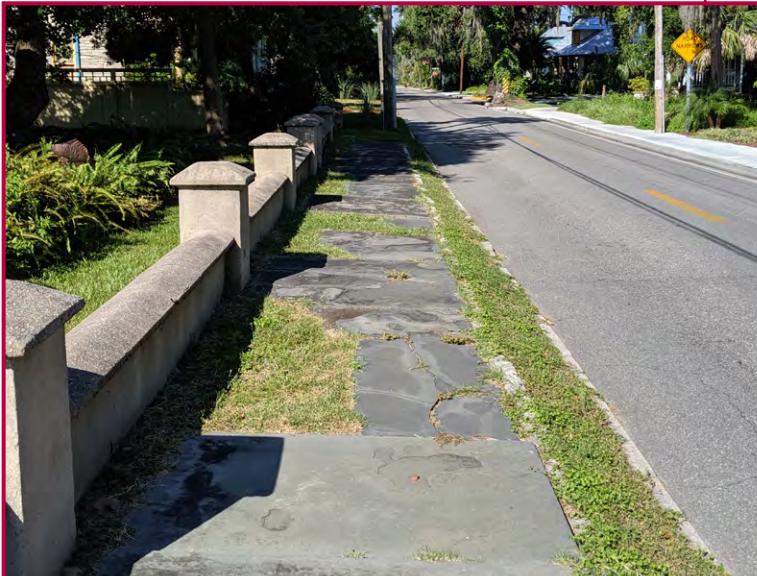
Existing on-street pedestrian path. West sections of South Street featuring quality, off-street sidewalk system.

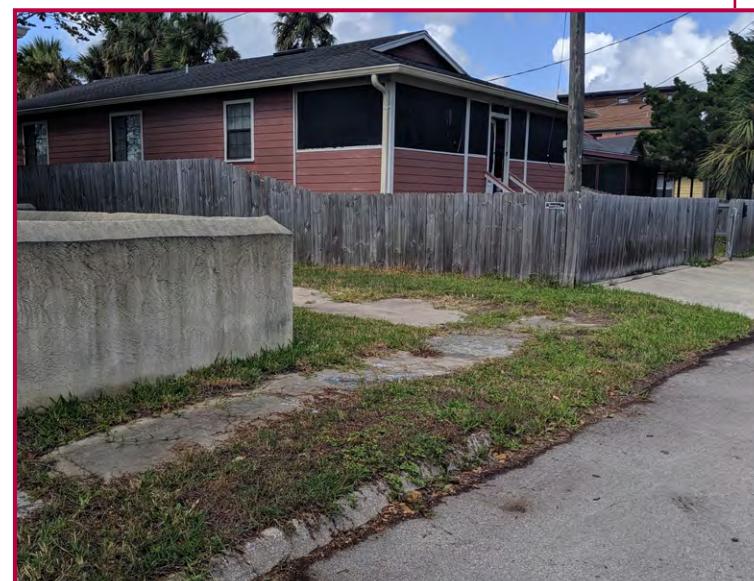
Broken/missing sections within a continuous section of good sidewalk.

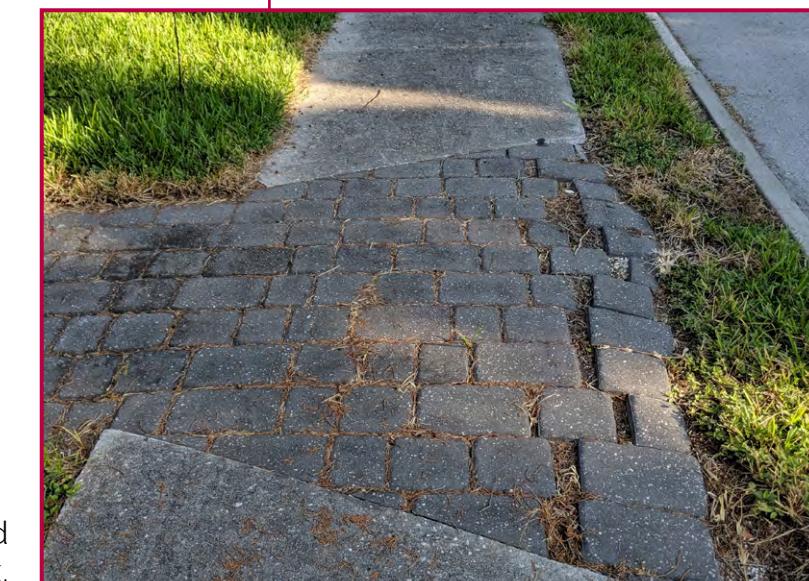
Damaged pavers within a good section of sidewalk.

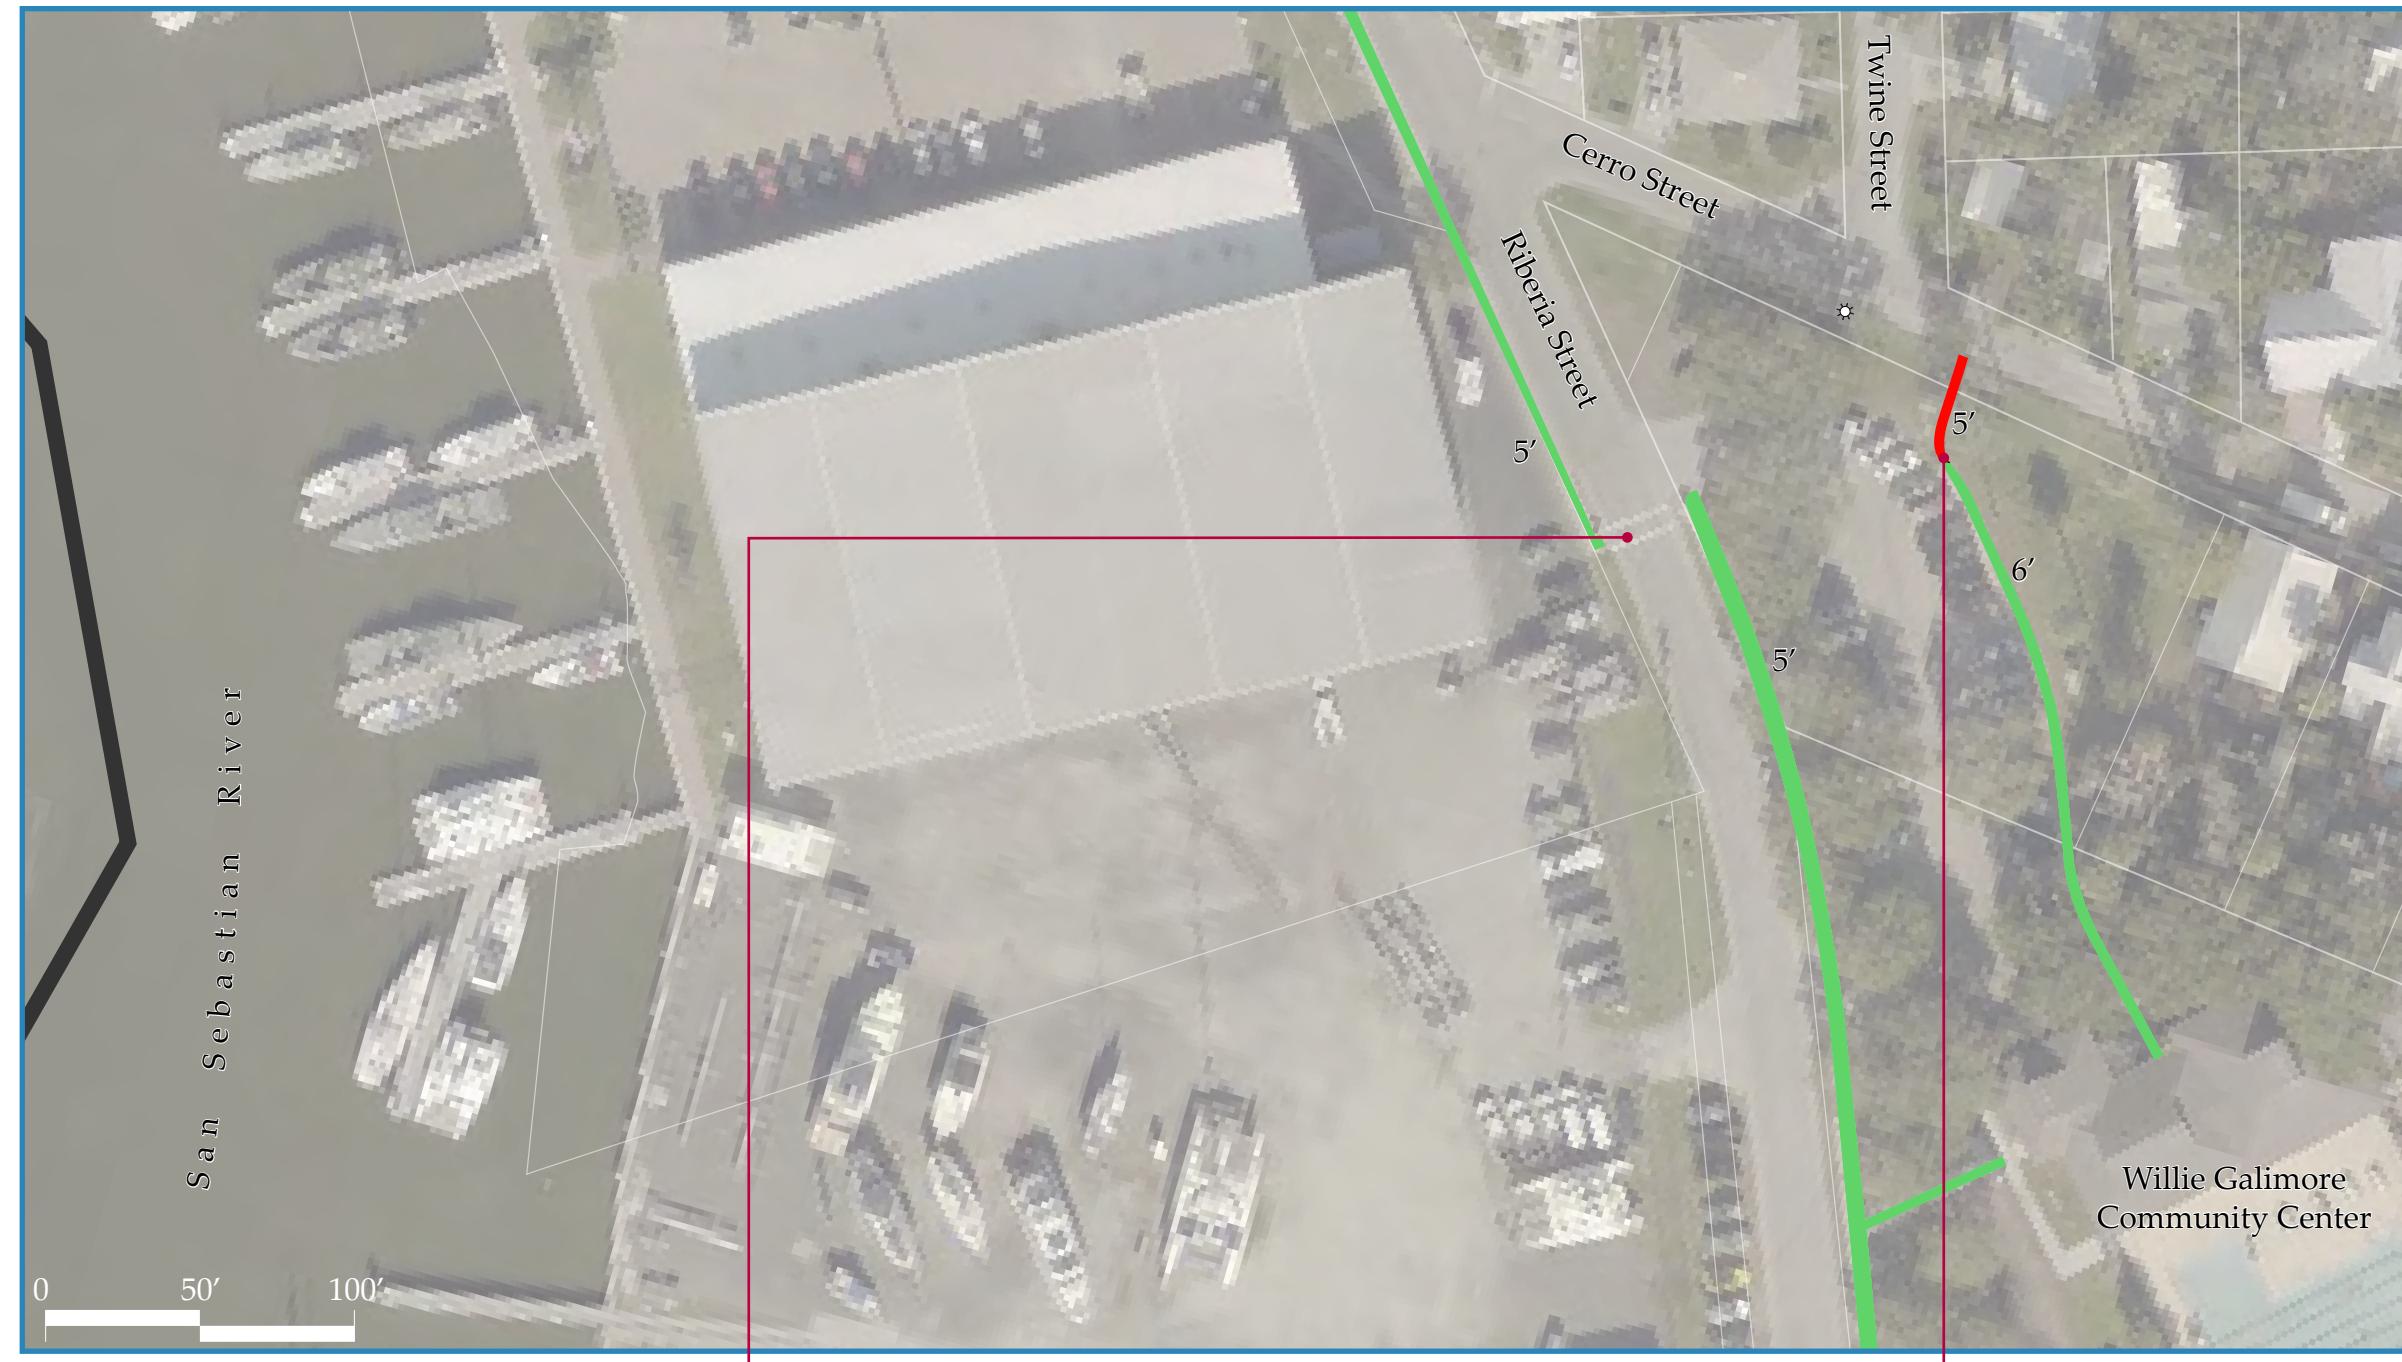
Connection to the Willie Galimore Recreation Center from Cerro St. is broken/missing asphalt.
