LINCOLNVILLE COMMUNITY REDEVELOPMENT AREA

STREETSCAPE SURVEY & ANALYSIS

October 3, 2019

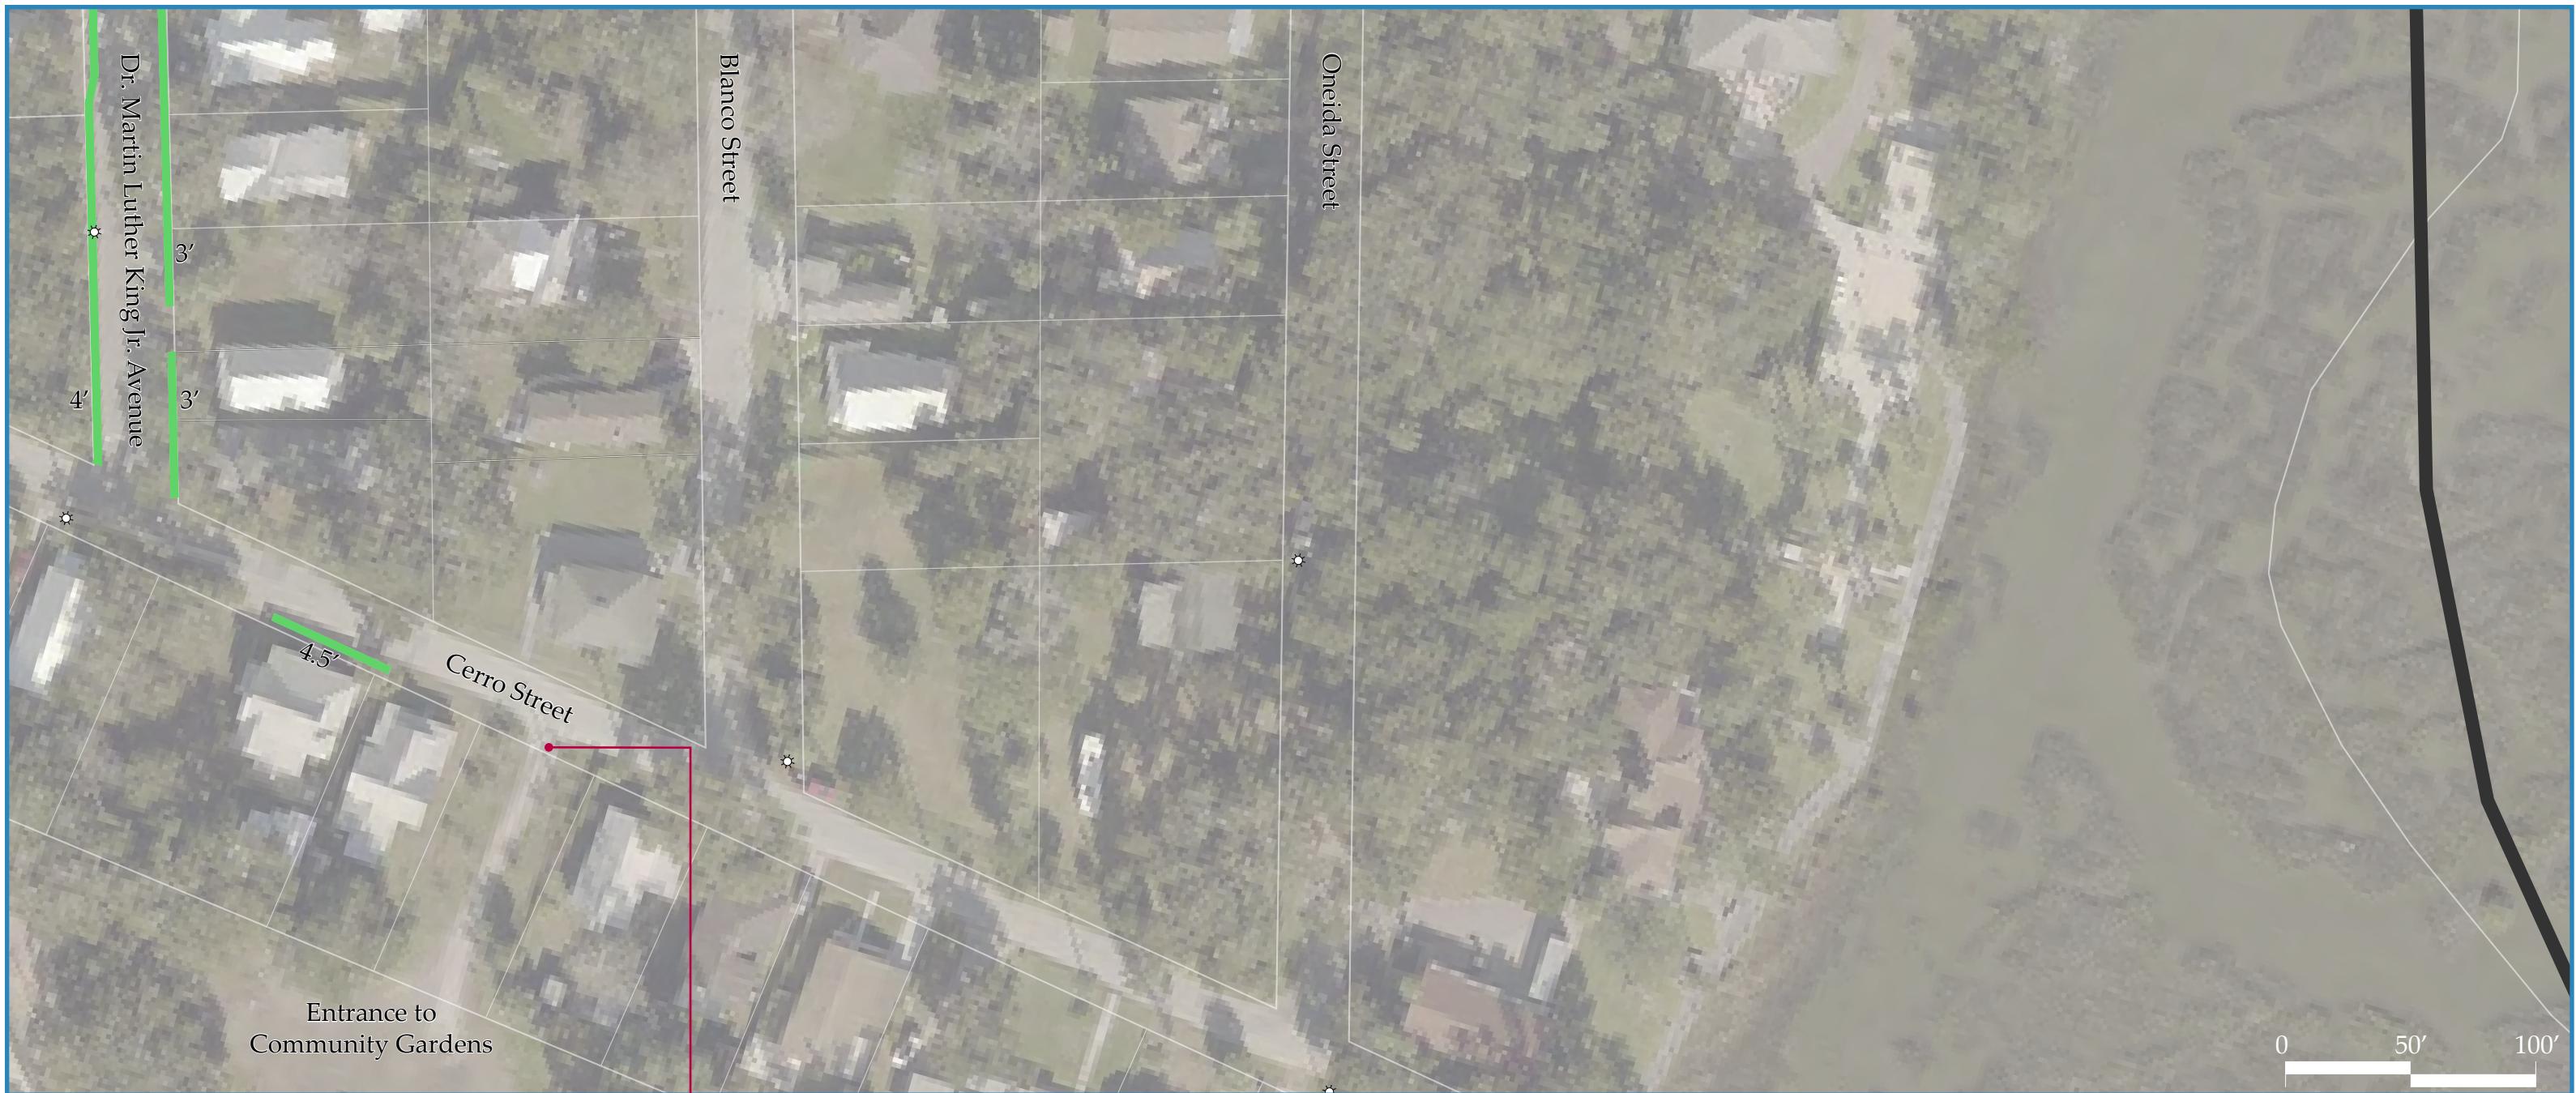
Unpaved entrance to Eddie L. Vickers Recreation Facility/Community Gardens.

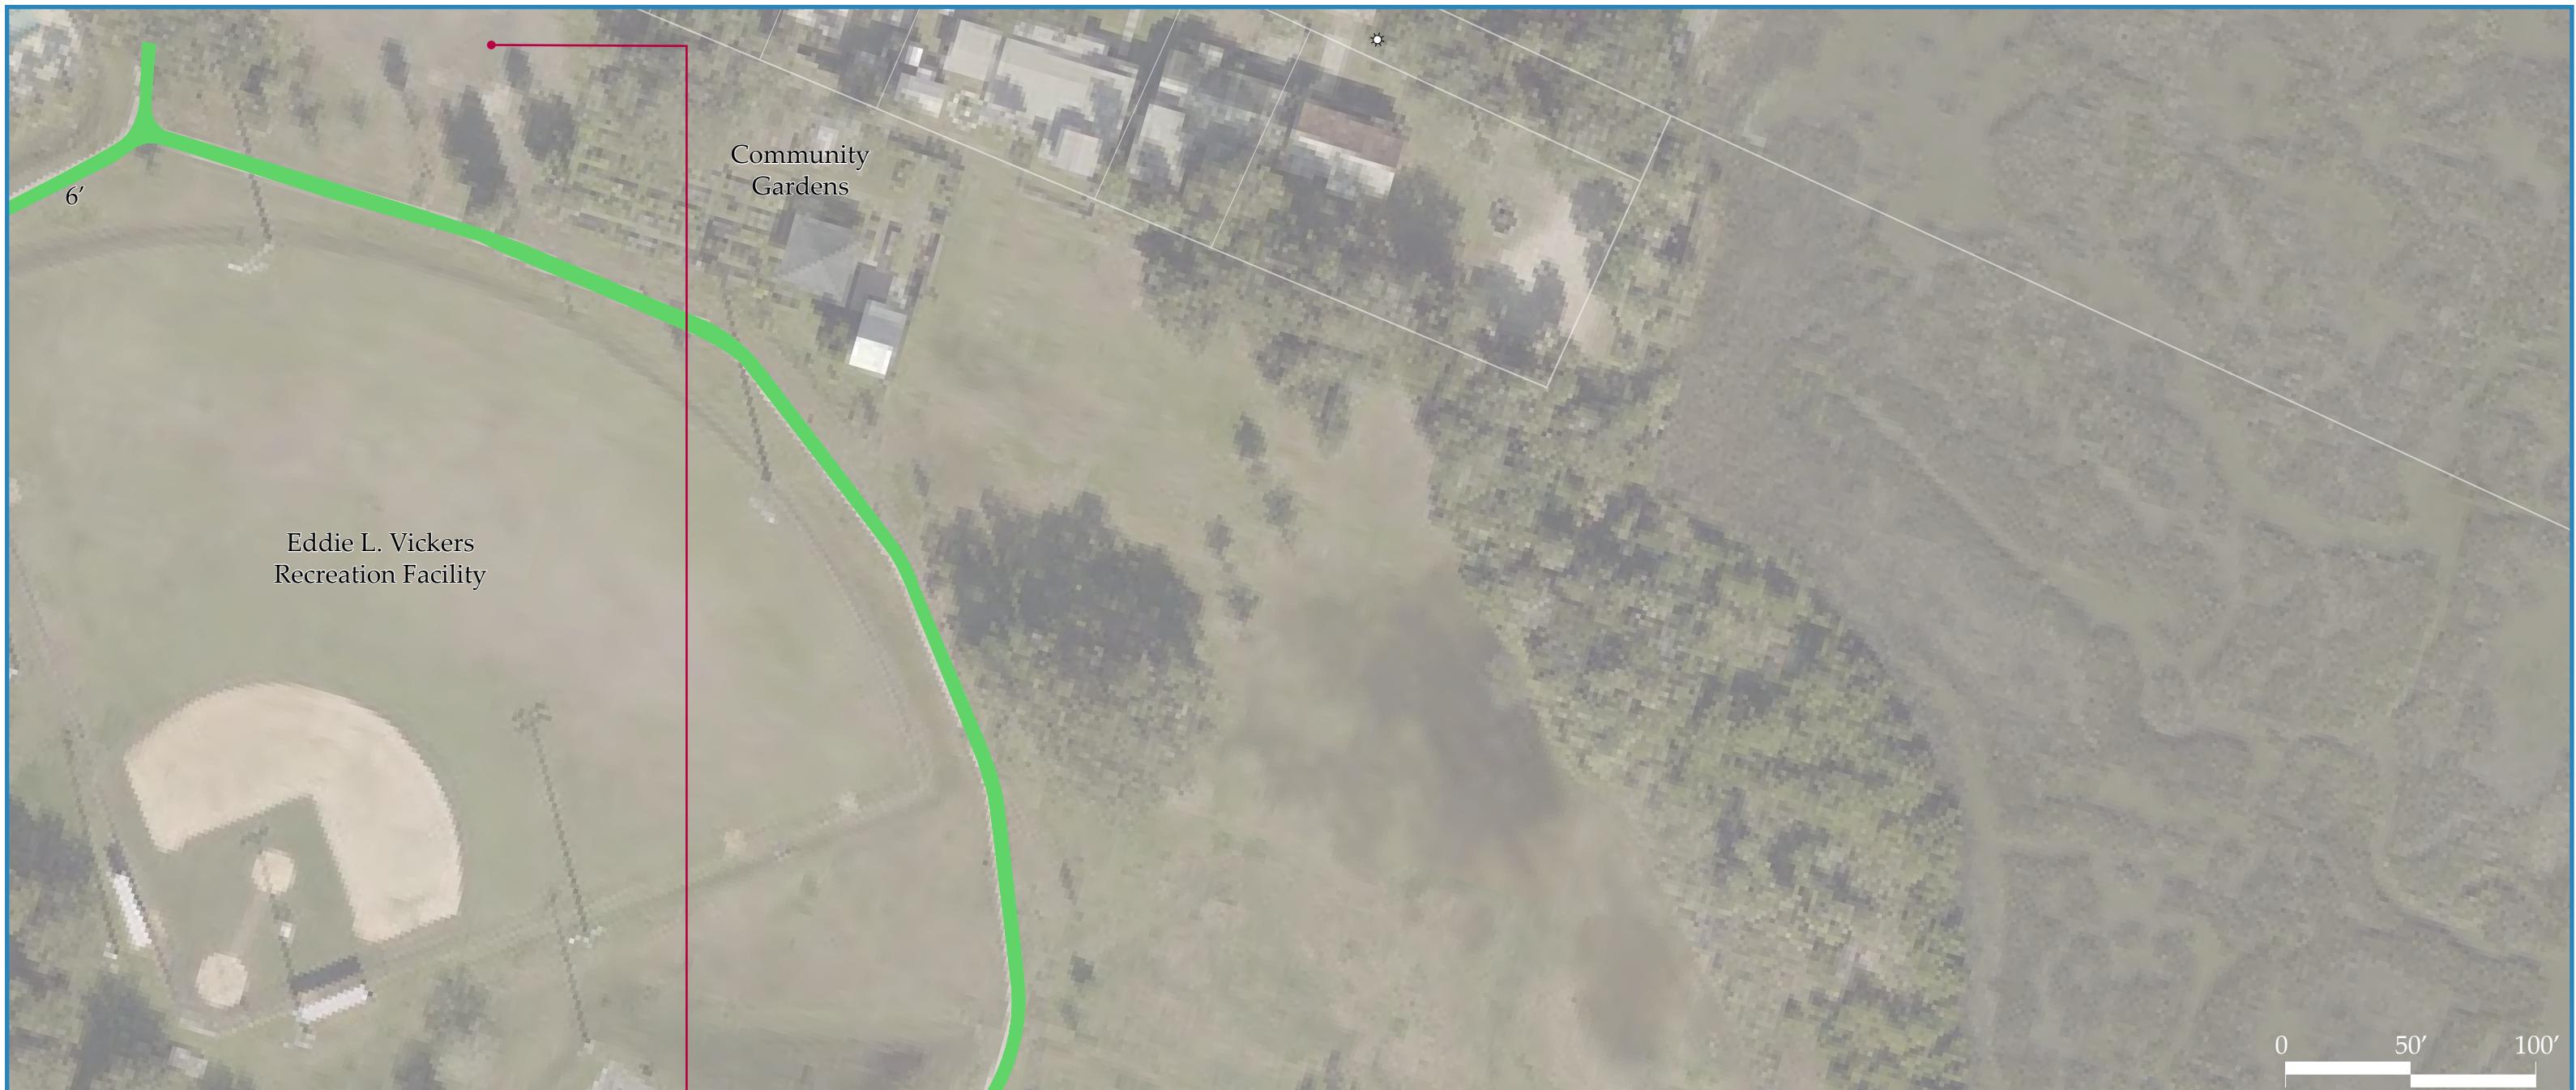
No accessible path to the Community Gardens, playground and parking area.
