# LINCOLNVILLE COMMUNITY REDEVELOPMENT AREA

PEDESTRIAN CONNECTIVITY STUDY

## PROJECT SCOPE

Building upon the initial framework established in the Lincolnville Streetscape Survey & Analysis ("Phase I") and using that information as a foundational planning tool, Kimley-Horn was tasked with preparing a Pedestrian Connectivity Study ("Phase II") which identifies missing and broken linkages in the existing sidewalk network and the "where and how" of outlining locations where initial improvements are recommended to begin.

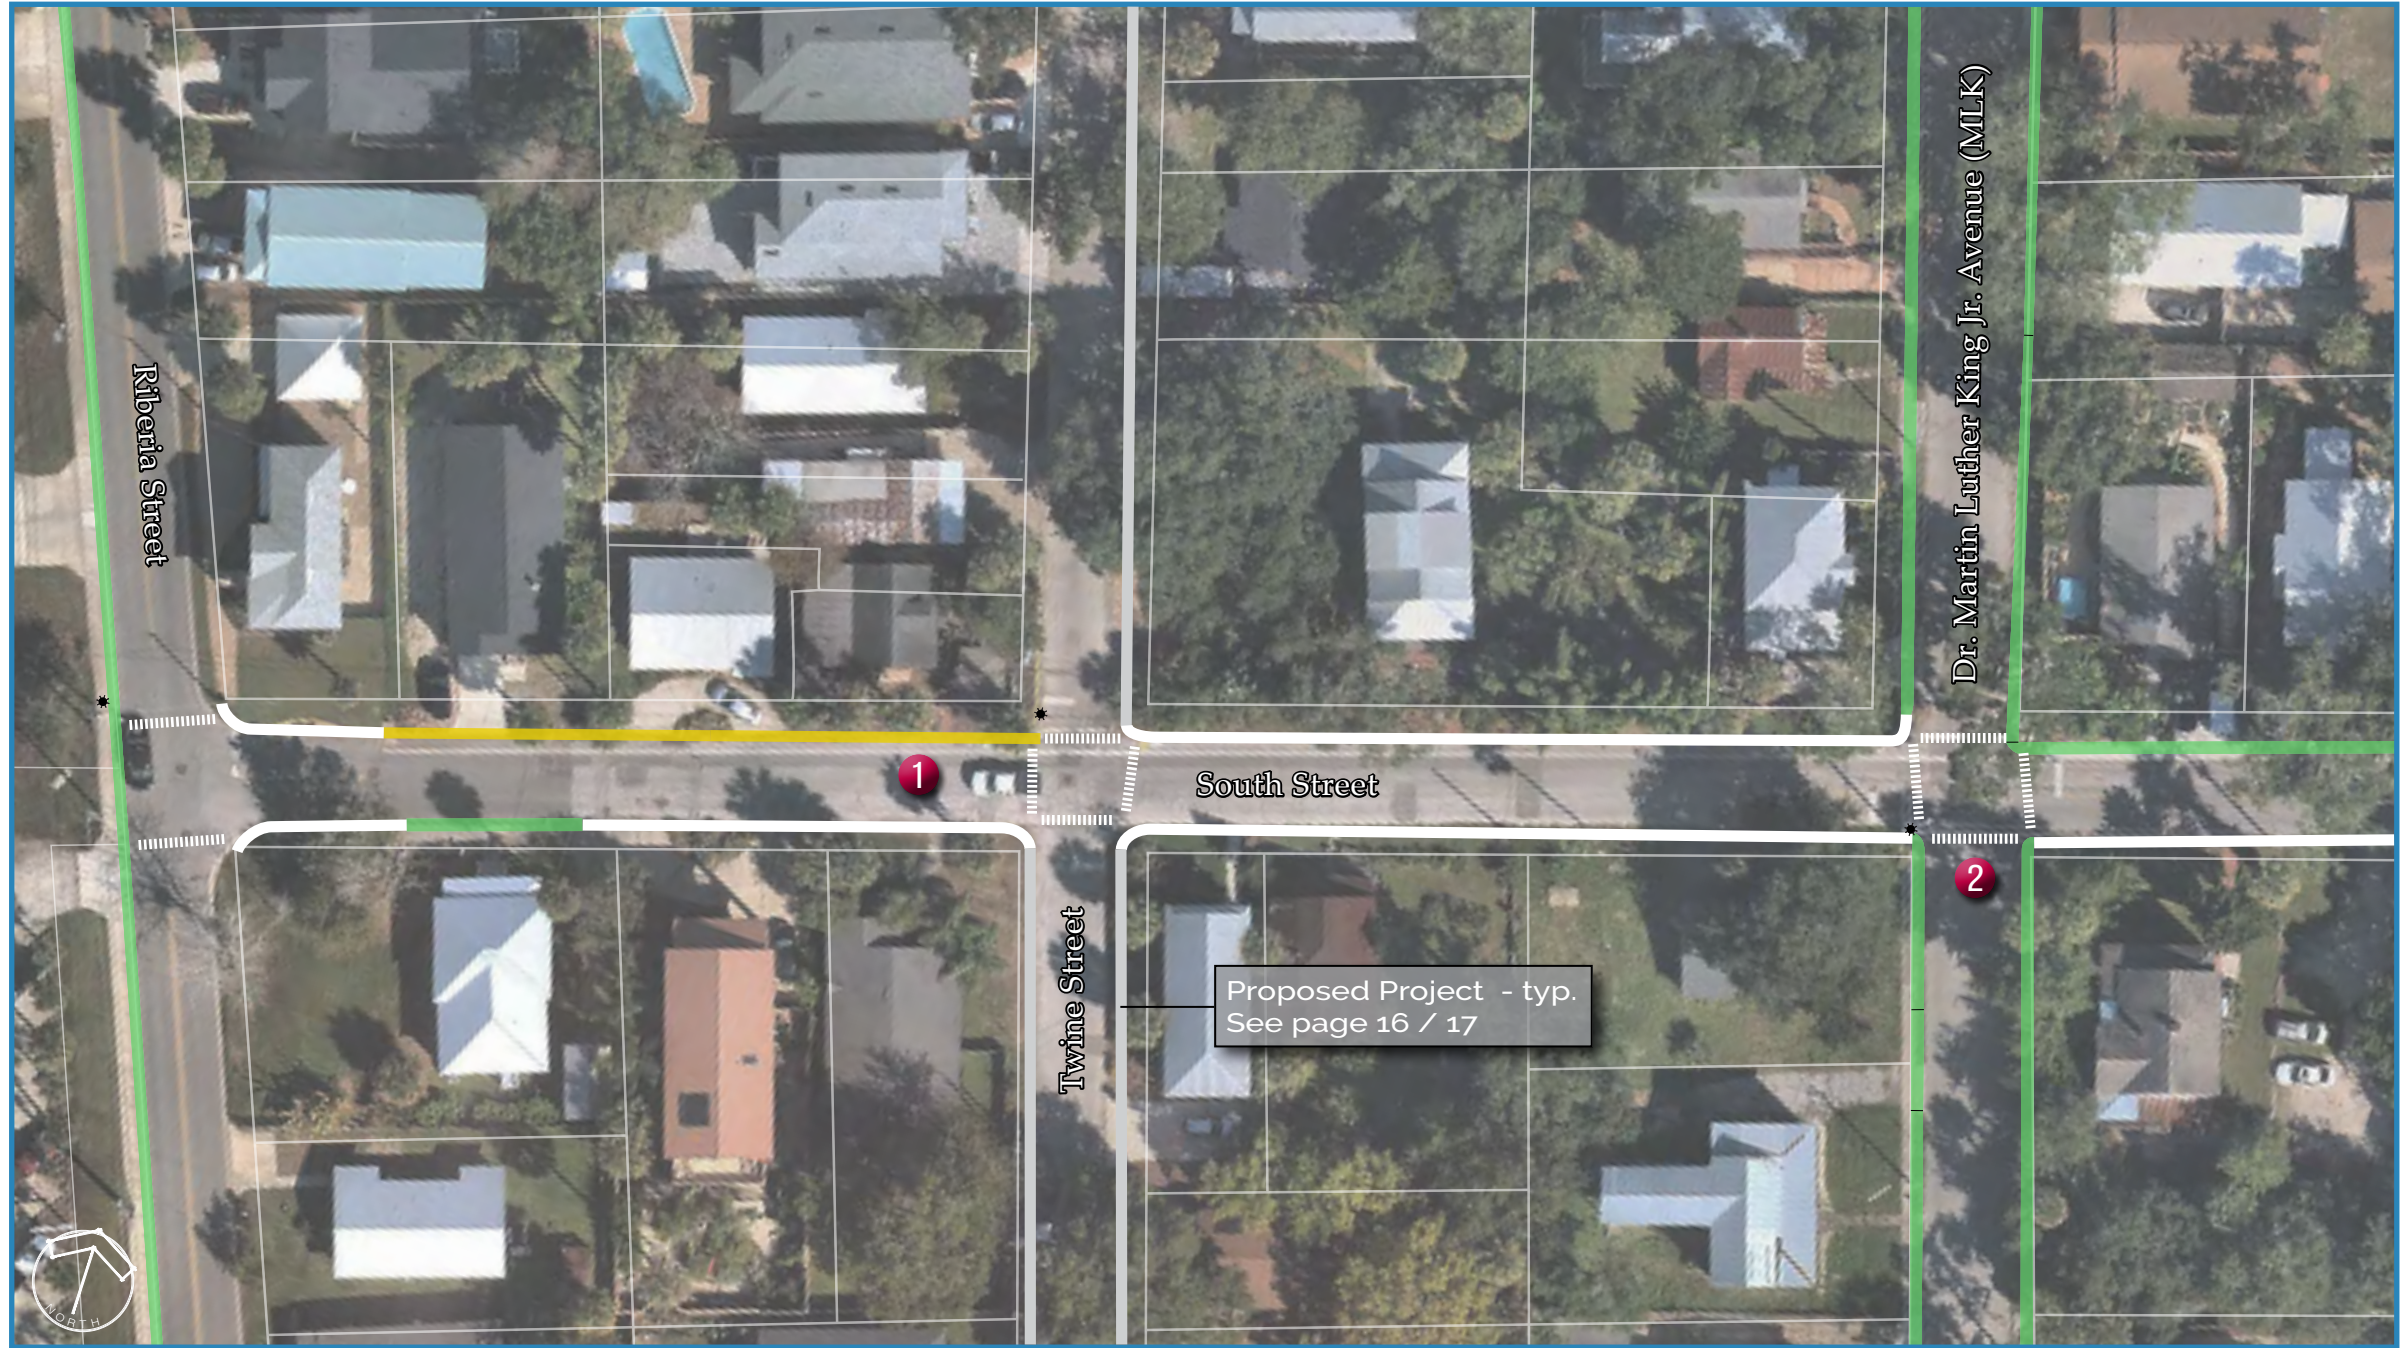
SOUTH STREET (RIBERIA ↔ ONEIDA)

South Street is a highly active, both vehicular and pedestrian, east/west corridor which provides a potential connection from Iberia Street to the southern end of Lake Maria Sanchez. However, with limited sidewalk infrastructure, users are not provided with a safe means of travel and would have to travel a fairly atypical distance north and south to reach the next east/west corridor.

Provide sidewalk and associated infrastructure primarily along both sides of South Street from Iberia Street to Washington

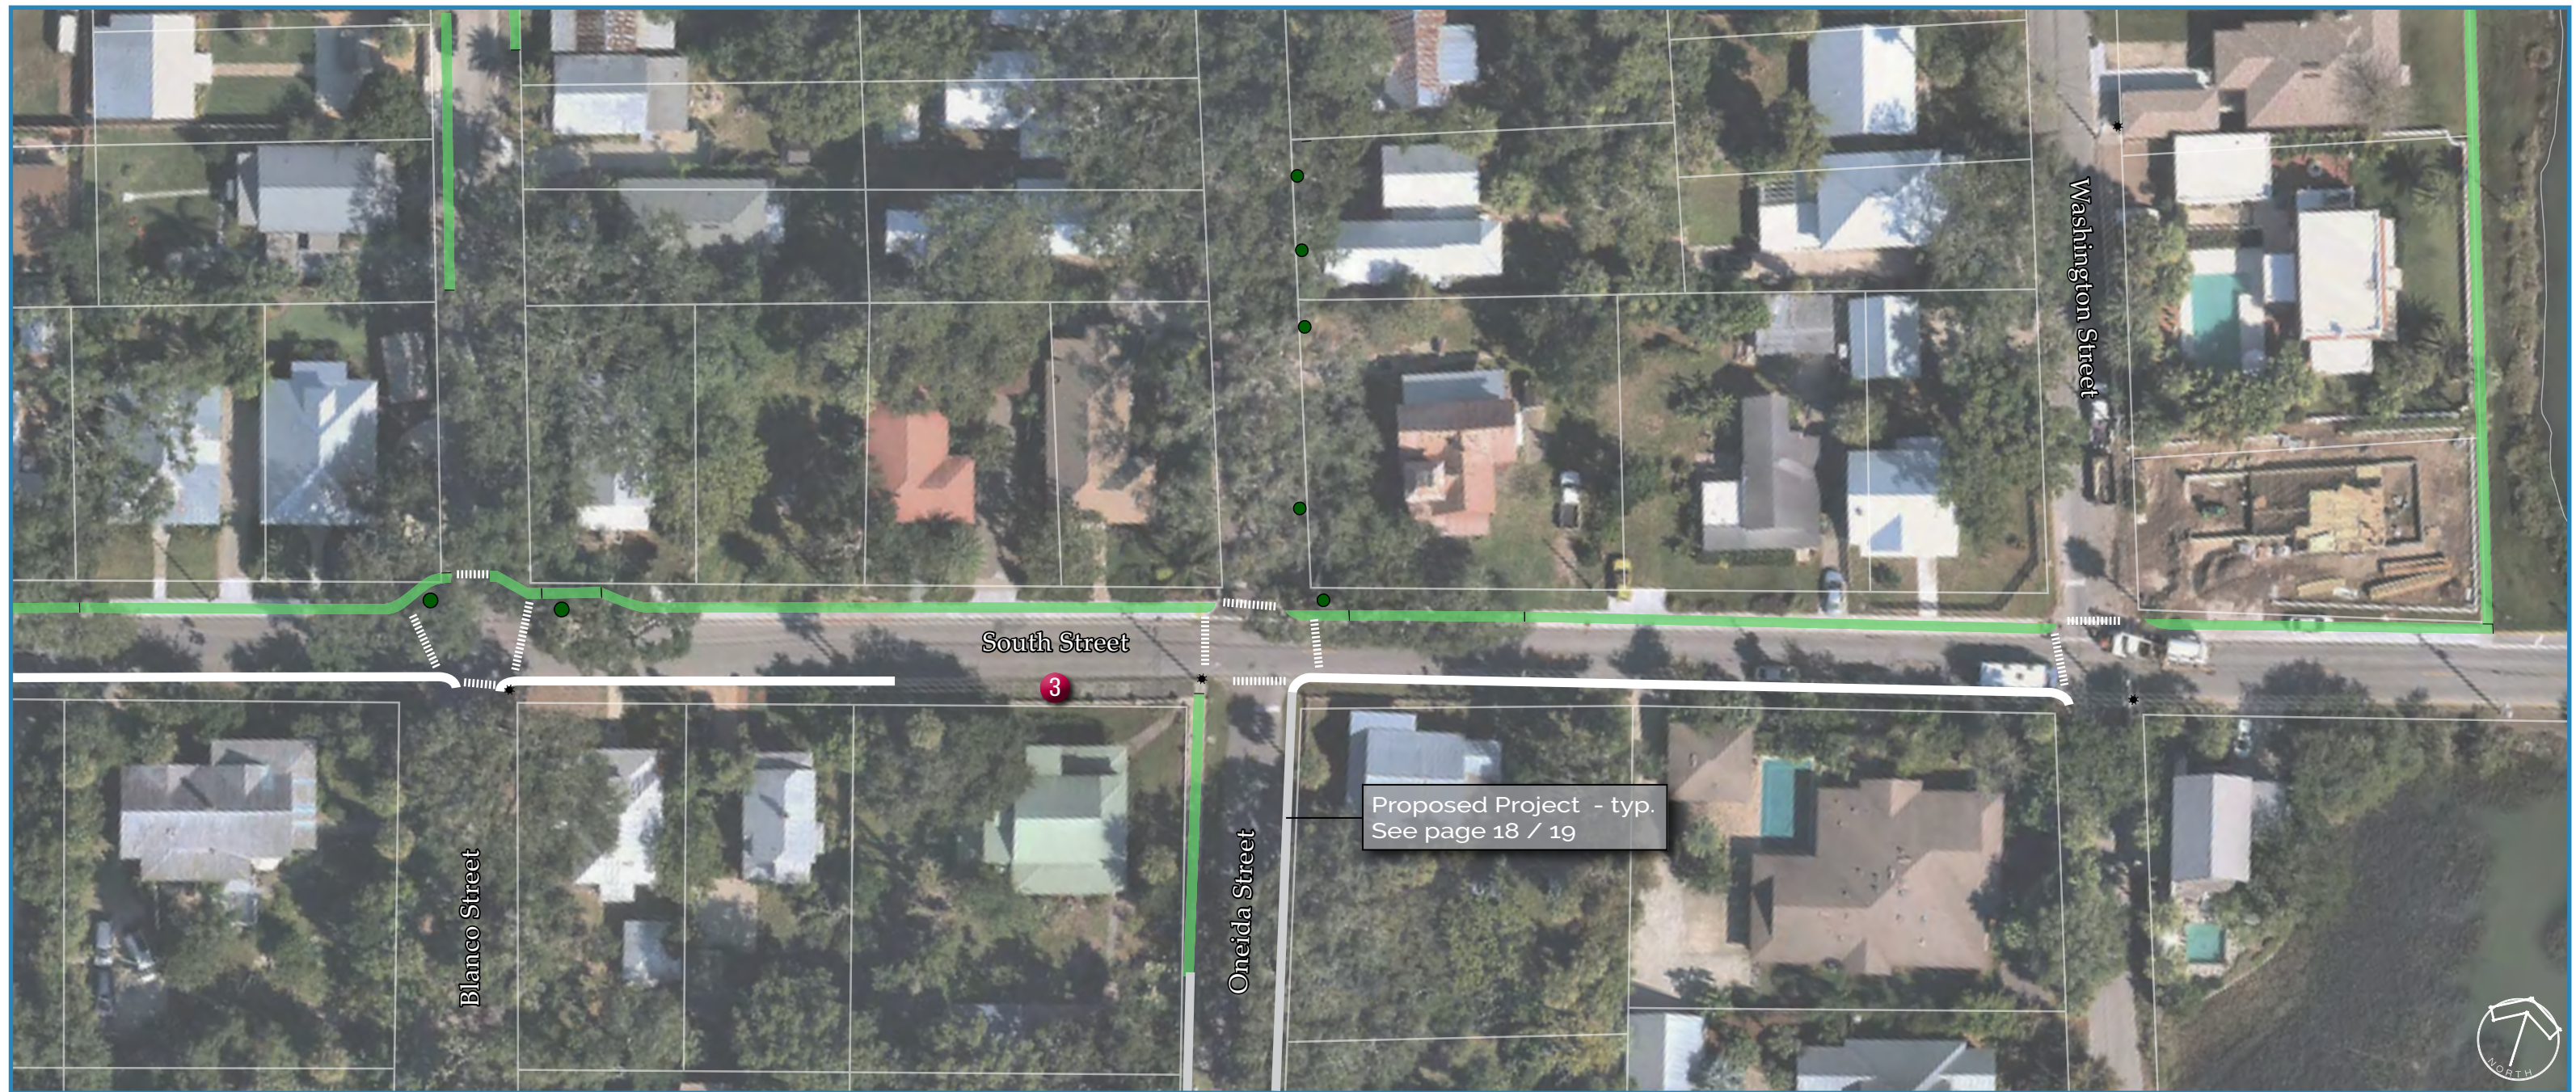
- 1 Existing pedestrian pathway within the roadway to be replaced with sidewalk.
- 2 Provide crosswalks as shown.
- 3 Existing slate sidewalk to remain.

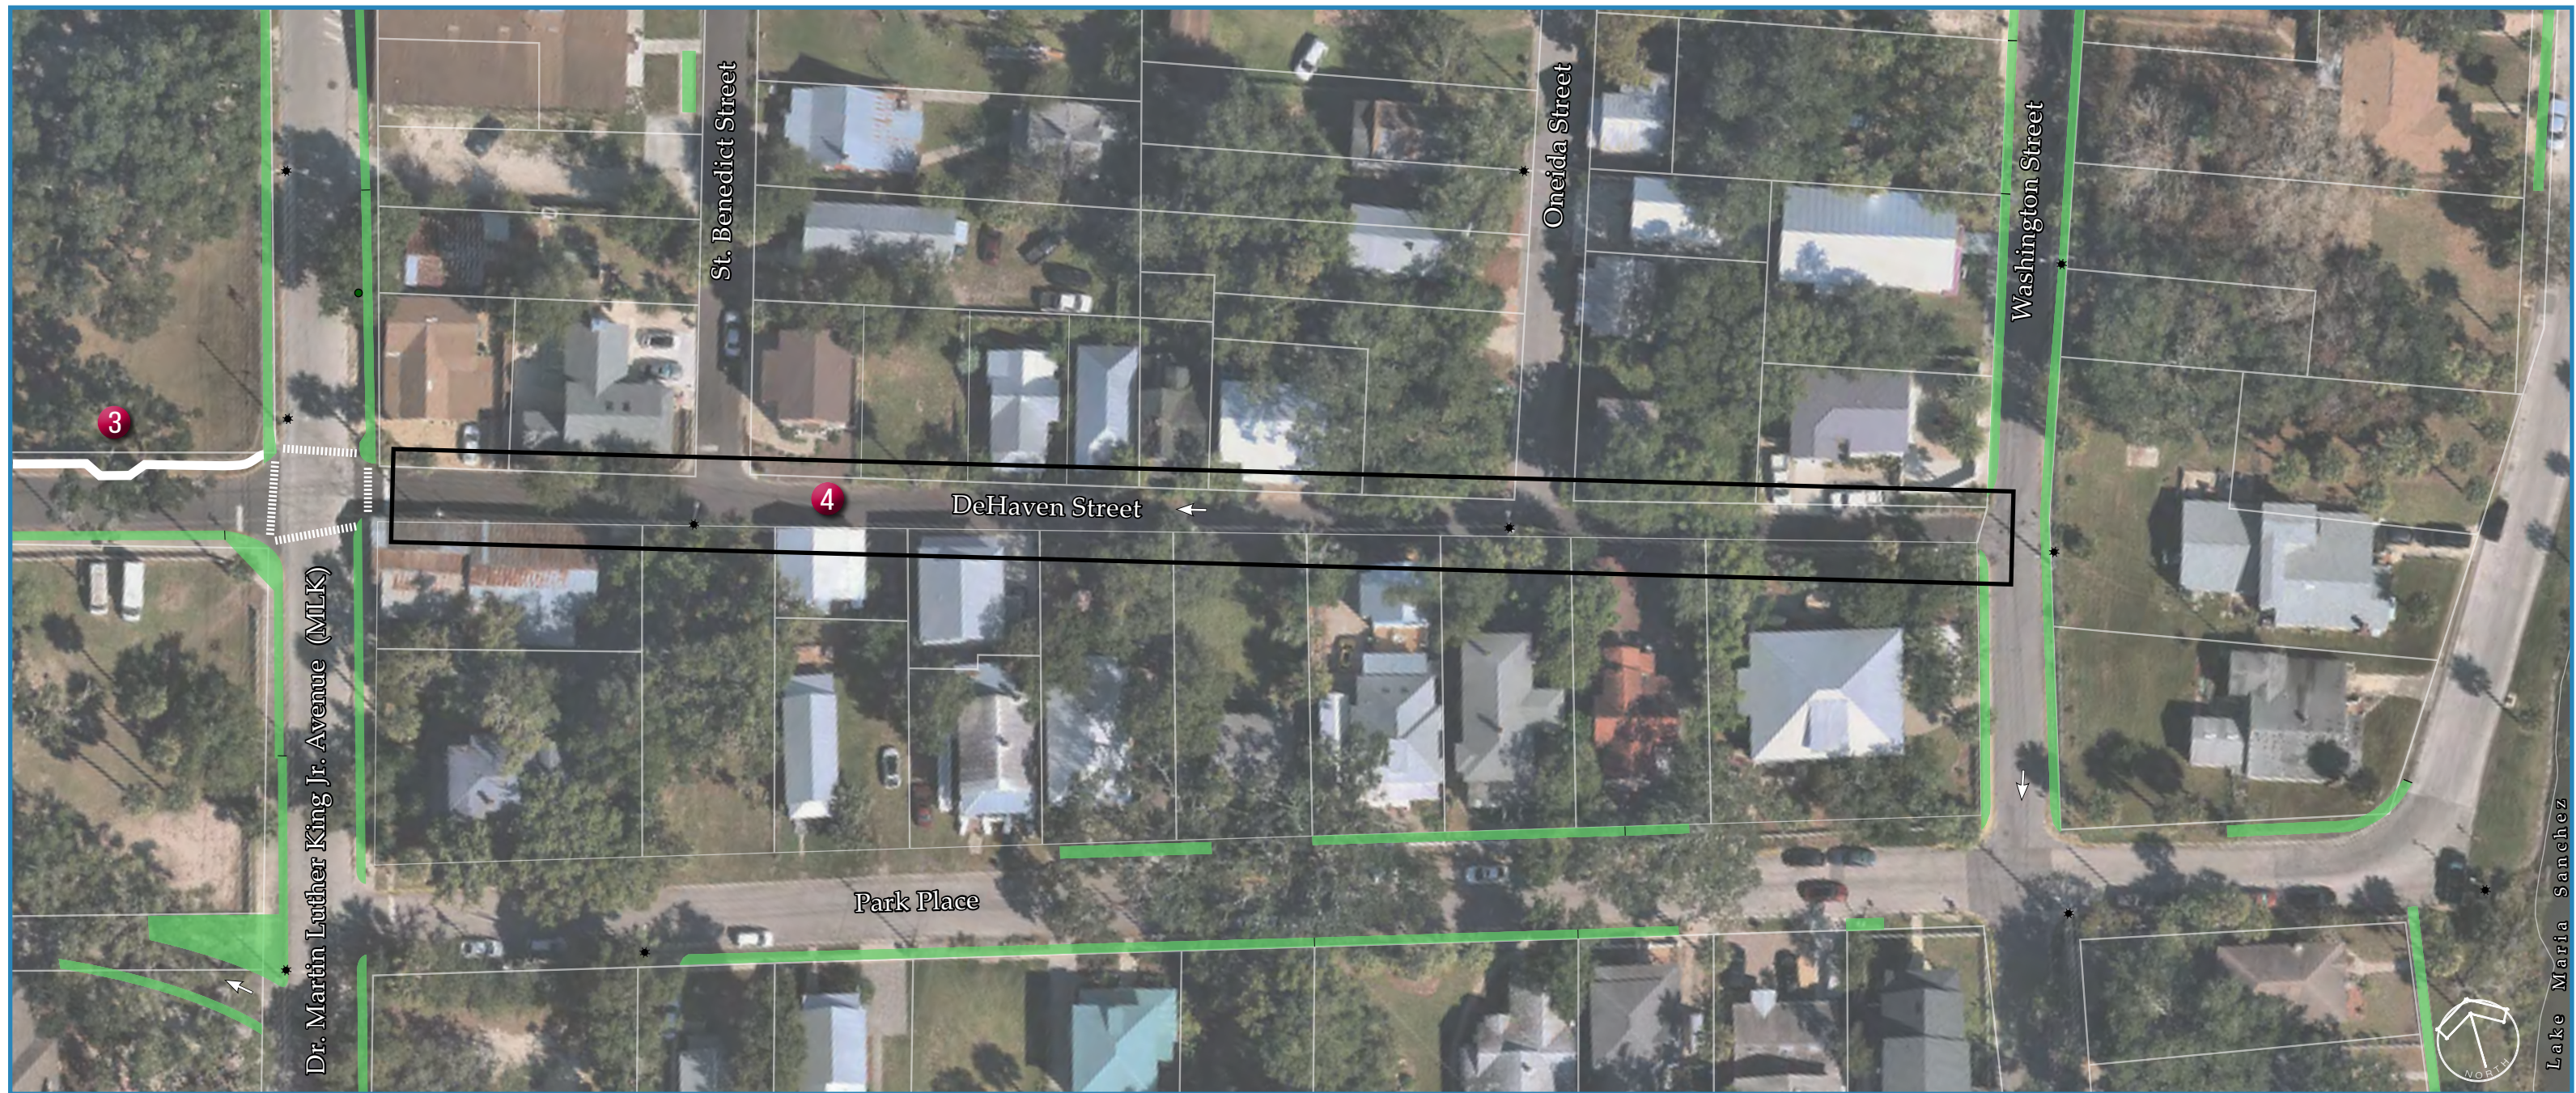
DeHAVEN STREET (RIBERIA ↔ MLK)

- 1 Route sidewalk around utilities / power pole locations by adjusting sidewalk width and/or location. Minimum 36" width (32" for brief obstructions) per FBC.
- 2 Provide crosswalks as shown.
- 3 Existing large trees within the right-of-way may require alternate sidewalk layout. See Strategy #1, page 20.
- 4 This area (MLK to Washington) was visually explored and deemed likely too narrow to accommodate both pedestrian and vehicular uses safely. However, this pedestrian connection would be valuable in completing the full DeHaven Street east/west pedestrian corridor.

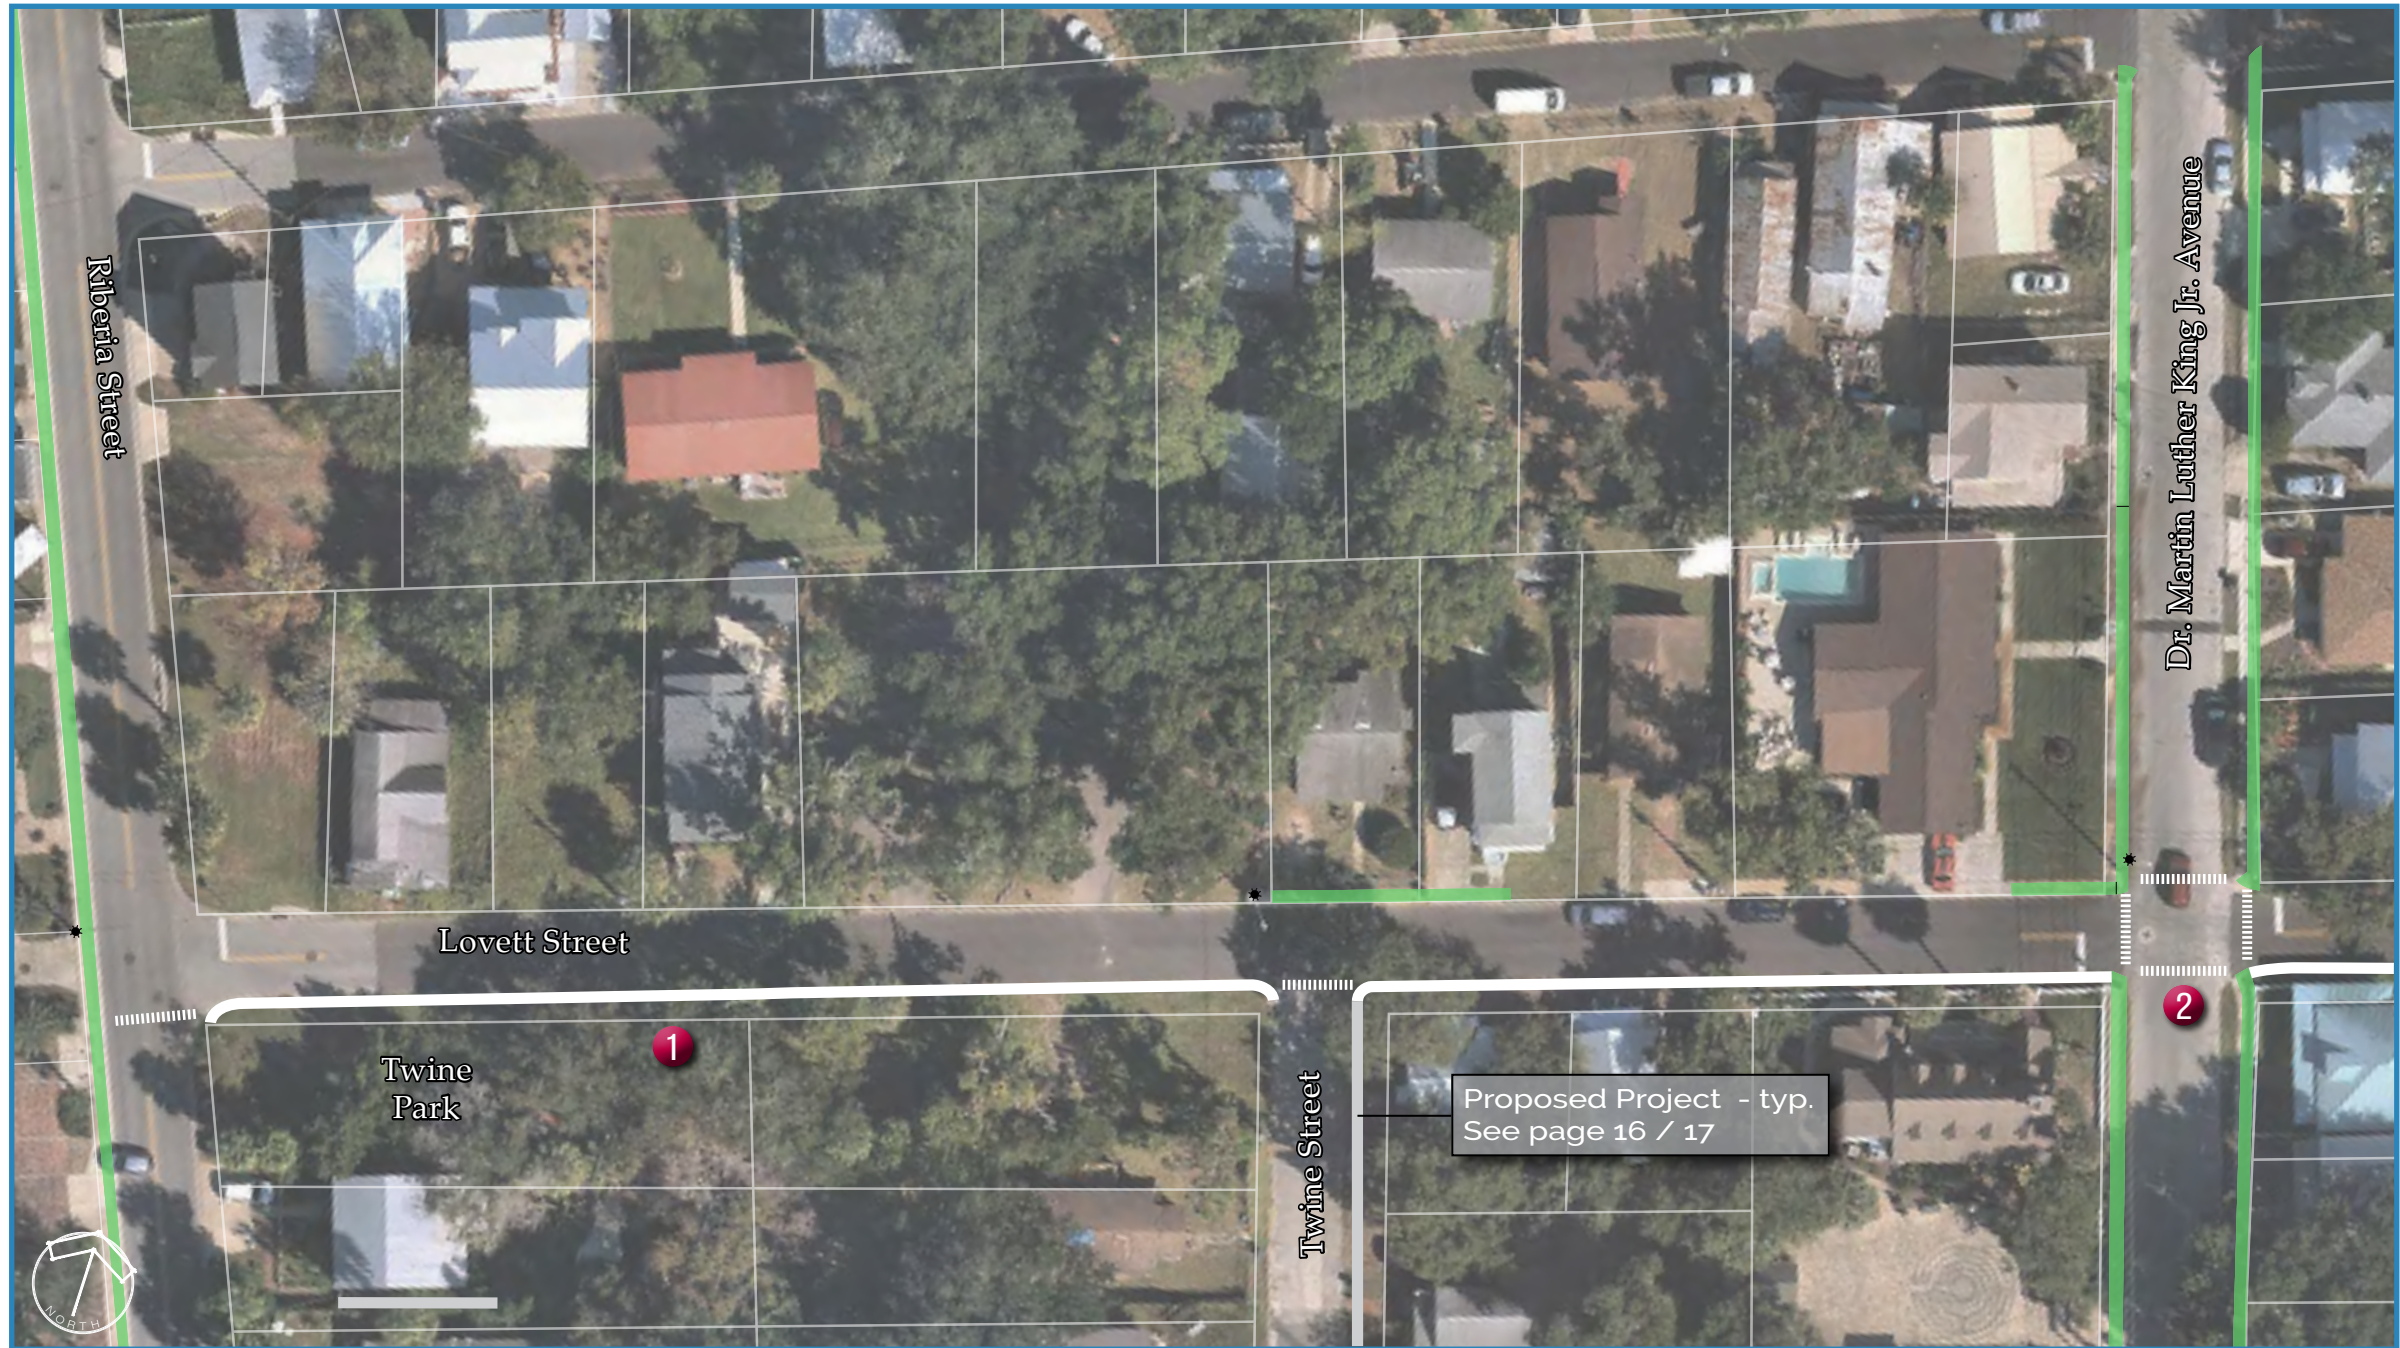
This aerial photograph shows DeHaven Street running east-west. A green line along the north side of the street indicates the proposed project area. A text box in the upper left corner reads "Proposed Project - typ. See page 14 / 15". Surrounding streets labeled include Weeden Street, Sanford Street, Riberia Street, and Moore Street. A north arrow is in the bottom left corner. Red circles with numbers 1 and 2 are placed on the map to indicate specific locations of interest.

DeHaven Street is a centrally located east/west corridor which provides a potential connection from Riberia Street to the Lincolnville core with its intersection at MLK. However, with limited sidewalk infrastructure, users are not provided with a safe means of travel and would have to travel several blocks to the north and south to find another safe east/west connection.

Provide sidewalk and associated infrastructure primarily along the north side of DeHaven from Riberia Street to MLK

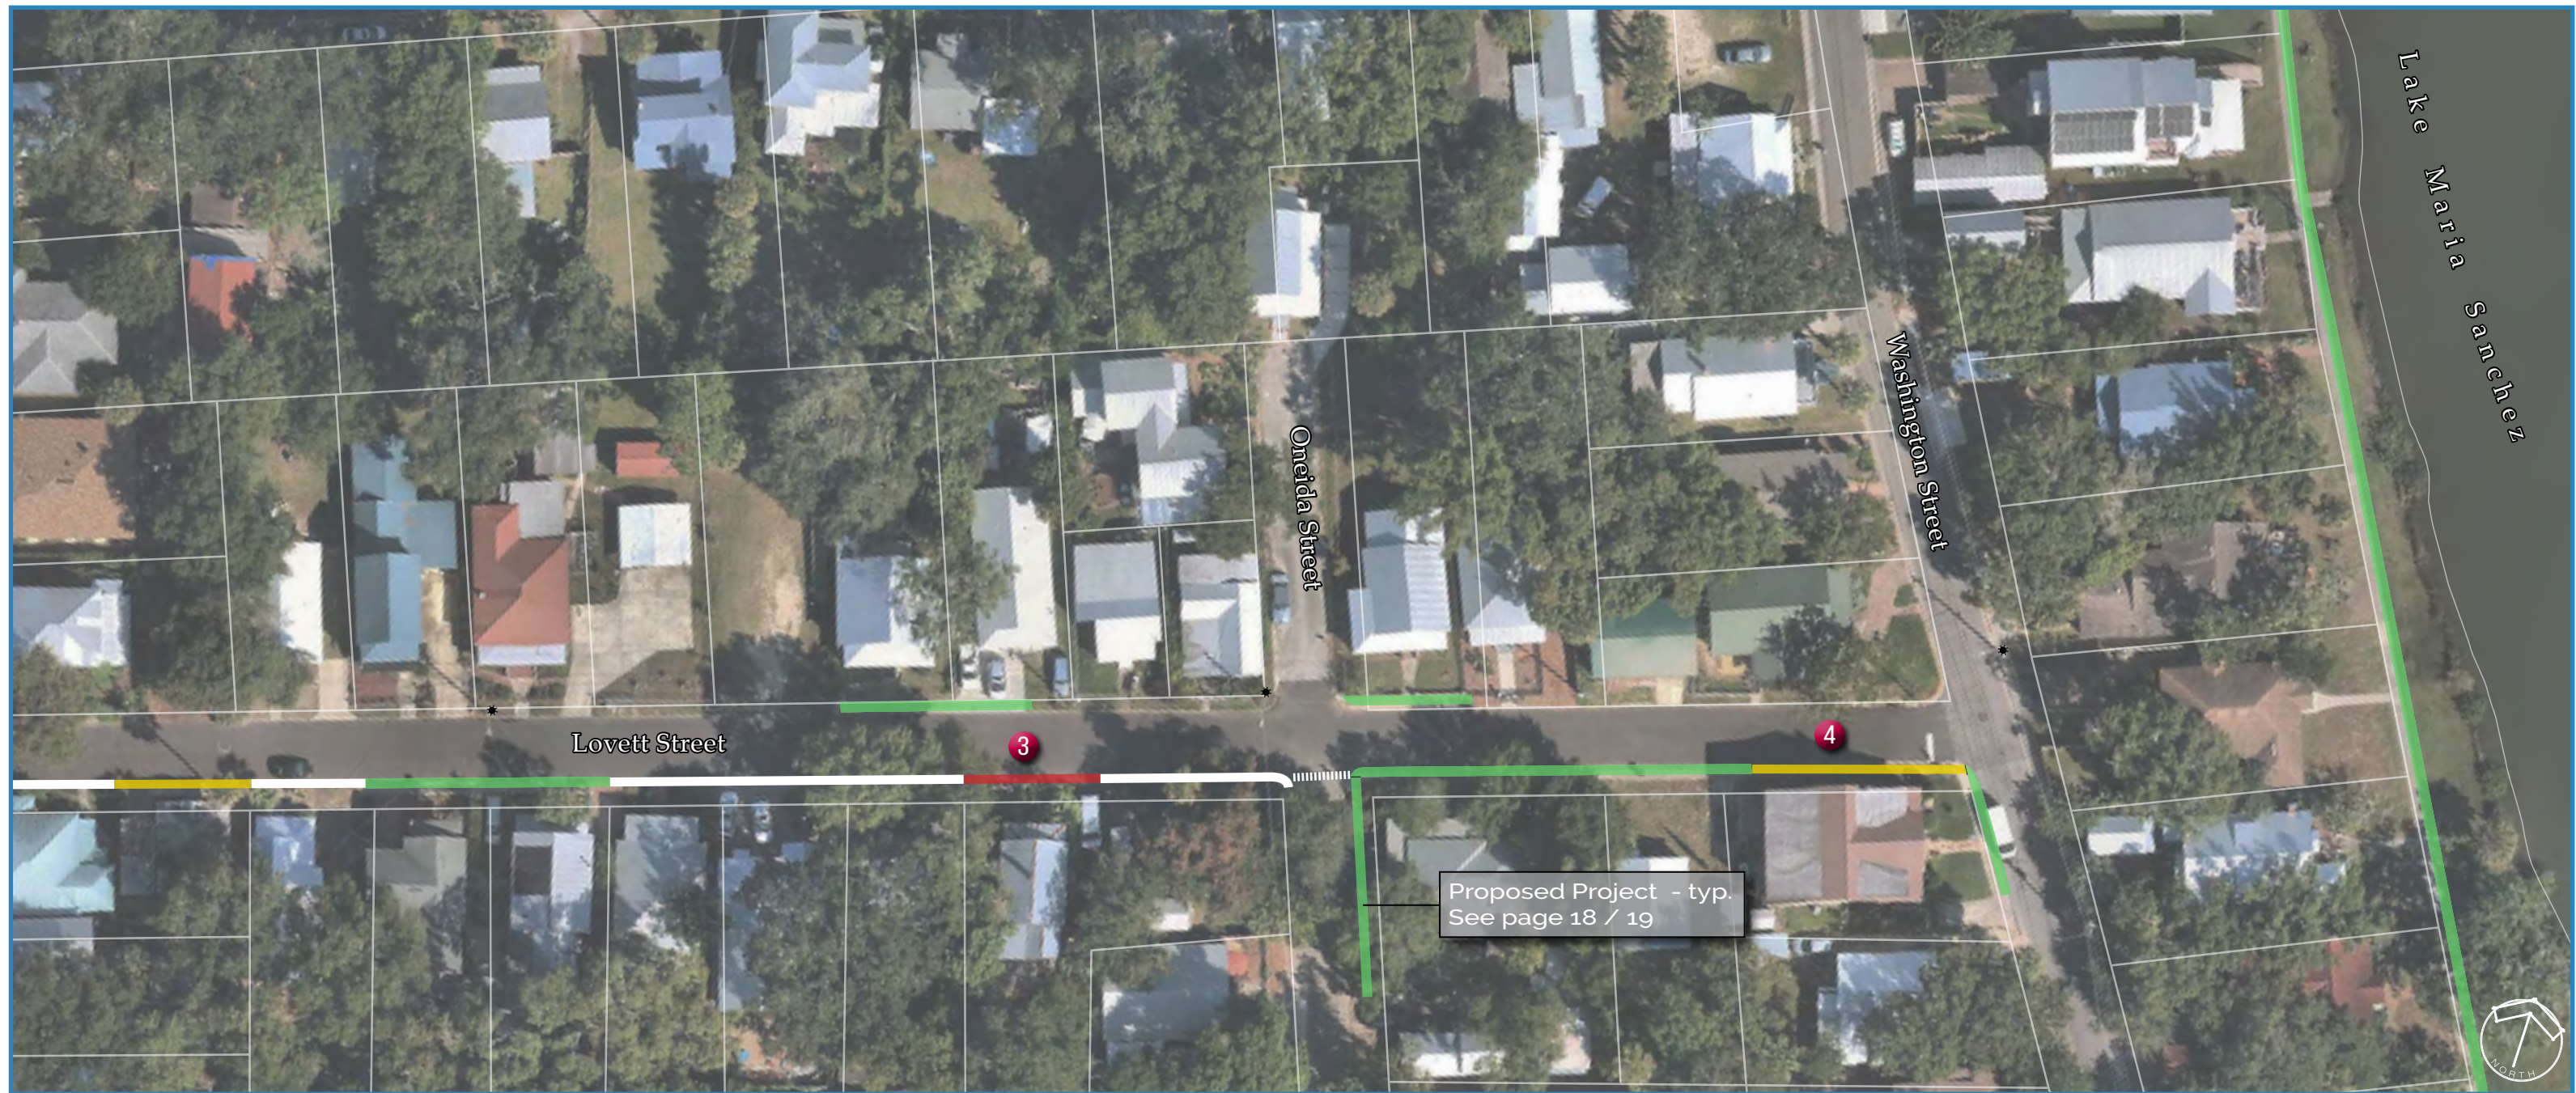
## **3** LOVETT STREET (RIBERIA ↔ WASHINGTON)

- 1 Palm Trees at Twine Park to be removed to allow sidewalk connection. New palms can be planted within the park.
- 2 Provide crosswalks as shown.
- 3 Existing Driveways may need repairs and/or alterations to connect with sidewalk.
- 4 Existing sidewalk is too narrow Existing slate sidewalk of historic significance to remain.

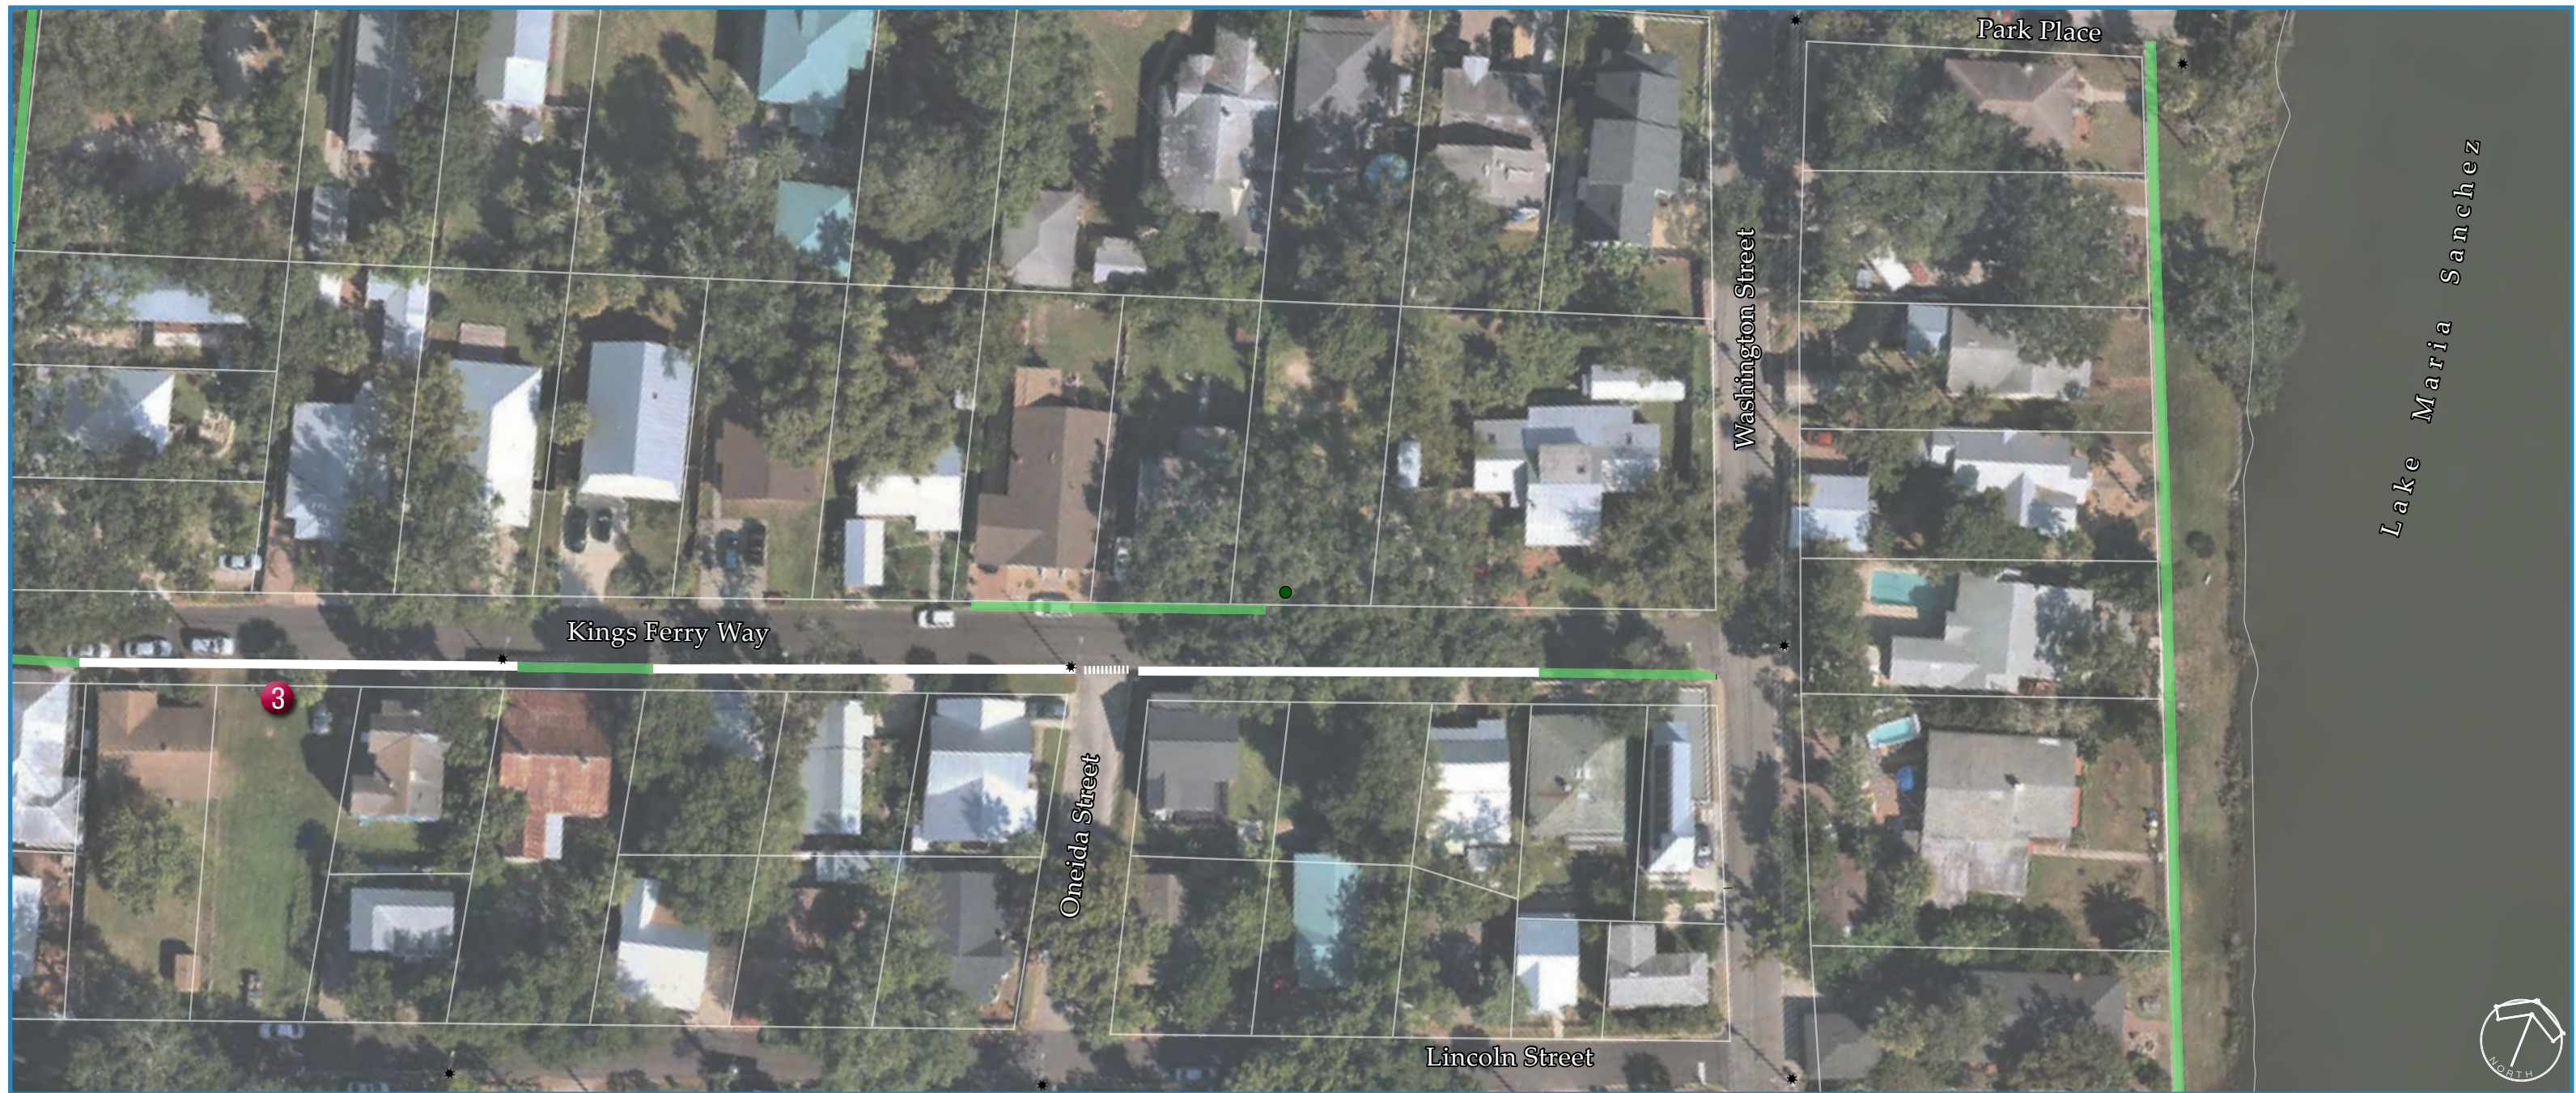
KINGS FERRY WAY

- 1 Route sidewalk around utilities / power pole locations by adjusting sidewalk width and/or location. Minimum 36" width (32" for brief obstructions) per FBC.
- 2 Provide crosswalks as shown.
- 3 Existing small trees within the right-of-way will require removal (palms and improperly pruned trees).
- 4 Sidewalk section previously identified as "Bad" to be removed prior to sidewalk installation.

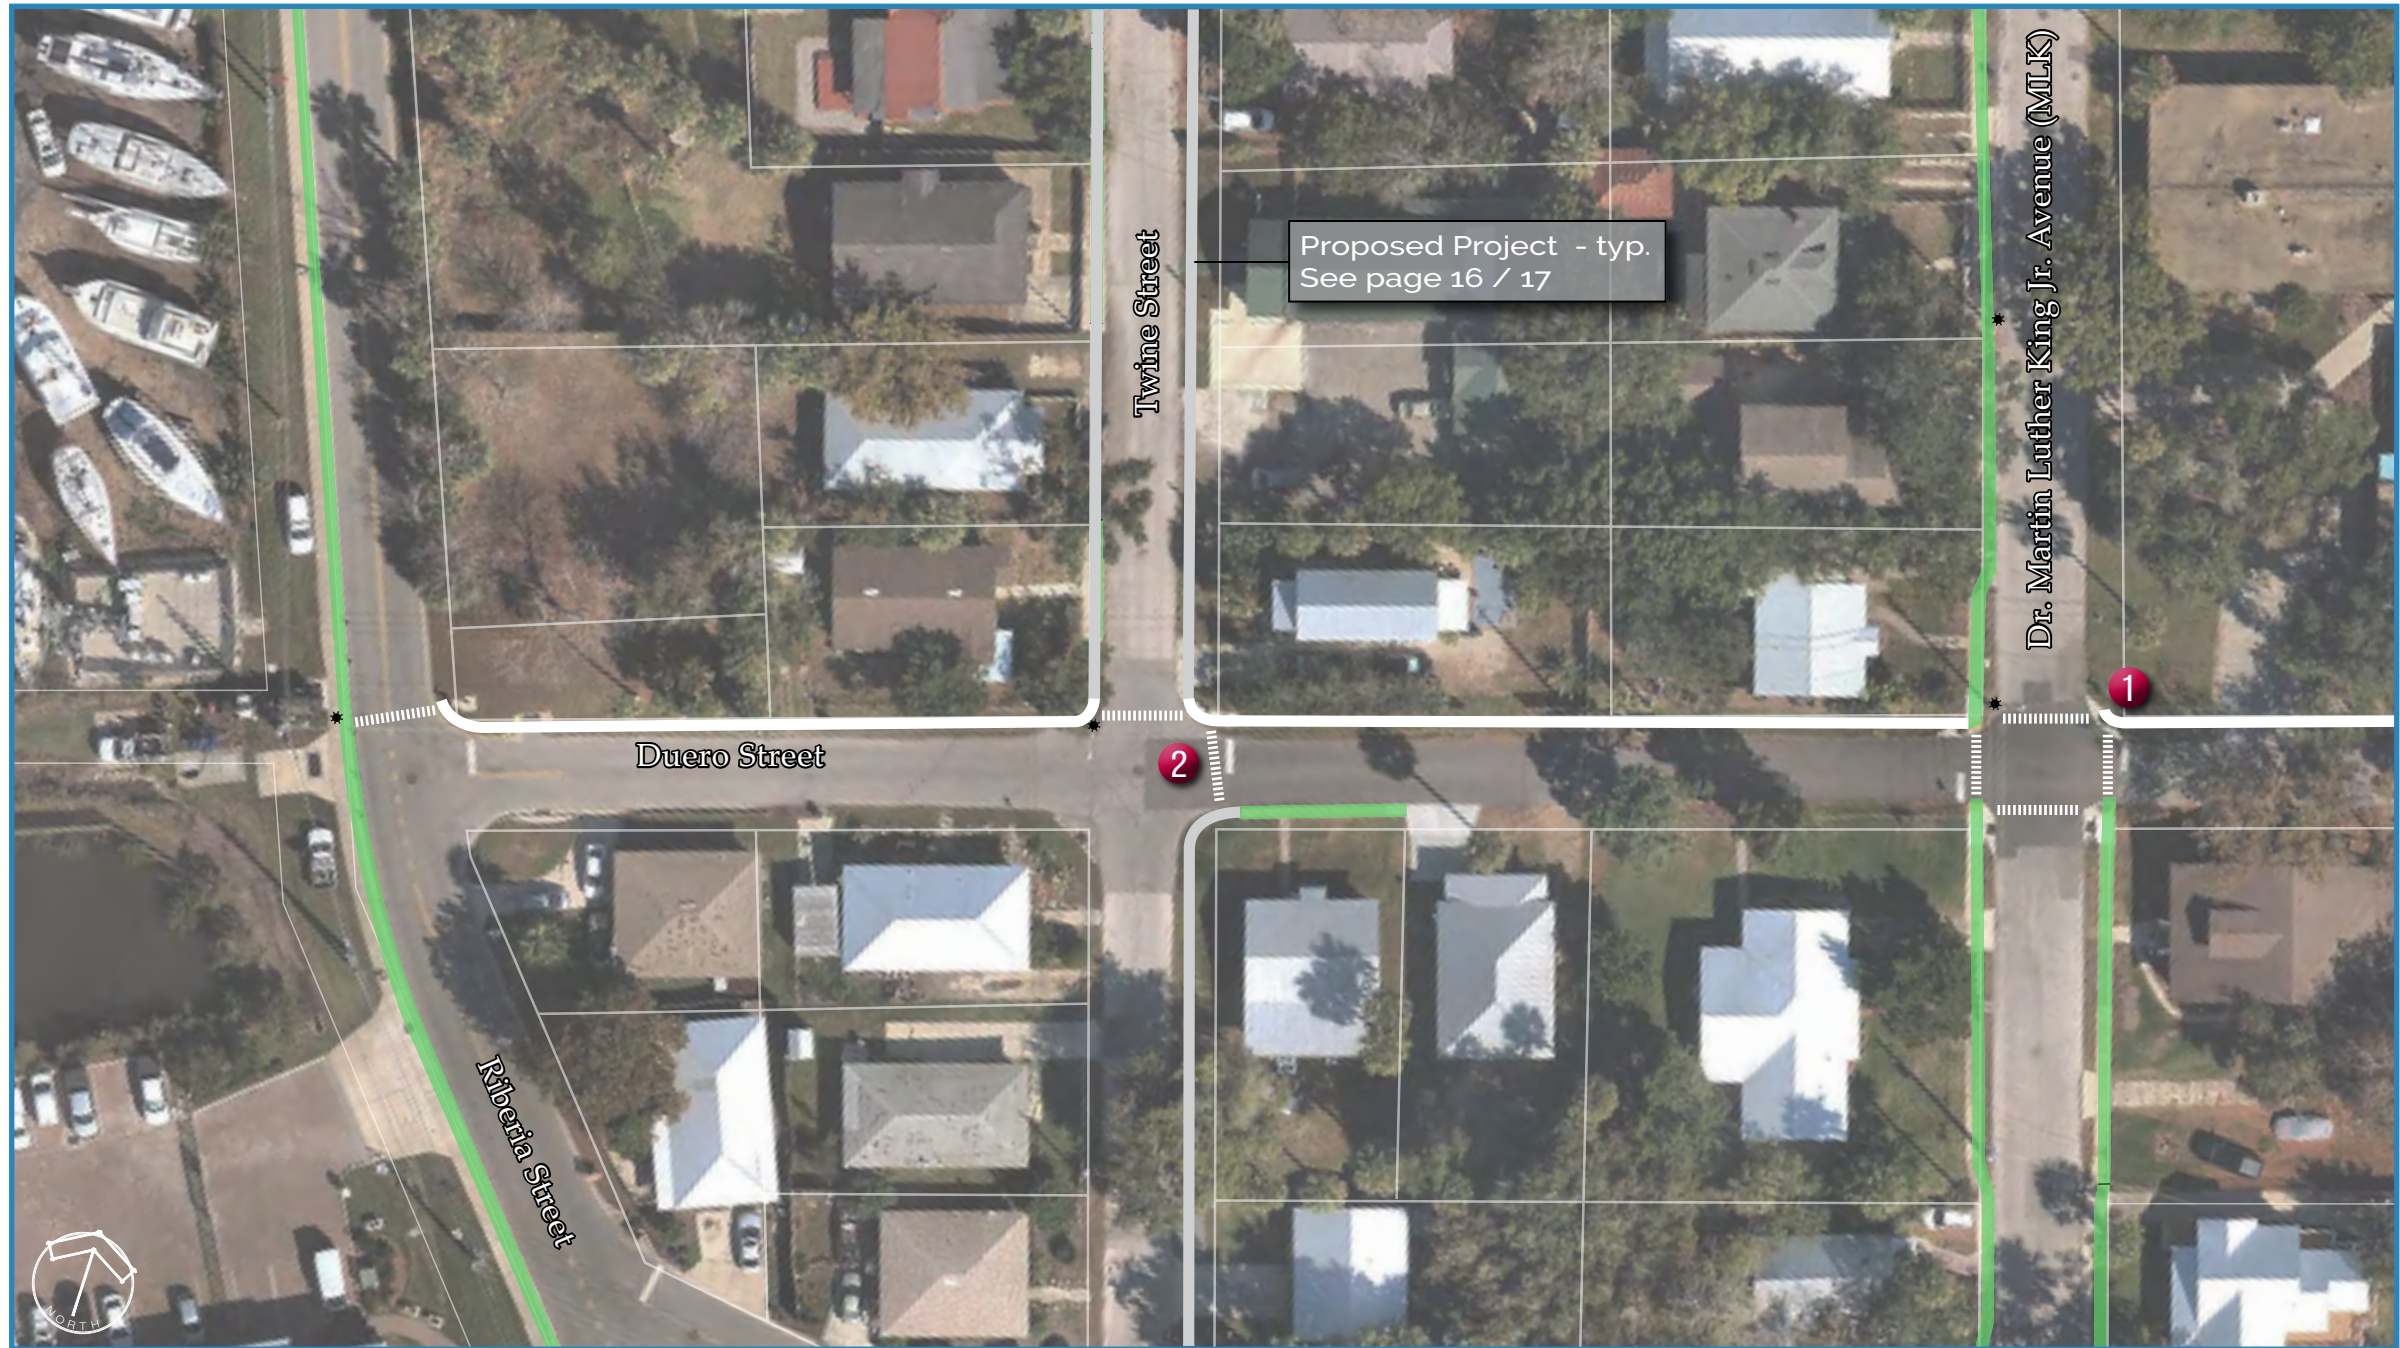
This aerial map shows Kings Ferry Way running east-west. Riberia Street is on the left, and Washington Street is on the right. Kings Ferry Way is highlighted in red. The area between Riberia Street and Washington Street is highlighted in green. The map shows the layout of the street, including intersections with Pomar Street, School Street, and Dr. Martin Luther King Jr. Avenue (MLK). A north arrow is located in the bottom left corner.

Kings Ferry Way is a centrally located east/west corridor which provides a potential connection from Riberia Street through the Lincolnville core ending at Washington Street. However, with very limited sidewalk infrastructure, users are not provided with a safe means of travel and would have to travel several blocks to the north and south to find another safe east/west connection.

Provide sidewalk and associated infrastructure primarily along the south side of Kings Ferry Way from Riberia Street to Washington Street.
