# LINCOLNVILLE COMMUNITY REDEVELOPMENT AREA

PEDESTRIAN CONNECTIVITY STUDY

## PROJECT SCOPE

Building upon the initial framework established in the Lincolnville Streetscape Survey & Analysis ("Phase I") and using that information as a foundational planning tool, Kimley-Horn was tasked with preparing a Pedestrian Connectivity Study ("Phase II") which identifies missing and broken linkages in the existing sidewalk network and the "where and how" of outlining locations where initial improvements are recommended to begin.

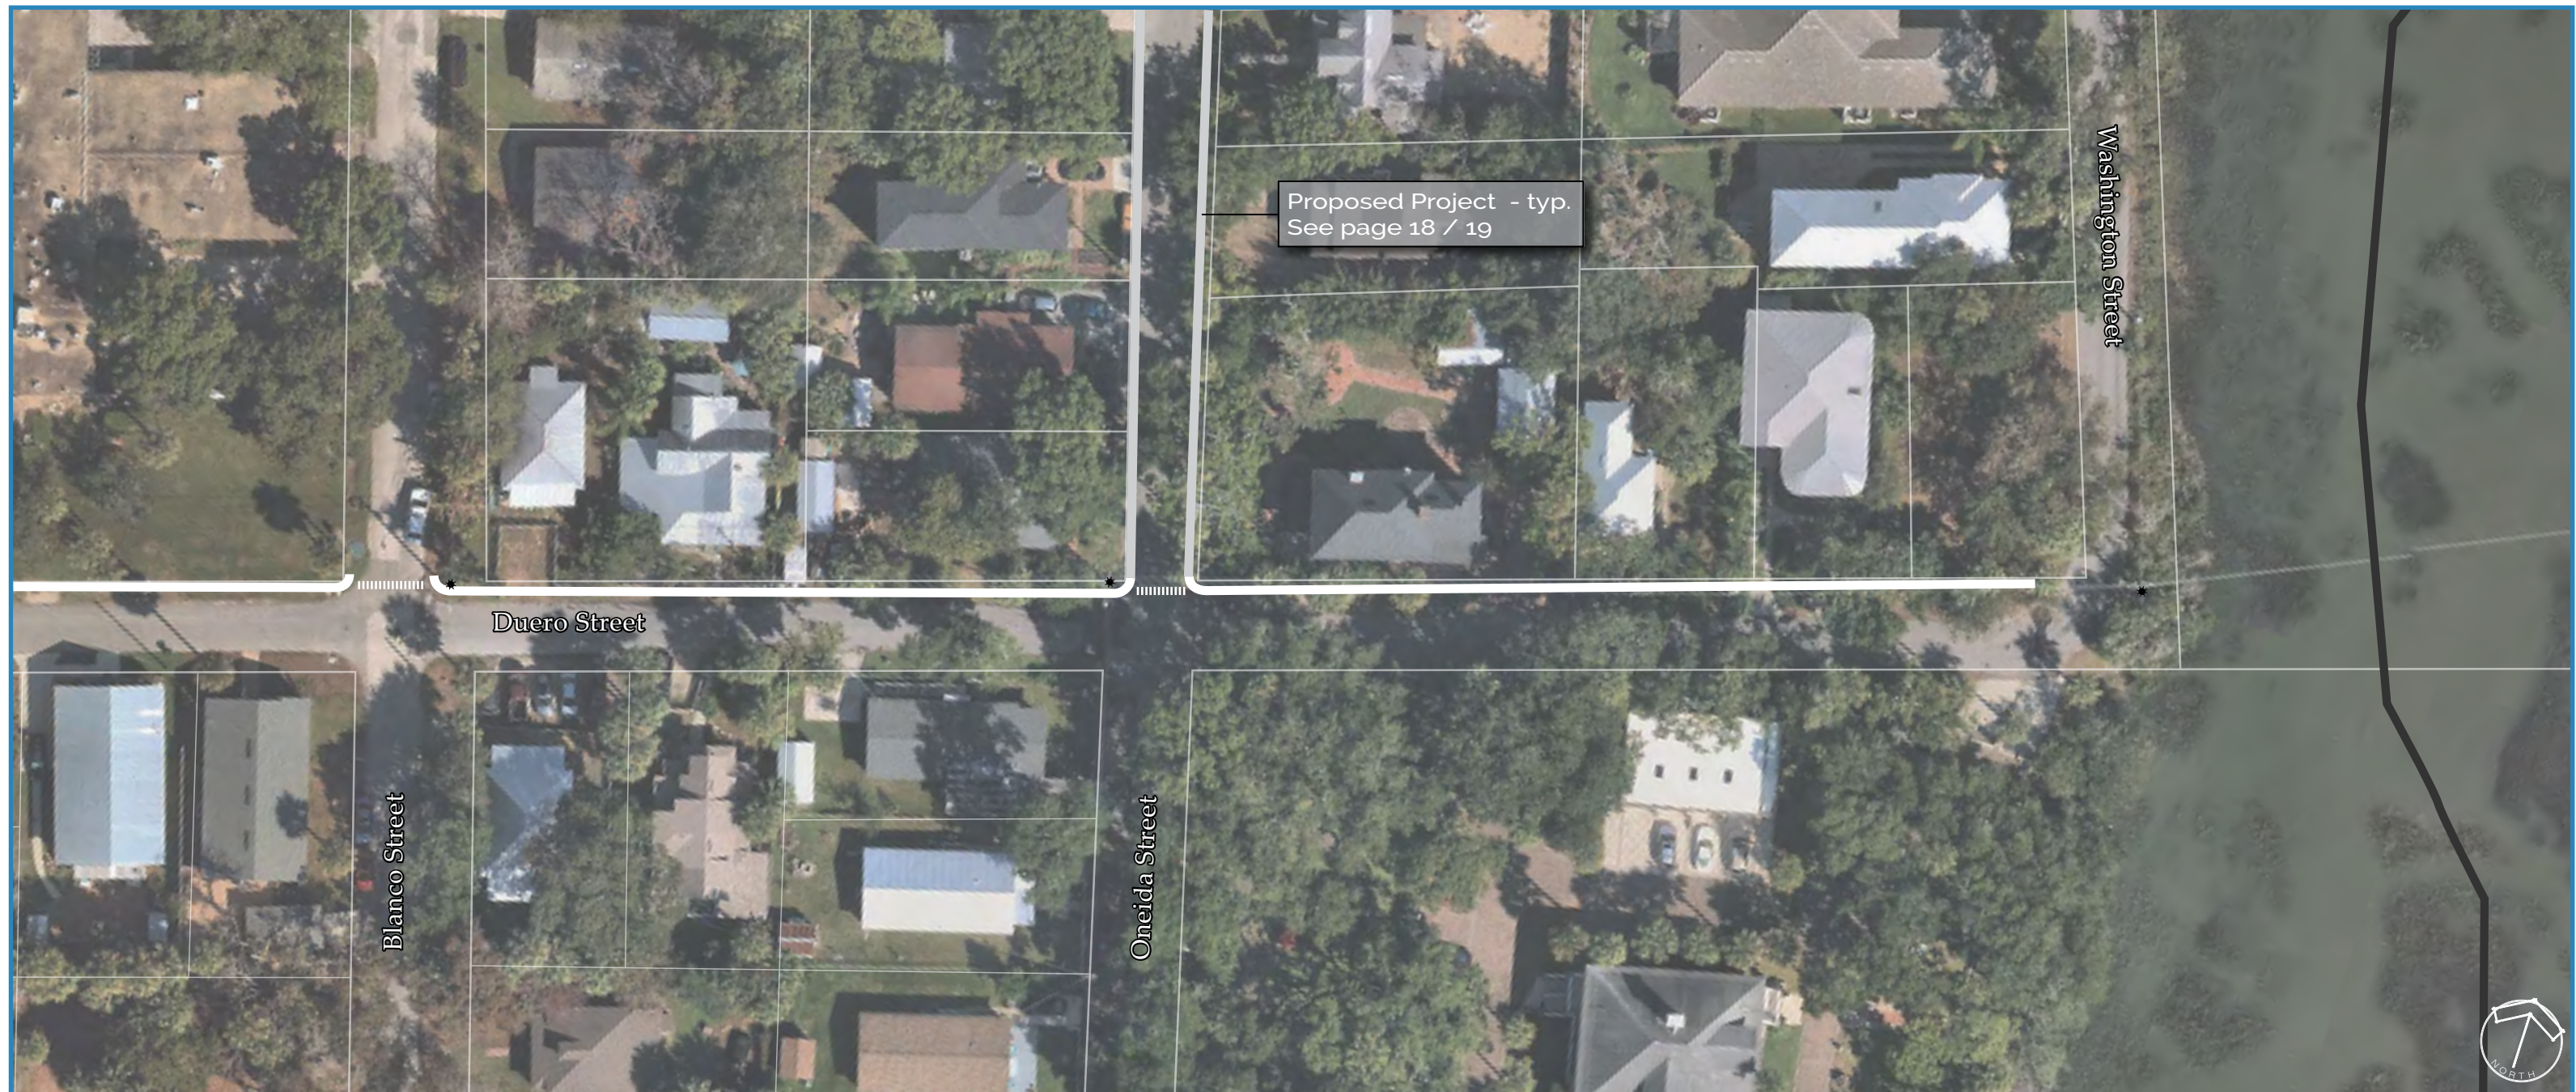
## 5 DUERO STREET (RIBERIA ↔ WASHINGTON)

- 1 Existing stormwater management system to be integrated into proposed sidewalk/curb.
- 2 Provide crosswalks as shown.

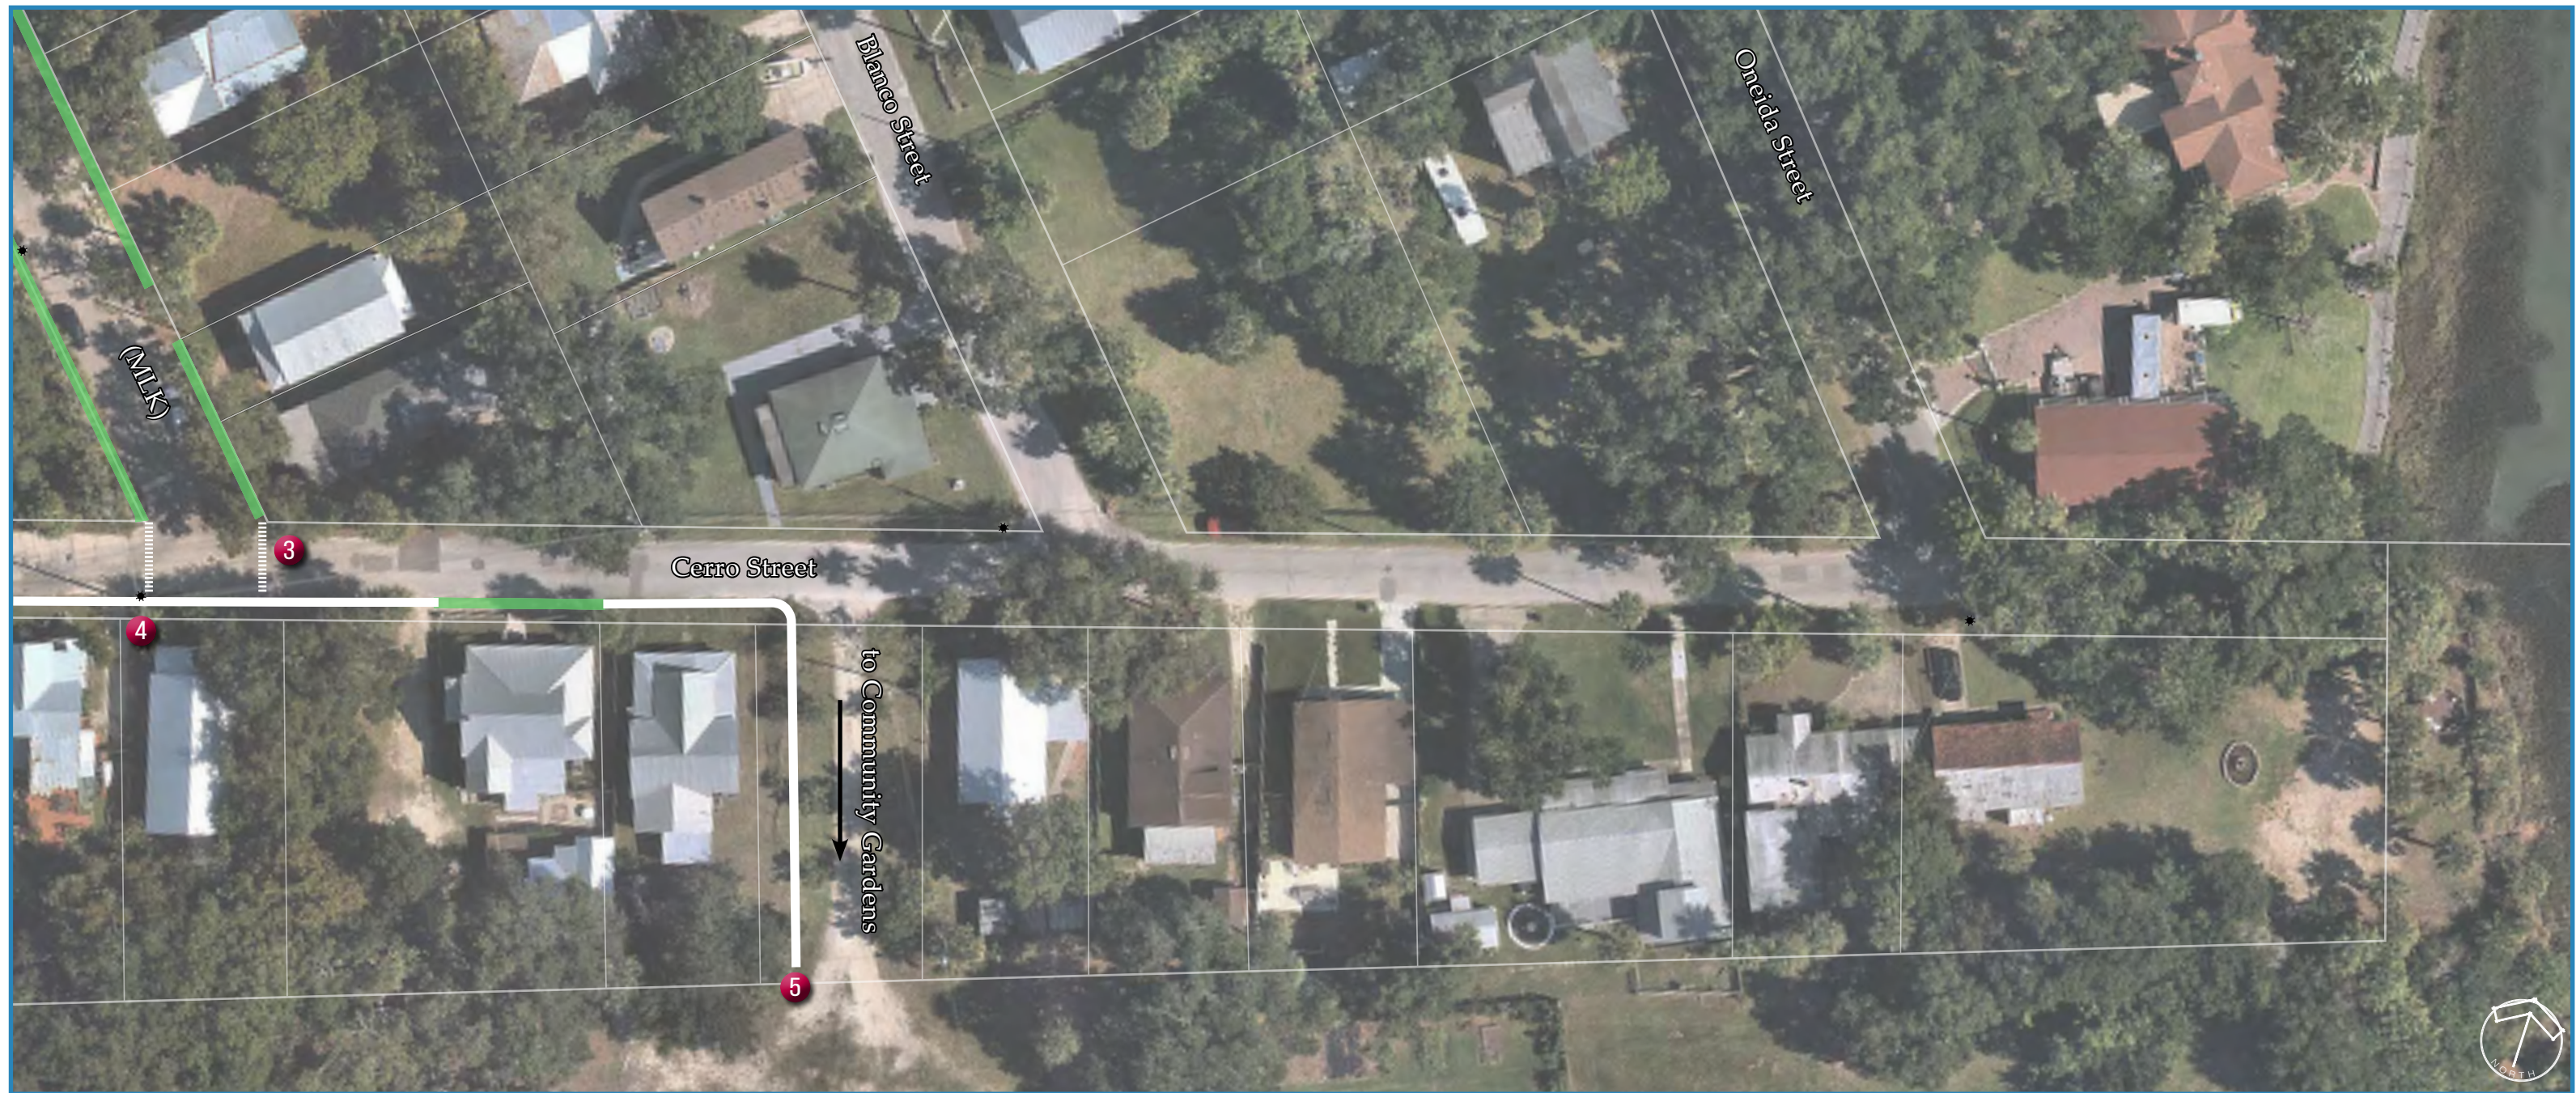
## 6 CERRO STREET (RIBERIA ↔ BLANCO)

- 1 Recommend to relocate crosswalk across Riberia to intersection of Cerro.
- 2 Repair sidewalk connection to Willie Galimore Center parking lot.
- 3 Provide crosswalks as shown.
- 4 Route sidewalk around utilities / power pole locations by adjusting sidewalk width and/or location. Minimum 36" width (32" for brief obstructions) per FBC.
- 5 Extend sidewalk connection to Community Gardens parking area.

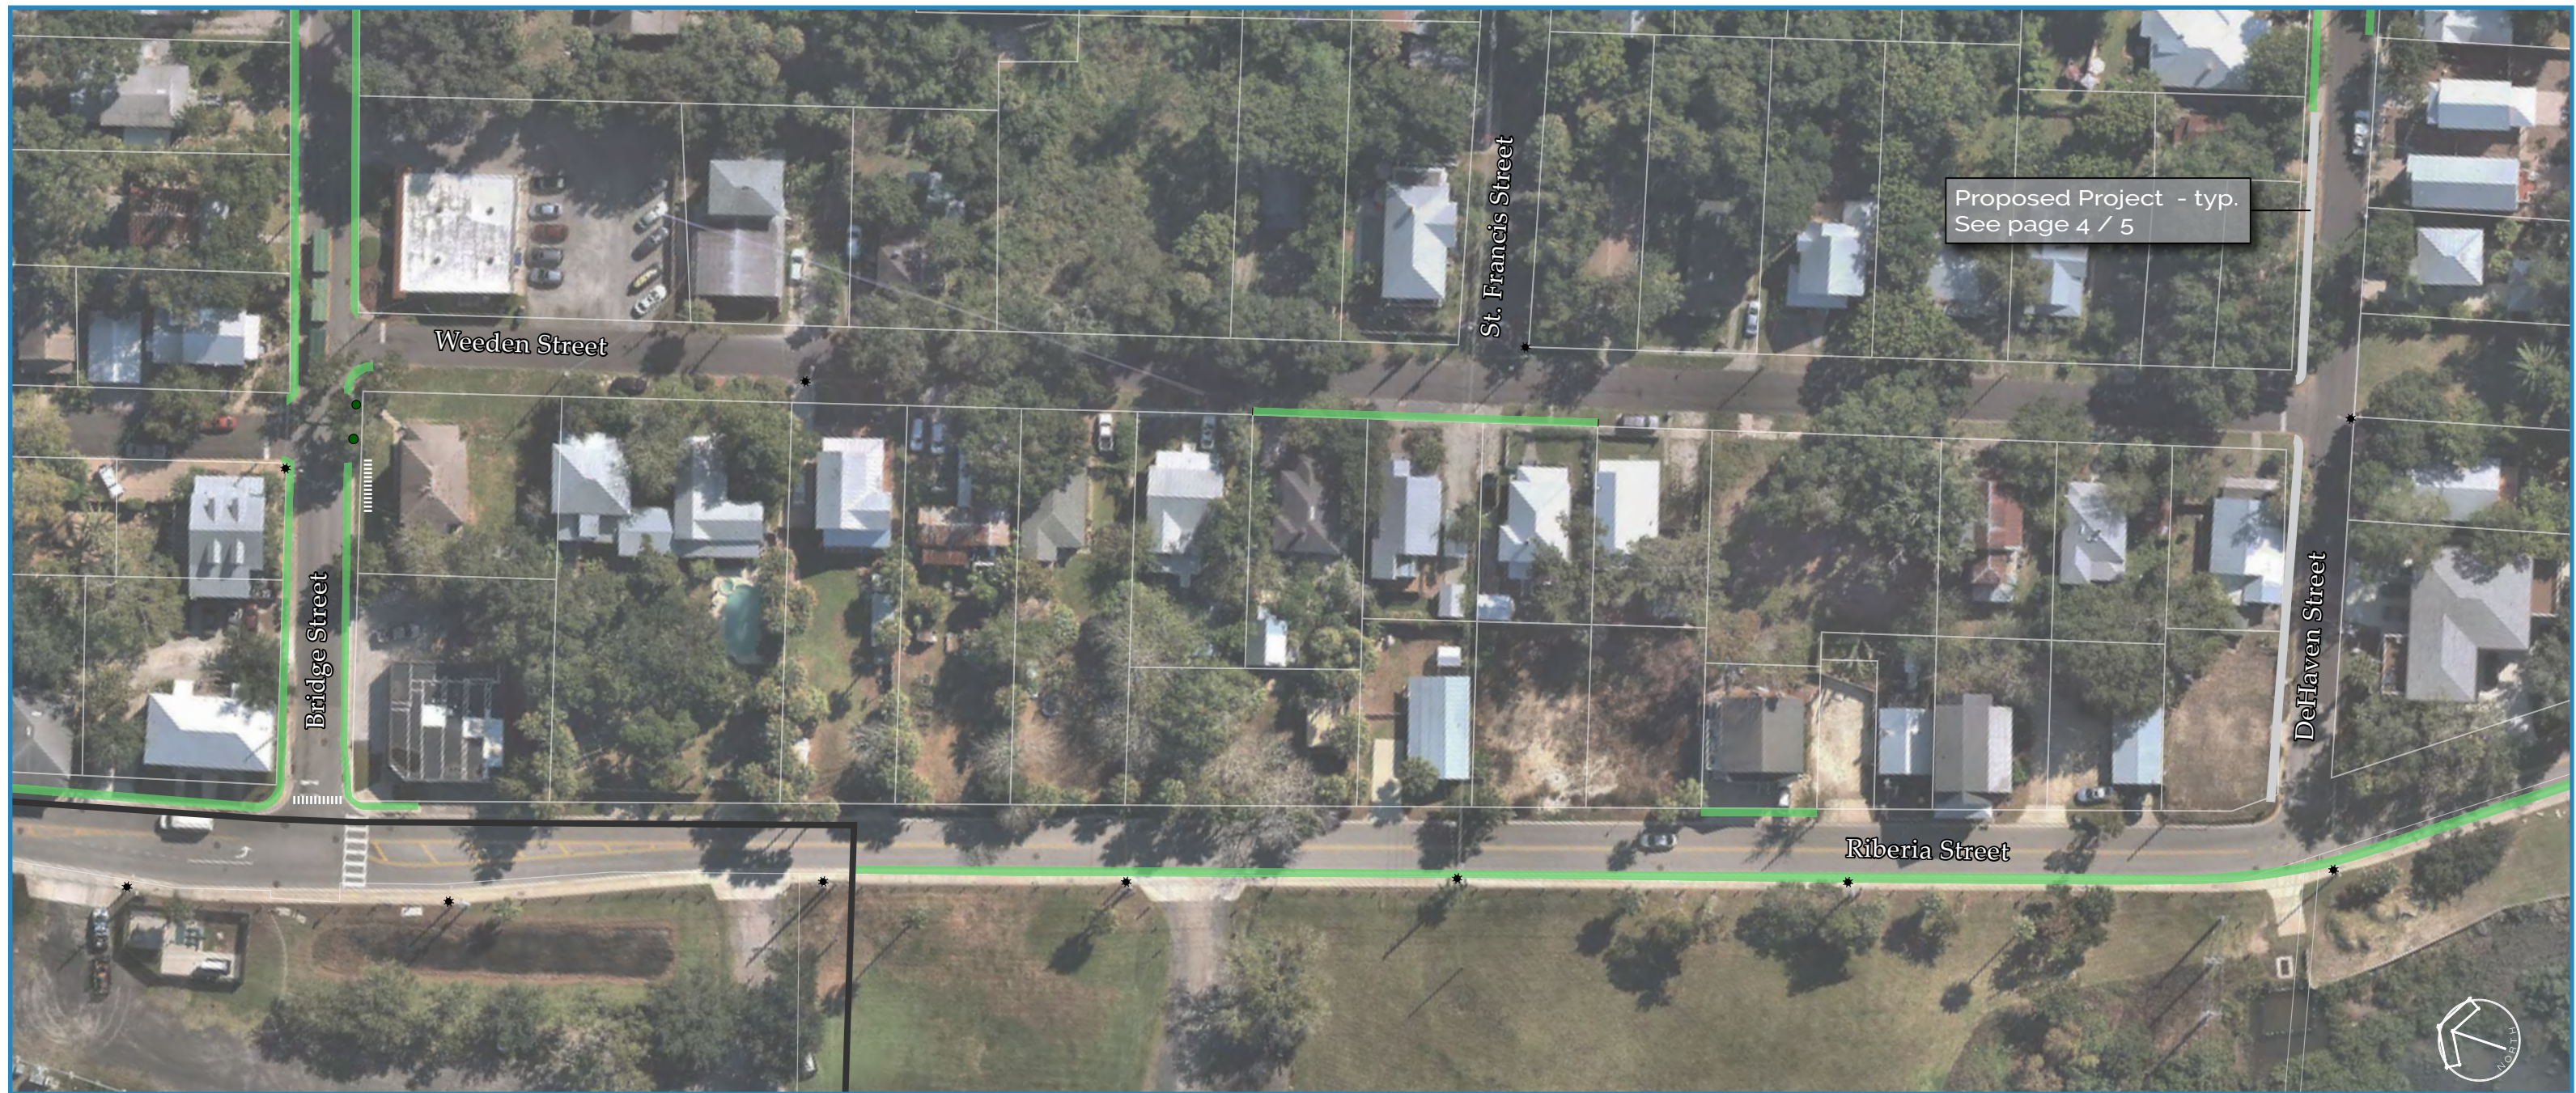
RIBERIA STREET (LAQUINTA ↔ BRIDGE)

- 1 Vegetation growing within the right-of-way to be removed.
- 2 Provide crosswalks as shown.

Existing building near the right-of-way may require alternate sidewalk layout. See Strategy #2, page 20.

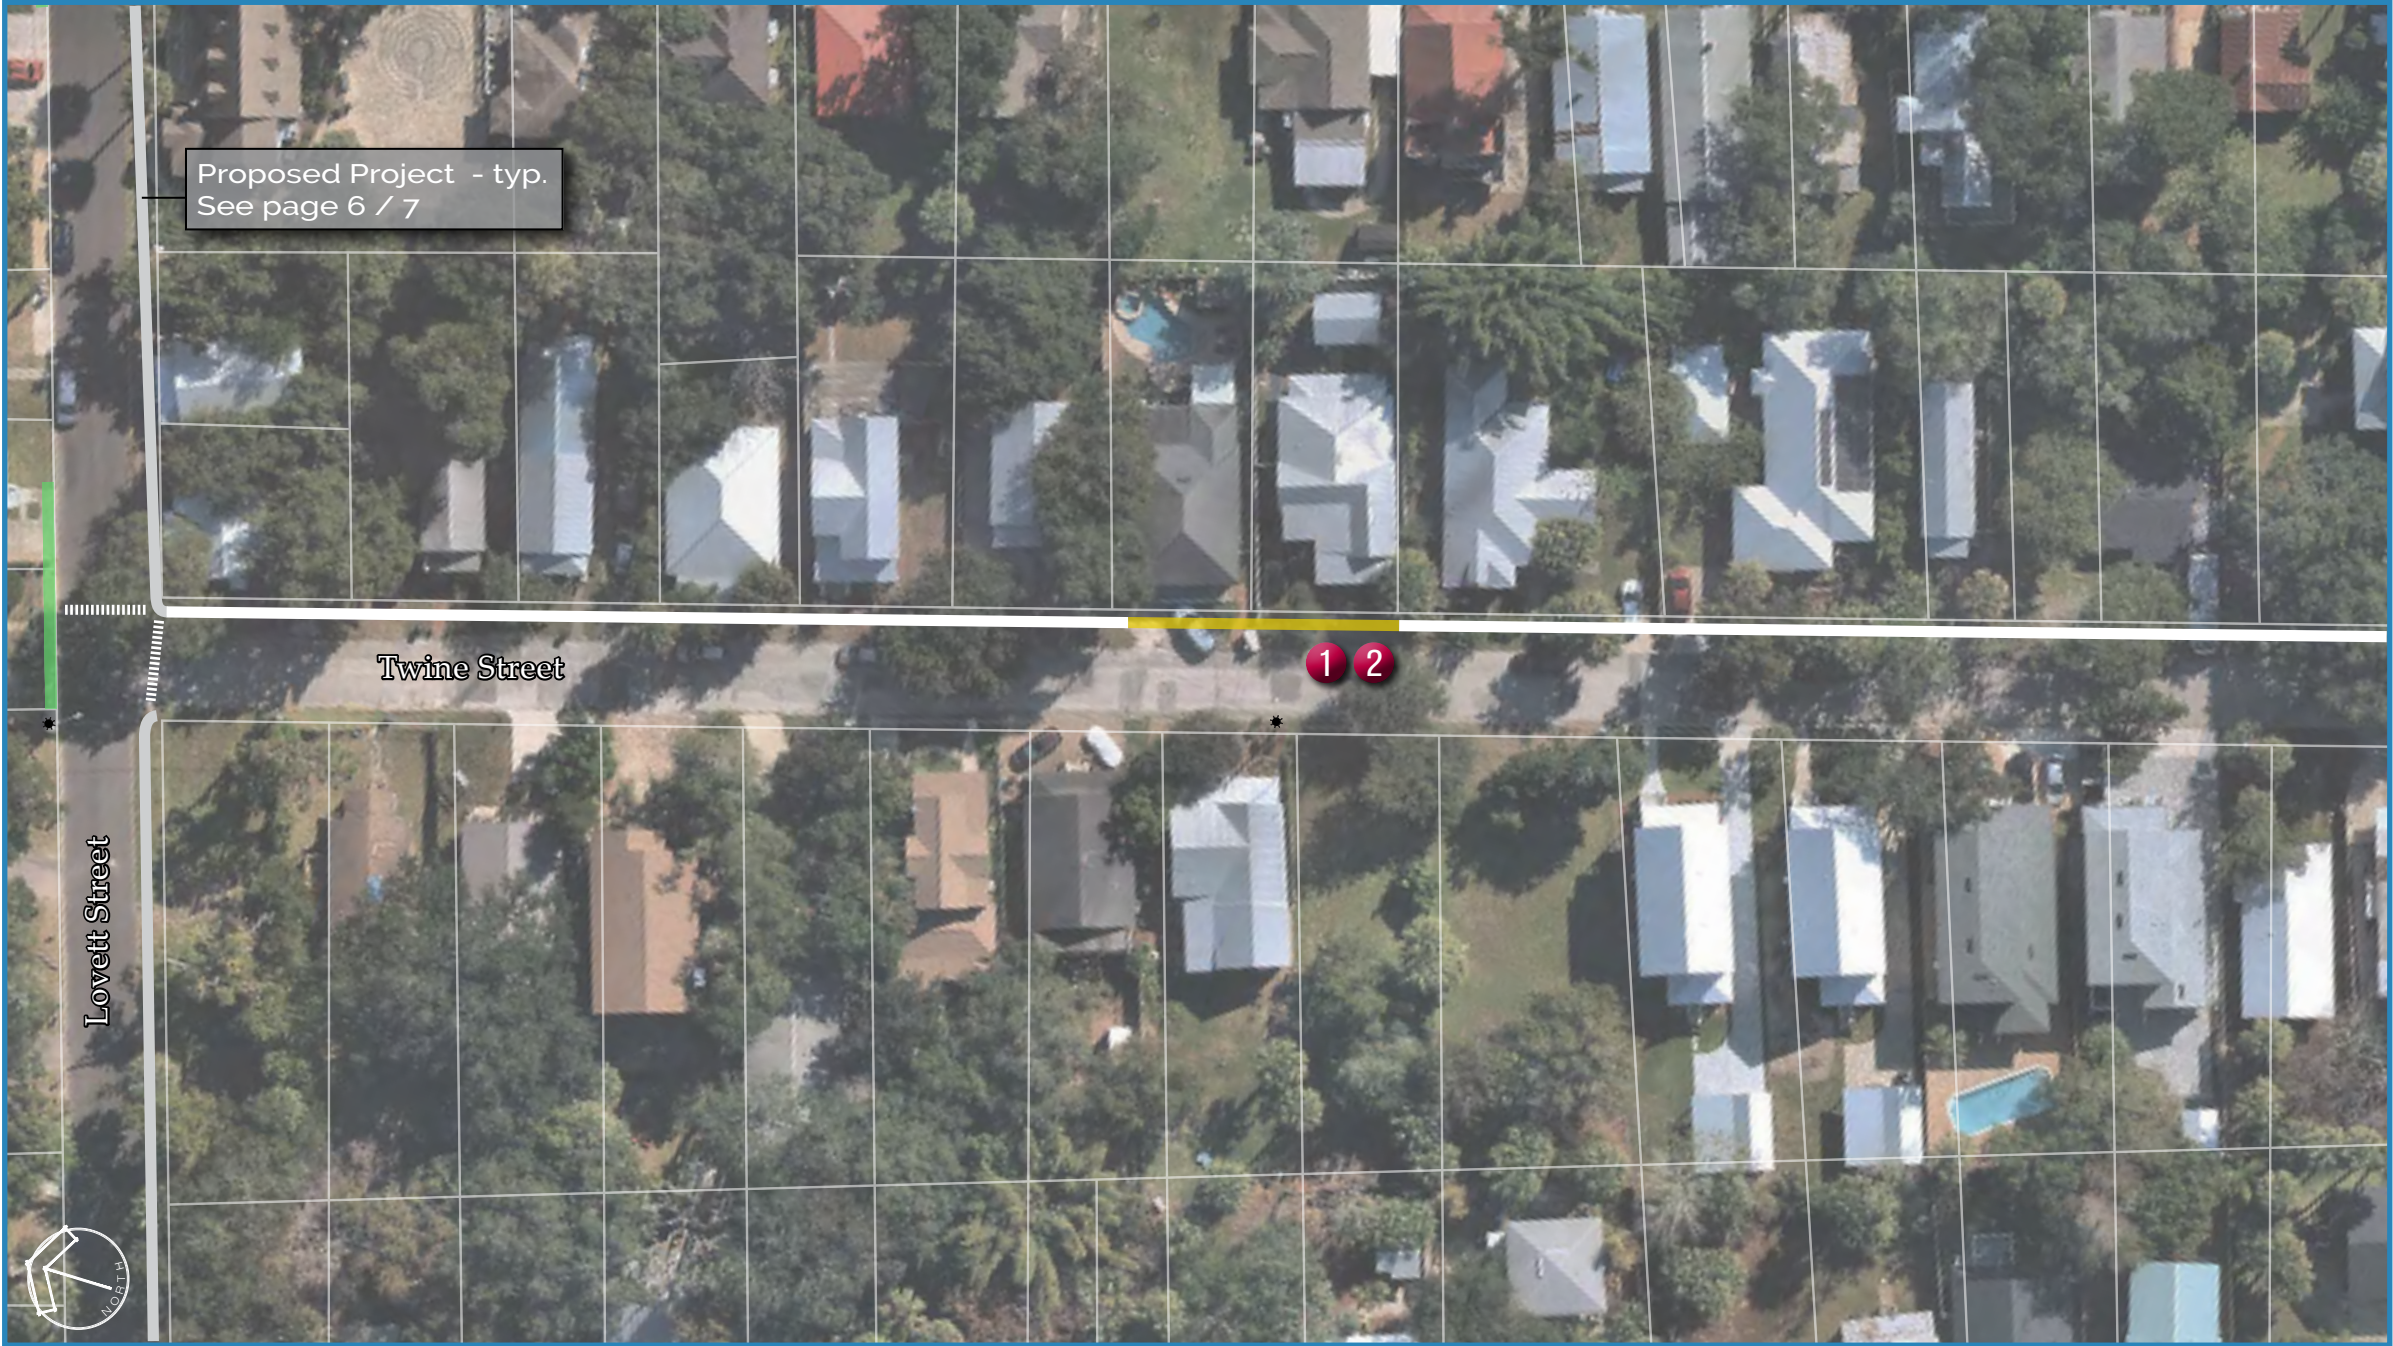
TWINE STREET

Twine Street, extending three north/south blocks in the southern half of the Lincolnville residential core, currently provides almost no considerations for pedestrian connectivity outside of a few small sections of sidewalk.

Provide sidewalk and associated infrastructure along Twine Street as graphically shown above.

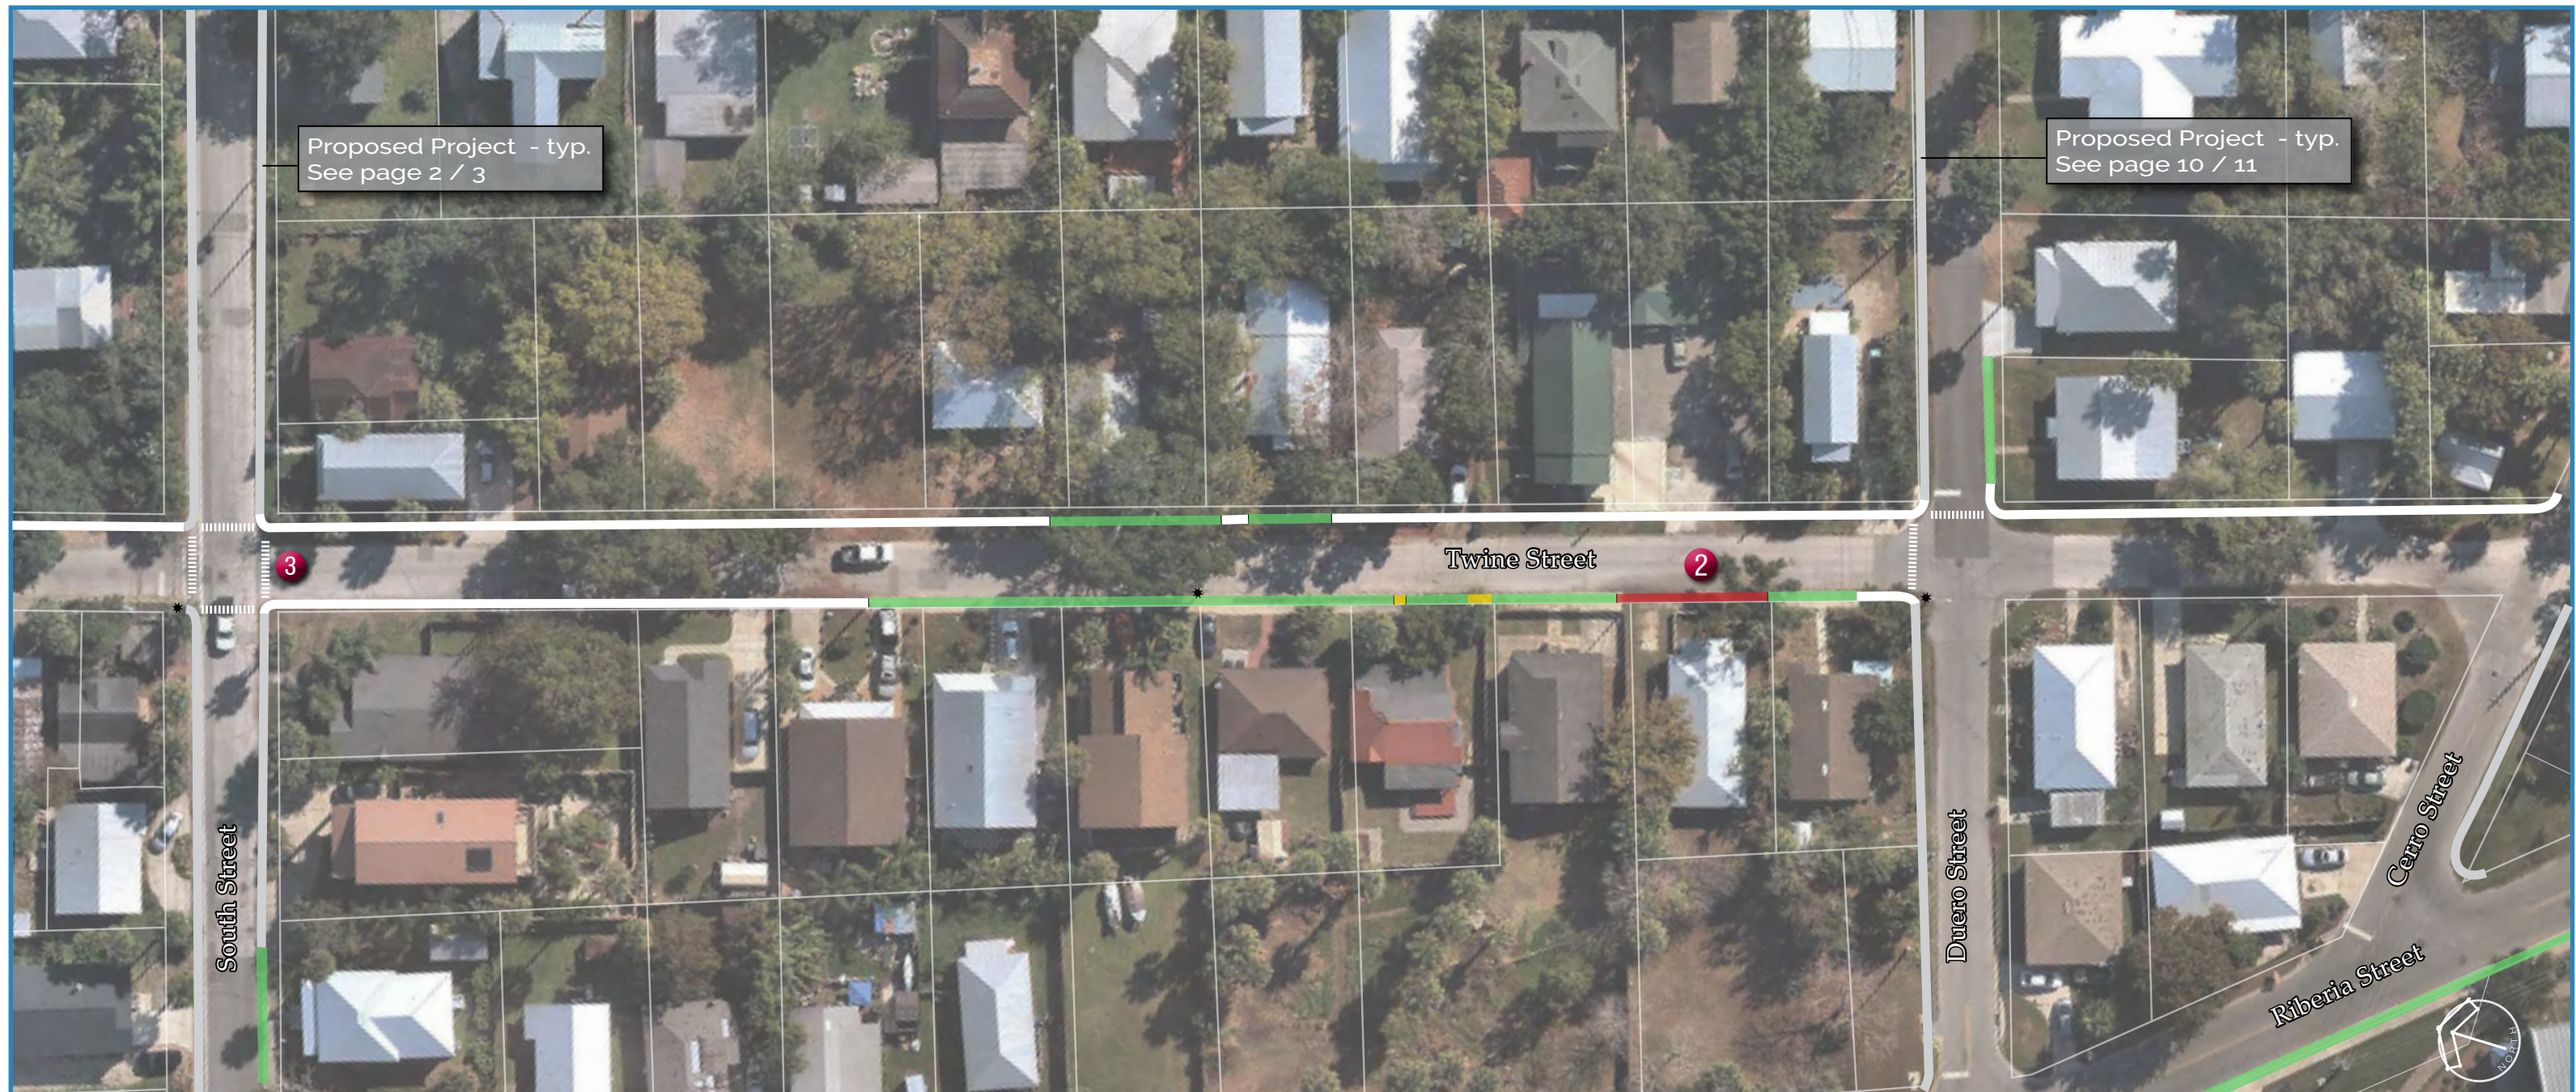
- 1 Route sidewalk around utilities / power pole locations by adjusting sidewalk width and/or location. Minimum 36" width (32" for brief obstructions) per FBC.
- 2 Sidewalk sections previously identified as "Fair" and/or "Bad" to be removed prior to sidewalk installation.
- 3 Provide crosswalks as shown.

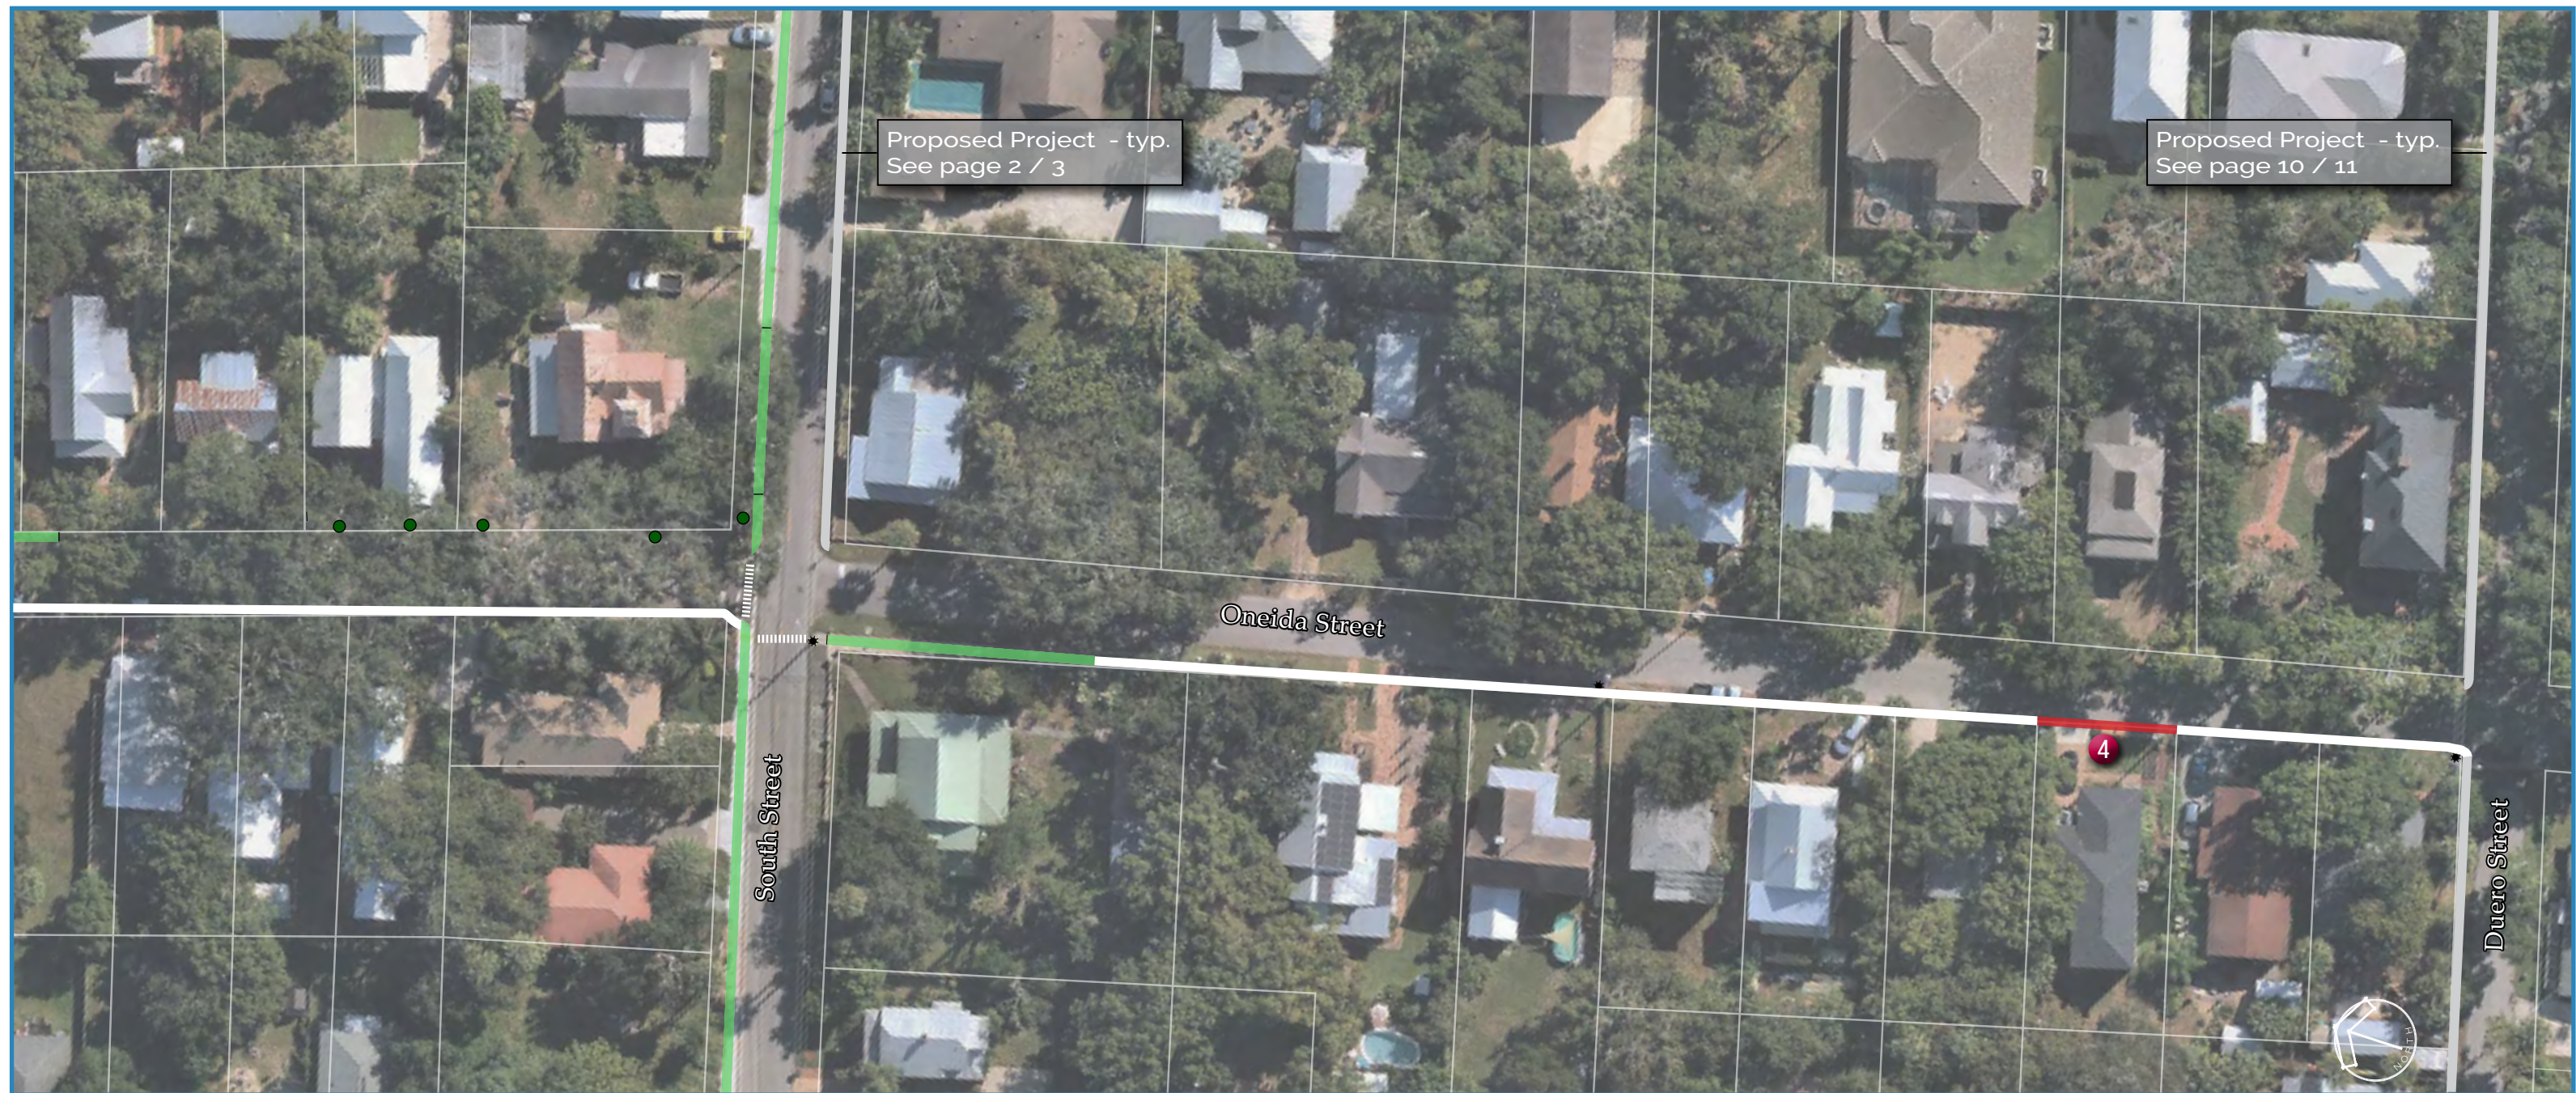
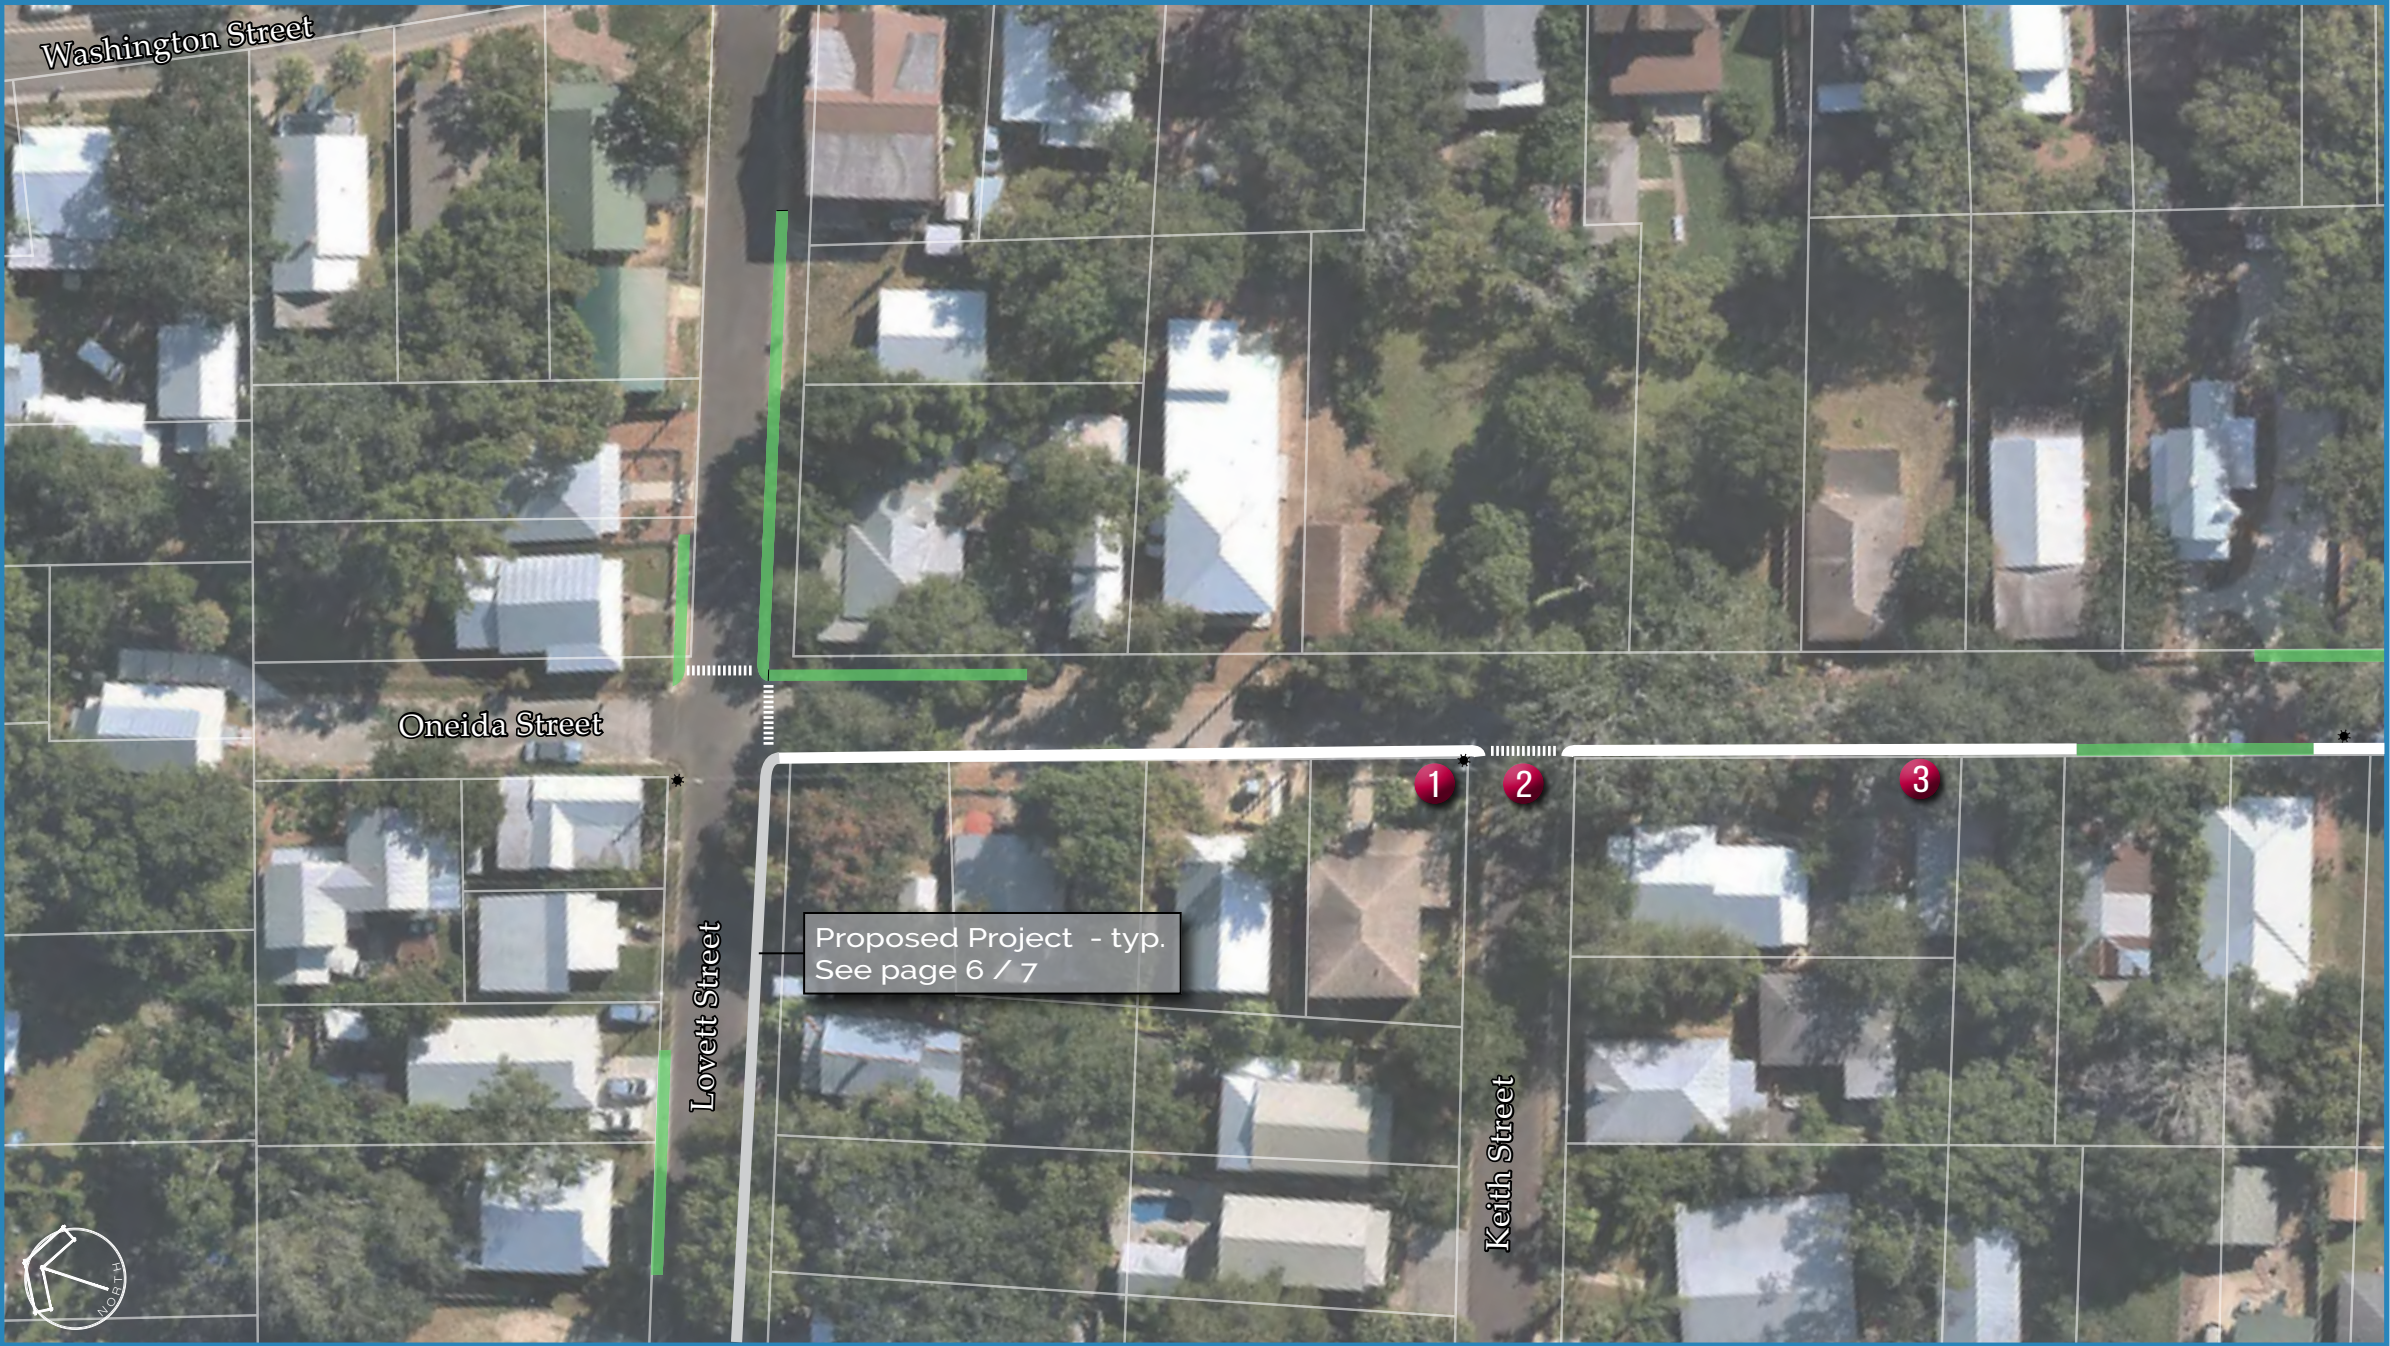
ONEIDA STREET

Oneida Street, extending three north/south blocks in the southern half of the Lincolnville residential core, currently provides almost no considerations for pedestrian connectivity outside of a few small sections of sidewalk.

Provide sidewalk and associated infrastructure along Oneida Street as graphically shown above.

- 1 Route sidewalk around utilities / power pole locations by adjusting sidewalk width and/or location. Minimum 36" width (32" for brief obstructions) per FBC.
- 2 Provide crosswalks as shown.
- 3 Existing vegetation within the right-of-way will require removal (small trees and ornamental shrubs).
- 4 Sidewalk section previously identified as "Bad" to be removed prior to sidewalk installation.
