# LINCOLNVILLE COMMUNITY REDEVELOPMENT AREA

PEDESTRIAN CONNECTIVITY STUDY

## PROJECT SCOPE

Building upon the initial framework established in the Lincolnville Streetscape Survey & Analysis ("Phase I") and using that information as a foundational planning tool, Kimley-Horn was tasked with preparing a Pedestrian Connectivity Study ("Phase II") which identifies missing and broken linkages in the existing sidewalk network and the "where and how" of outlining locations where initial improvements are recommended to begin.

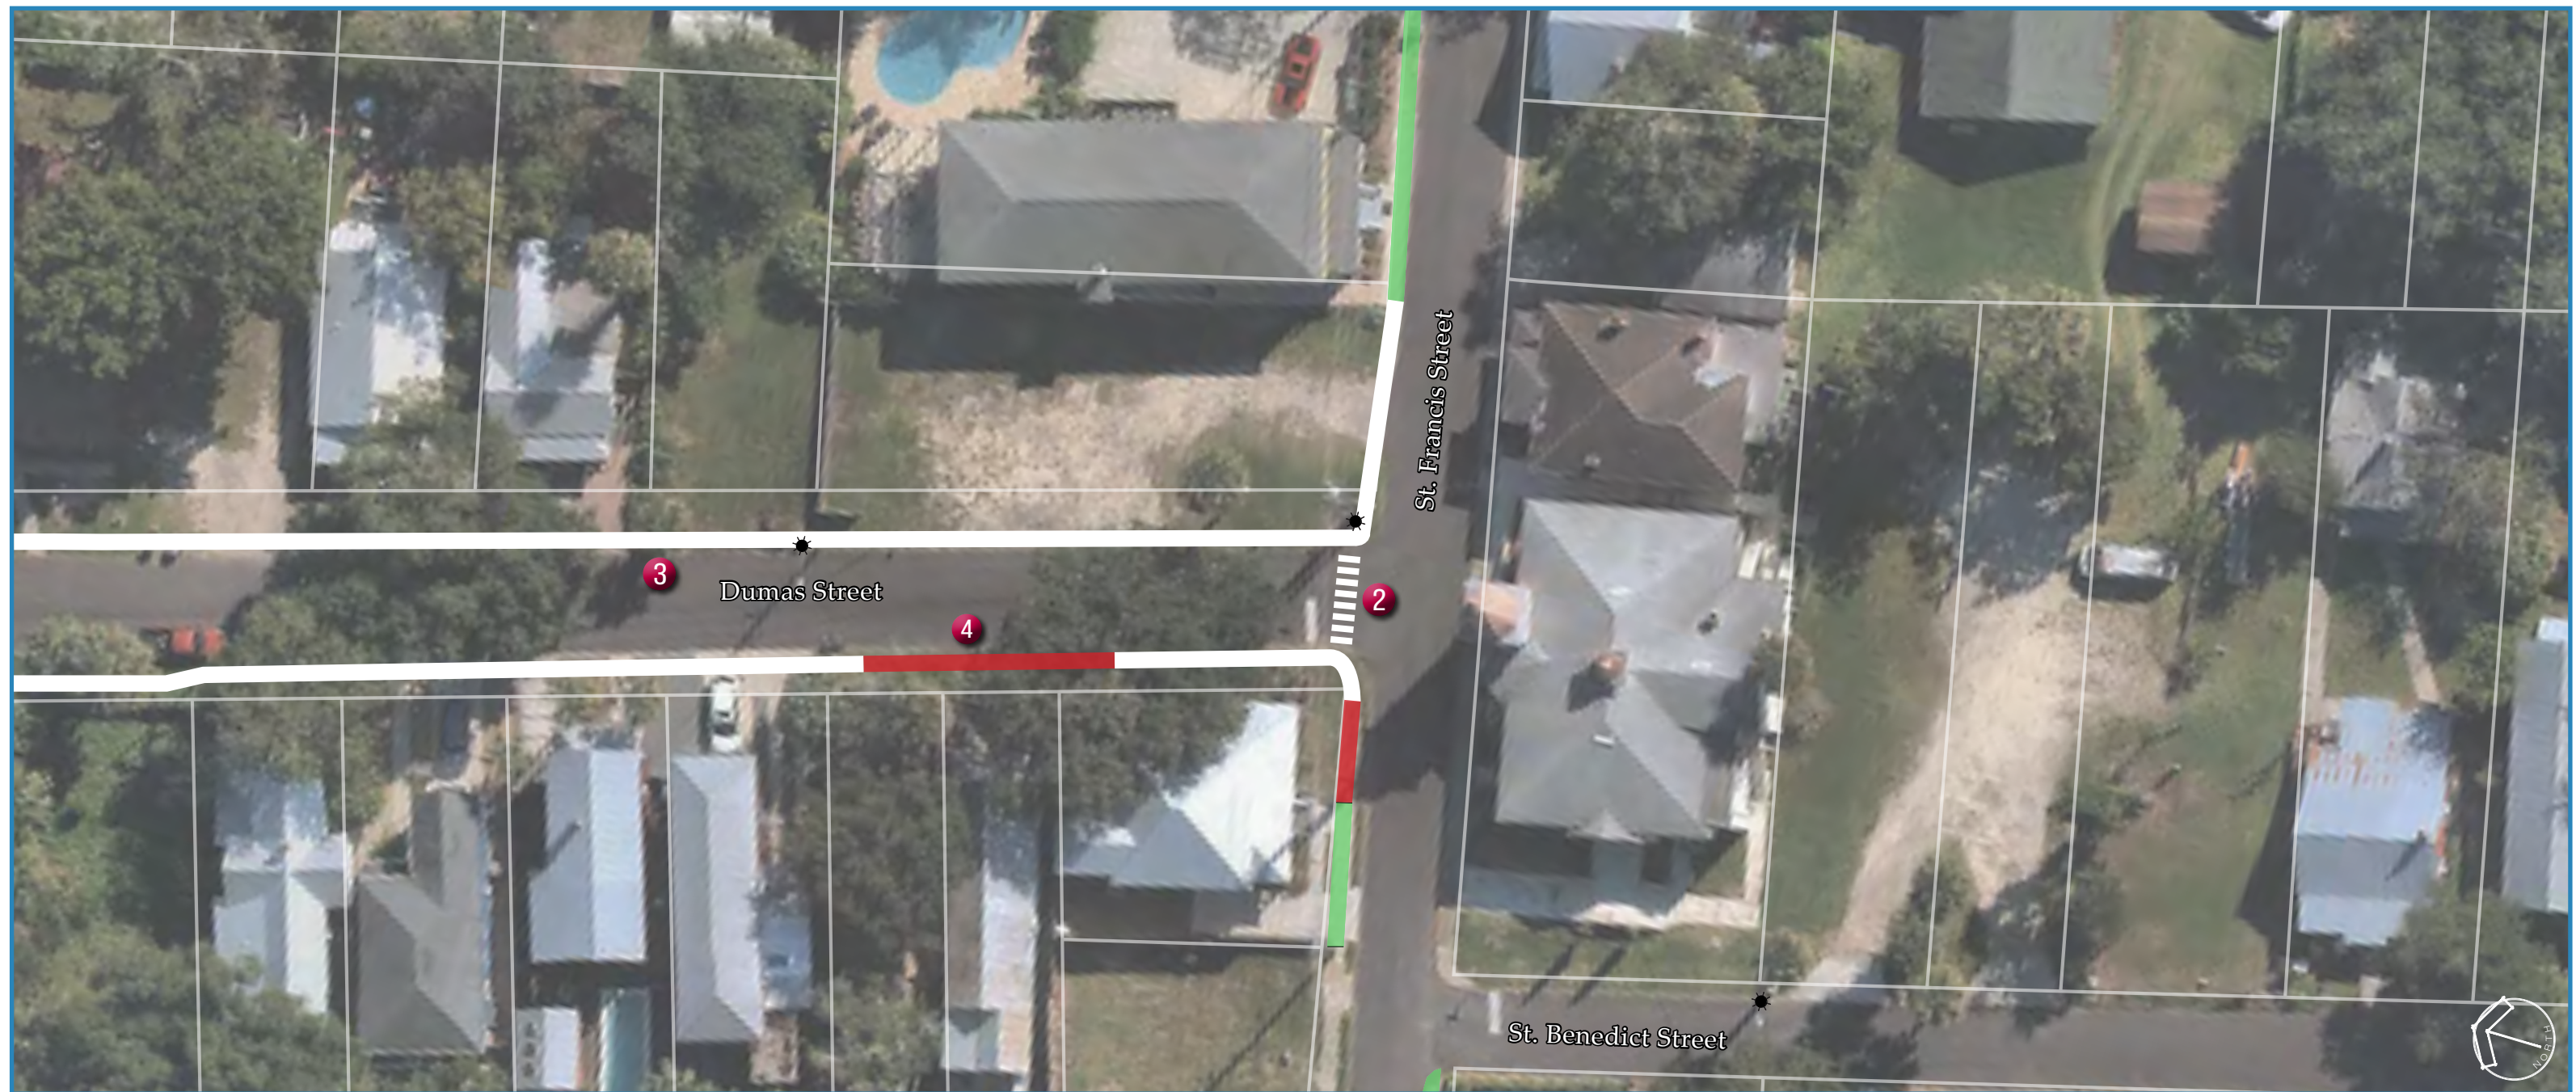
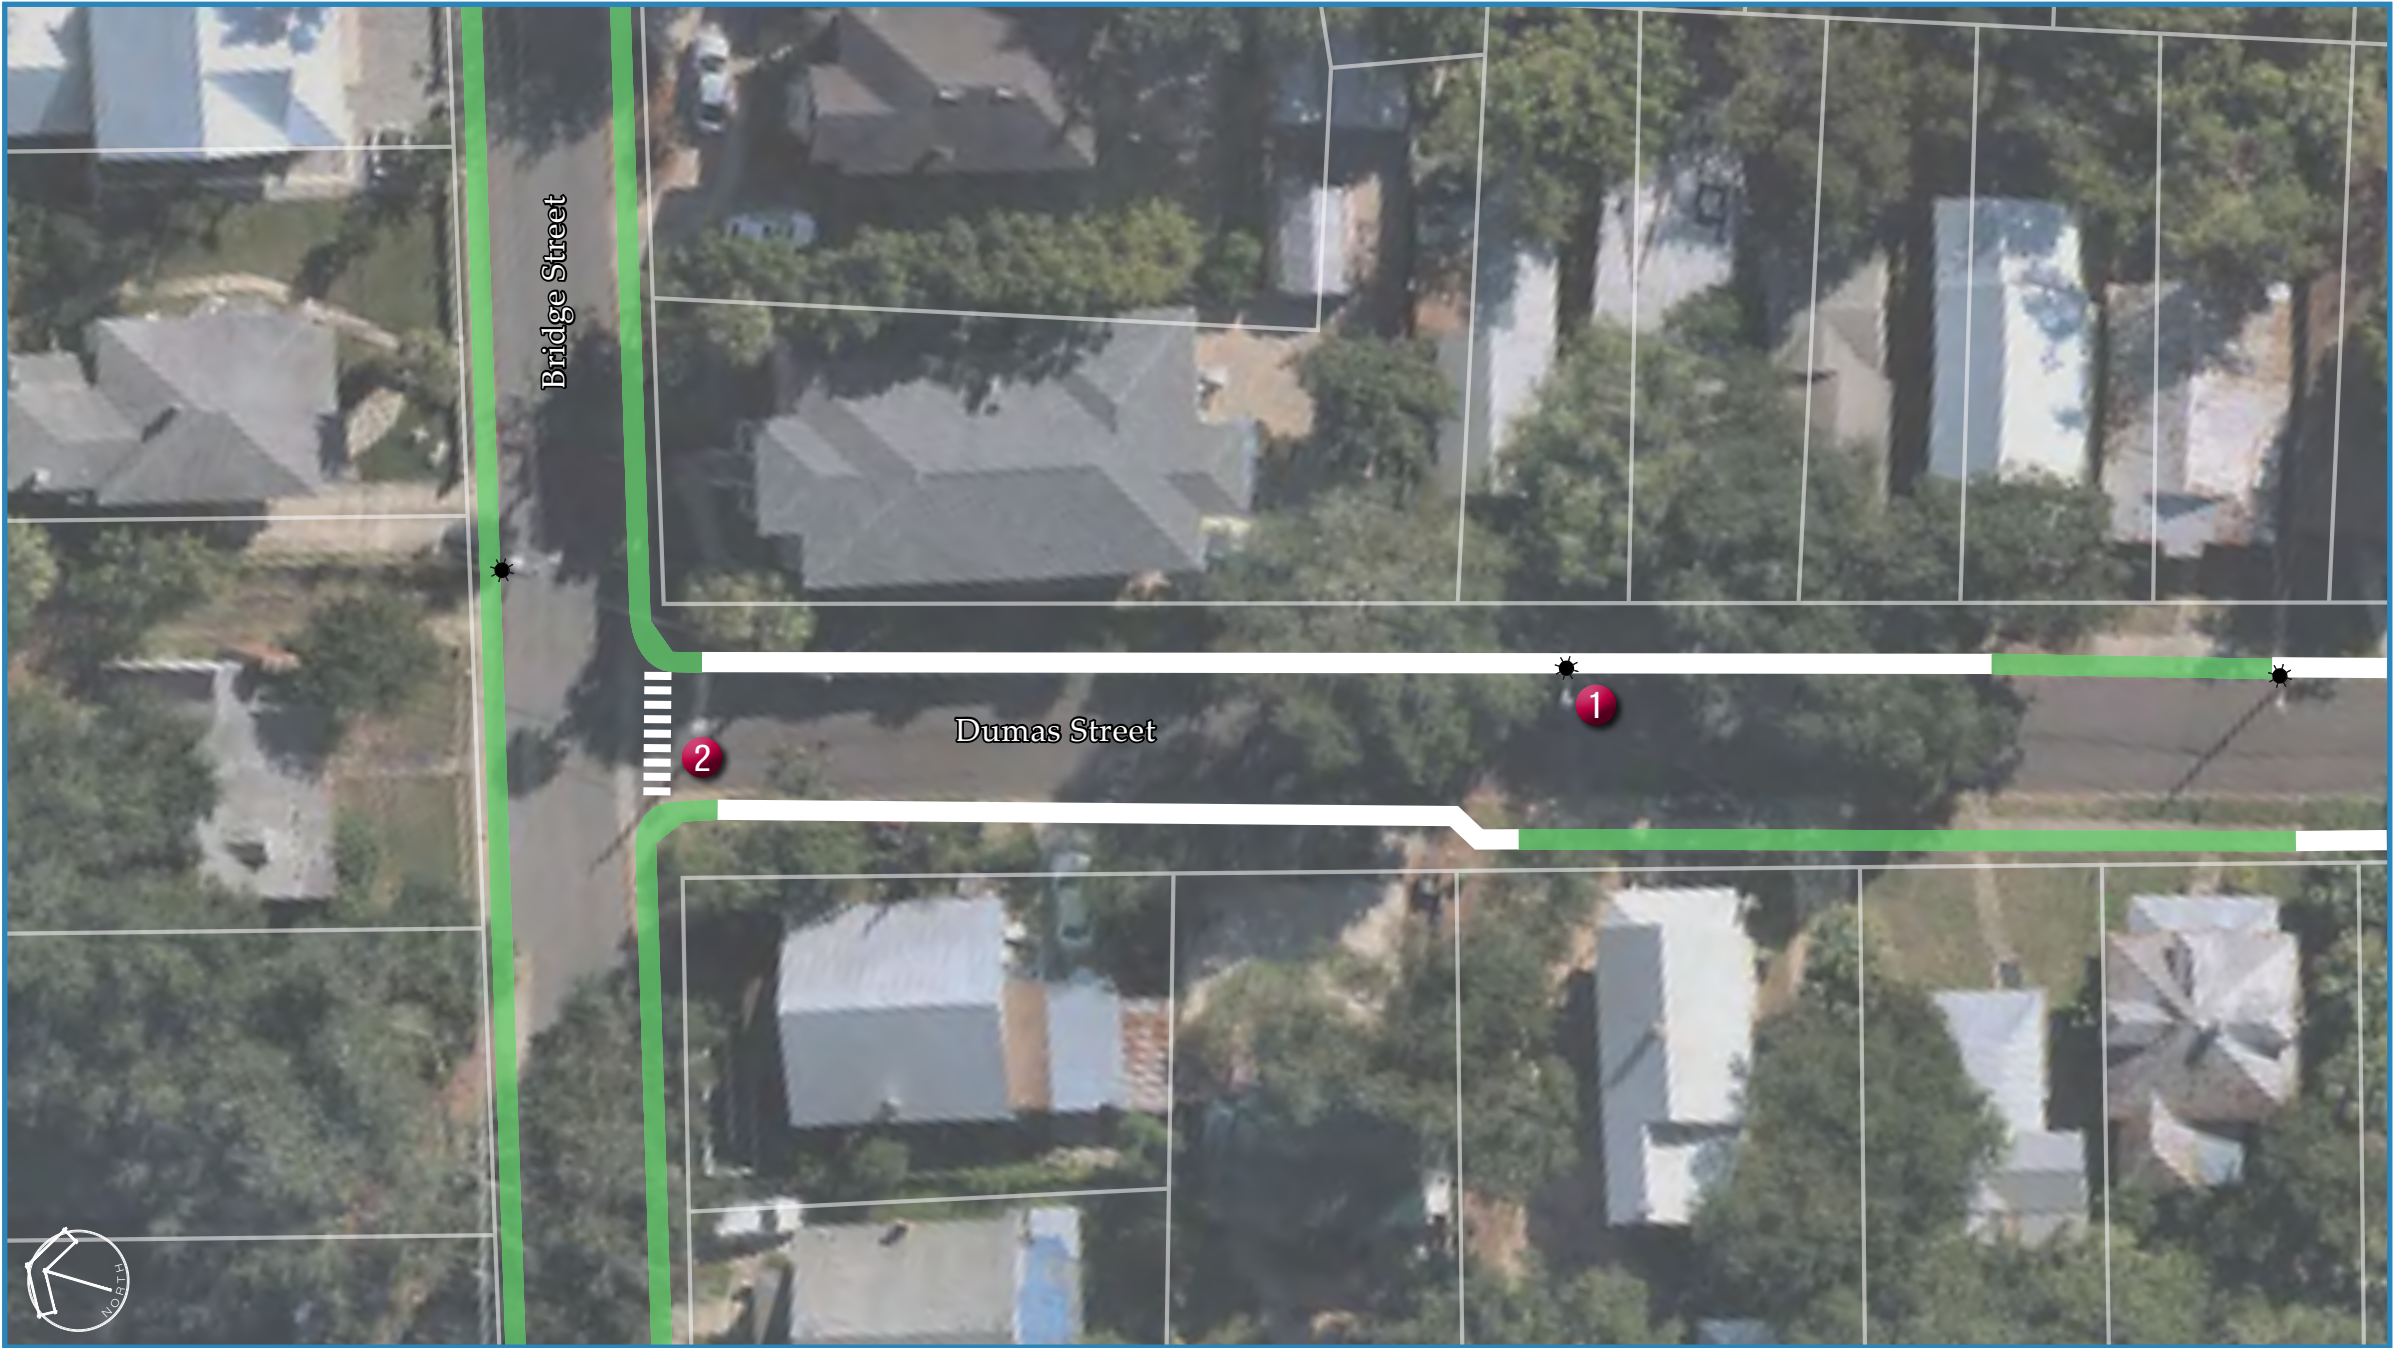
DUMAS STREET (BRIDGE ↔ ST. FRANCIS)

Dumas Street, extending one north/south block in the northern half of the Lincolnville residential core, currently provides almost no considerations for pedestrian connectivity outside of a few small sections of sidewalk.

Provide sidewalk and associated infrastructure along Dumas Street as graphically shown above.

- 1 Route sidewalk around utilities / power pole locations by adjusting sidewalk width and/or location. Minimum 36" width (32" for brief obstructions) per FBC.
- 2 Provide crosswalks as shown.
- 3 Existing vegetation within the right-of-way will require removal (small trees and ornamental shrubs).
- 4 Sidewalk section previously identified as "Bad" to be removed prior to sidewalk installation.
