LINCOLNVILLE COMMUNITY REDEVELOPMENT AREA

STREETSCAPE SURVEY & ANALYSIS

October 3, 2019

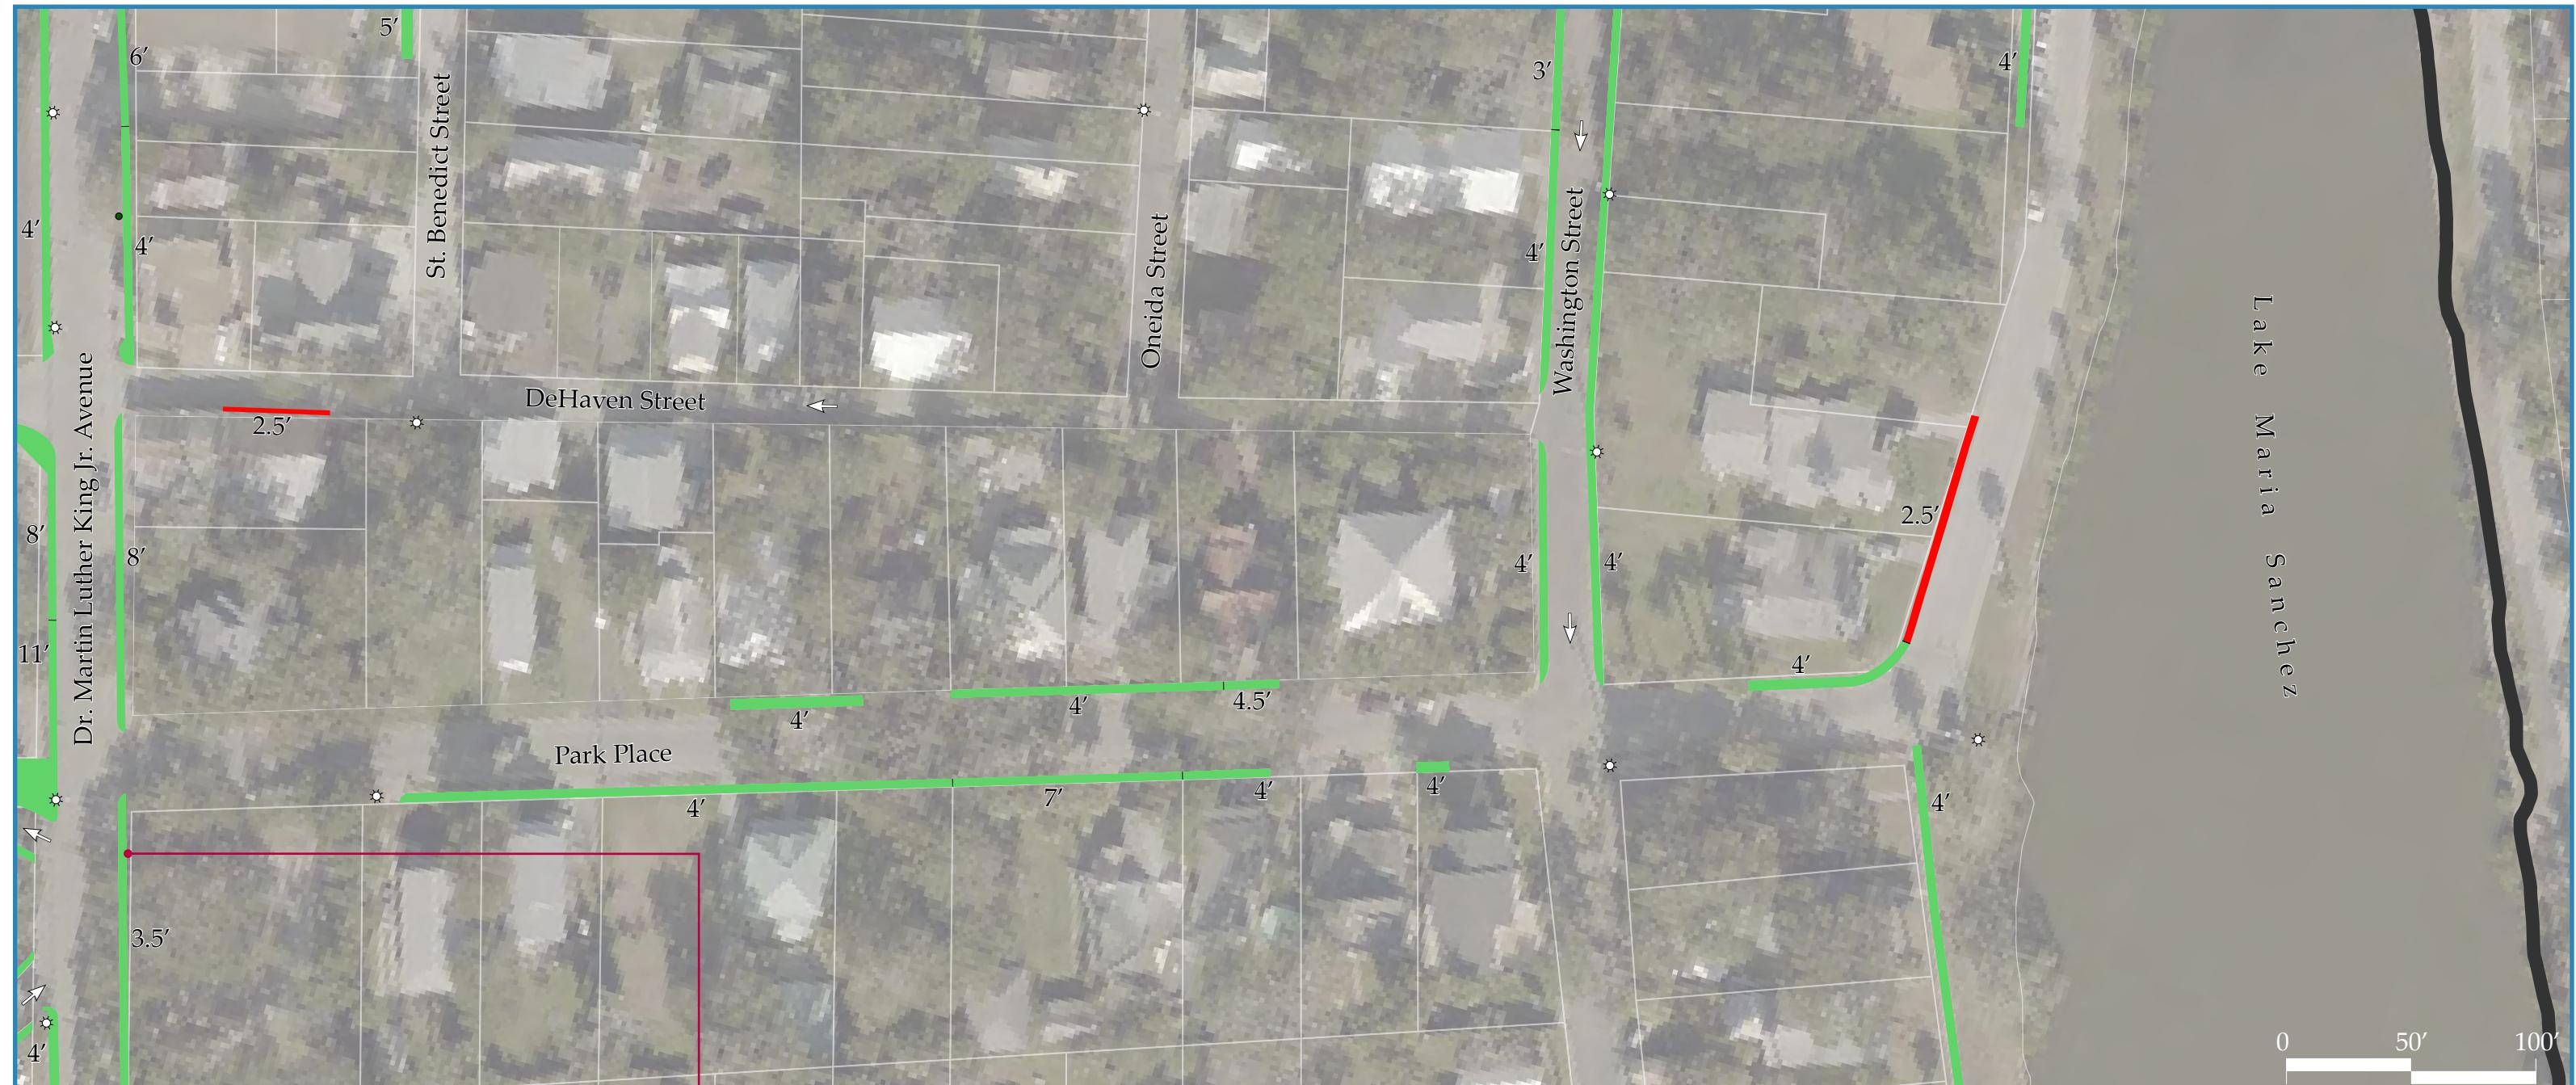
Good/continuous sidewalk along both sides of MLK Ave. with minor obstructions.

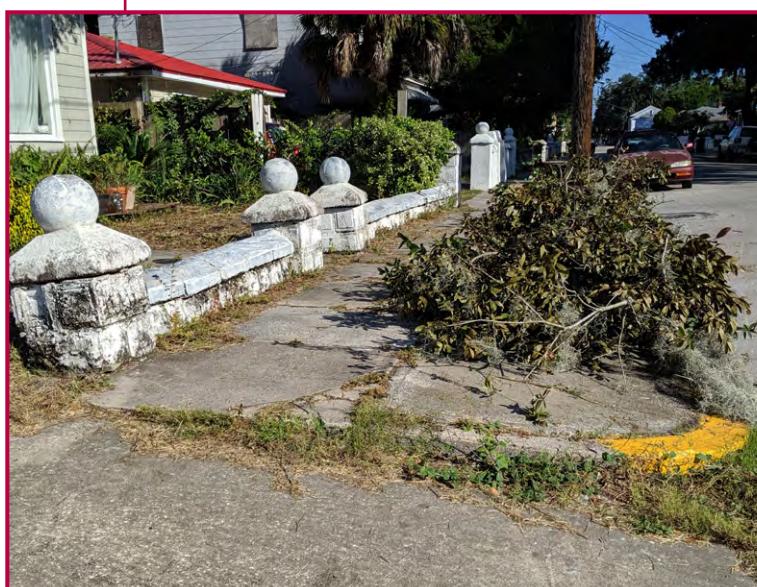
Non-ADA accessible transition.

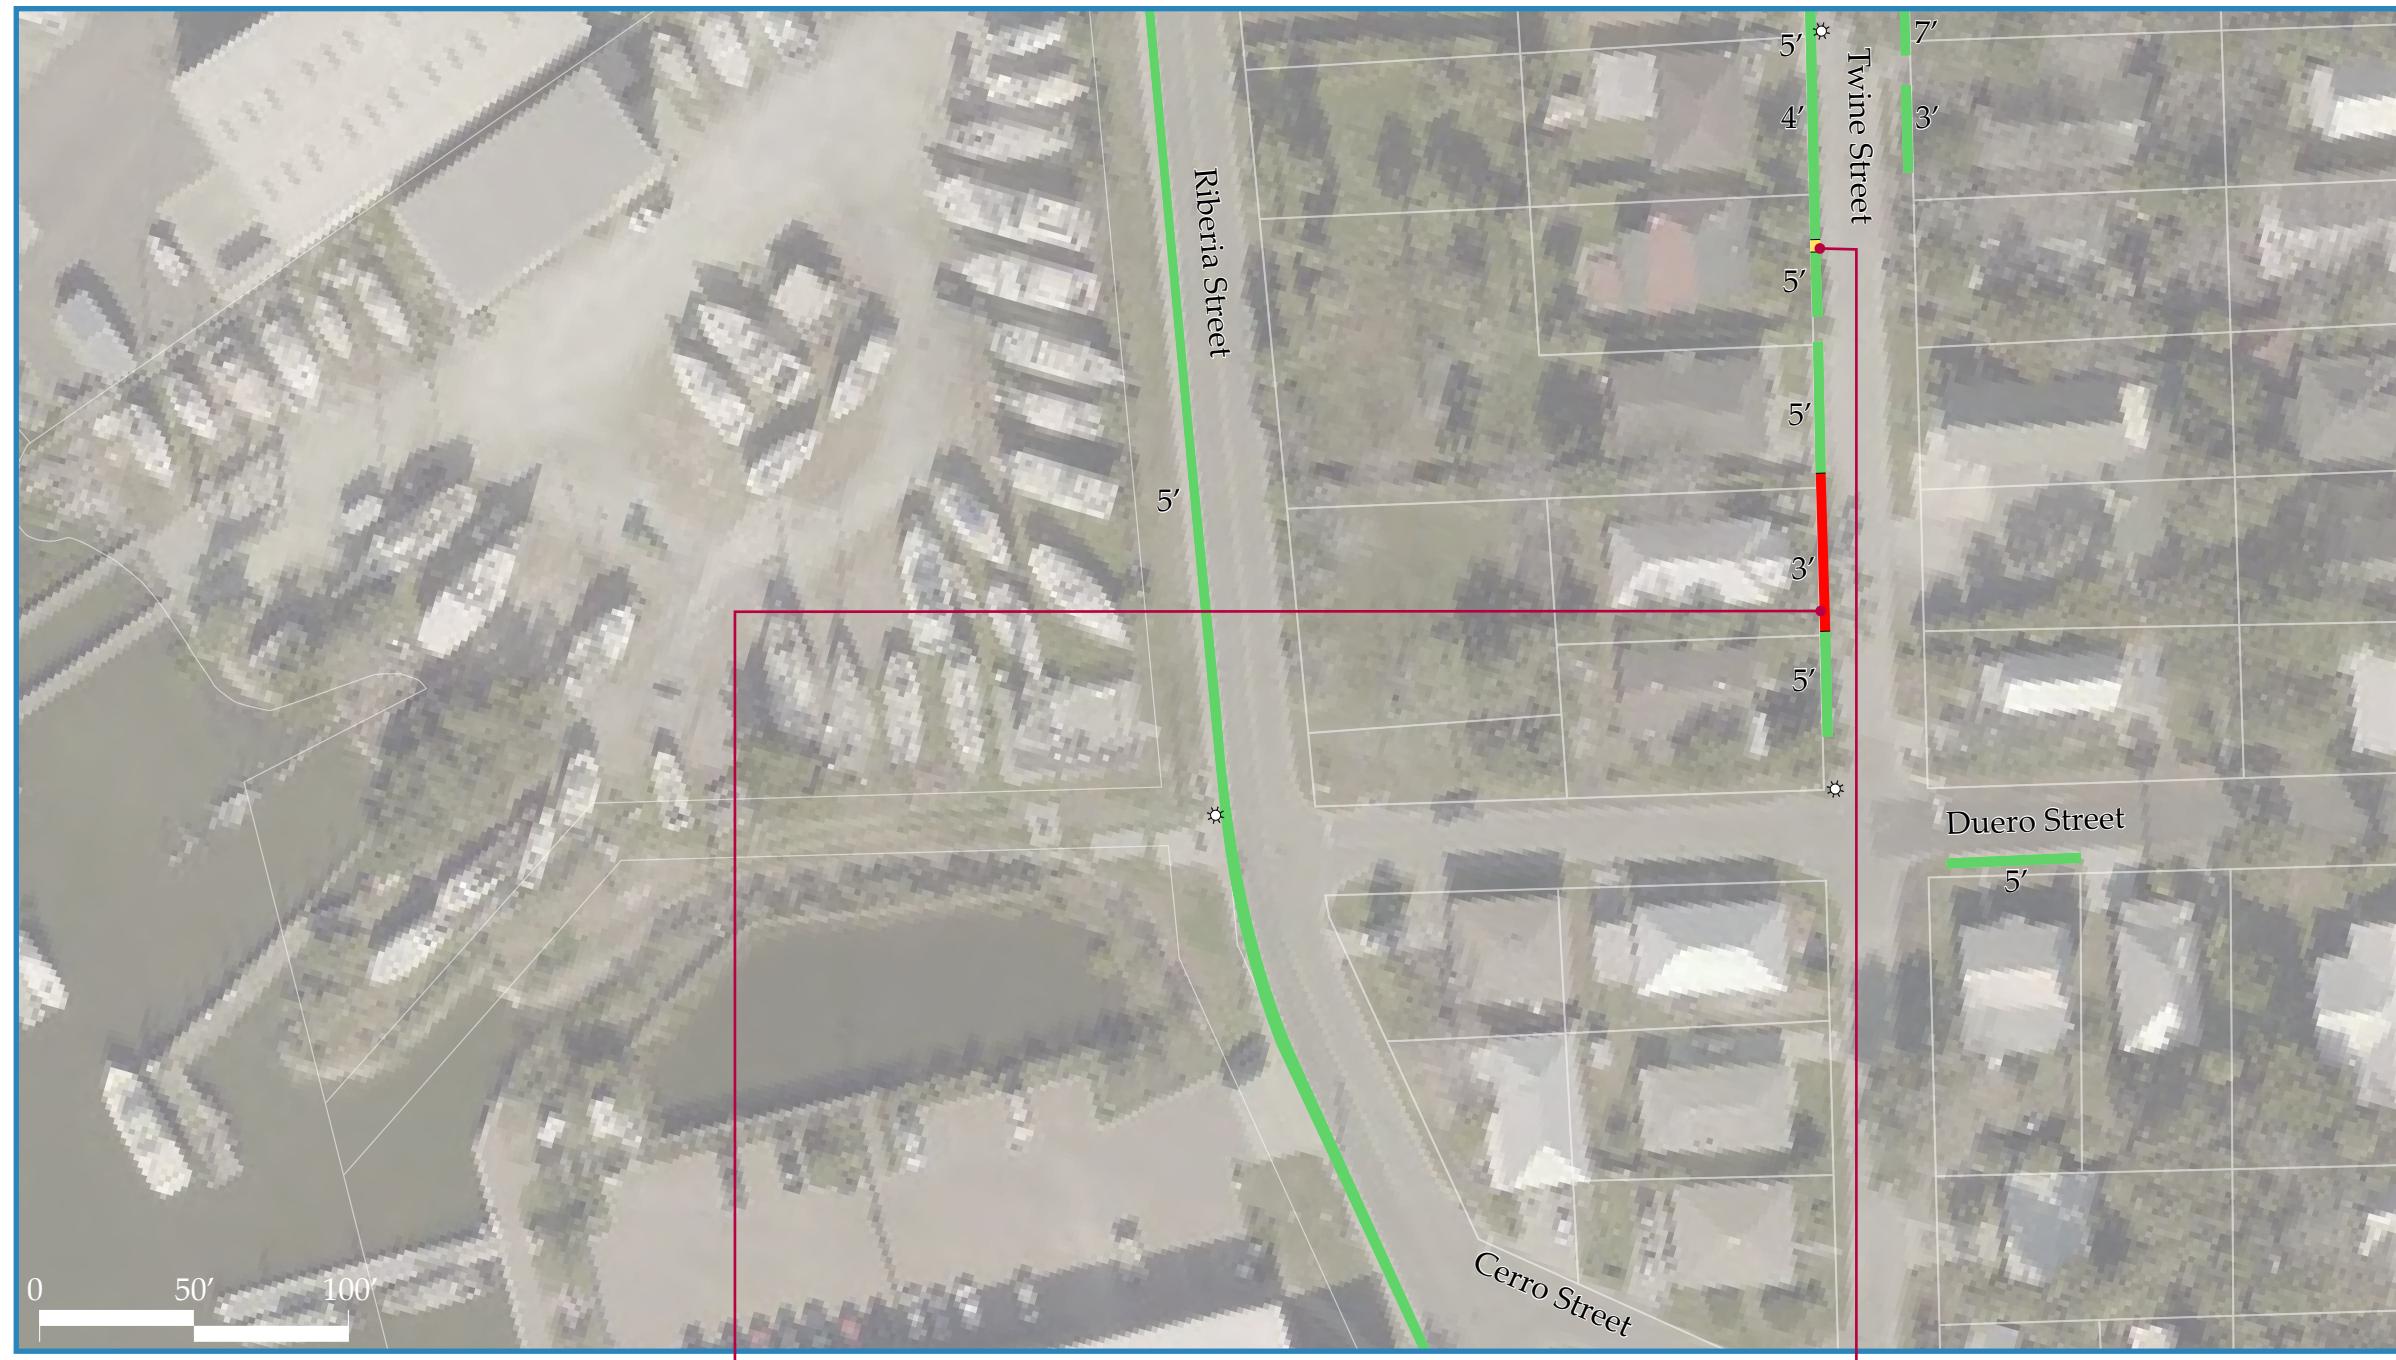
Broken/missing sections within a continuous section of good sidewalk.

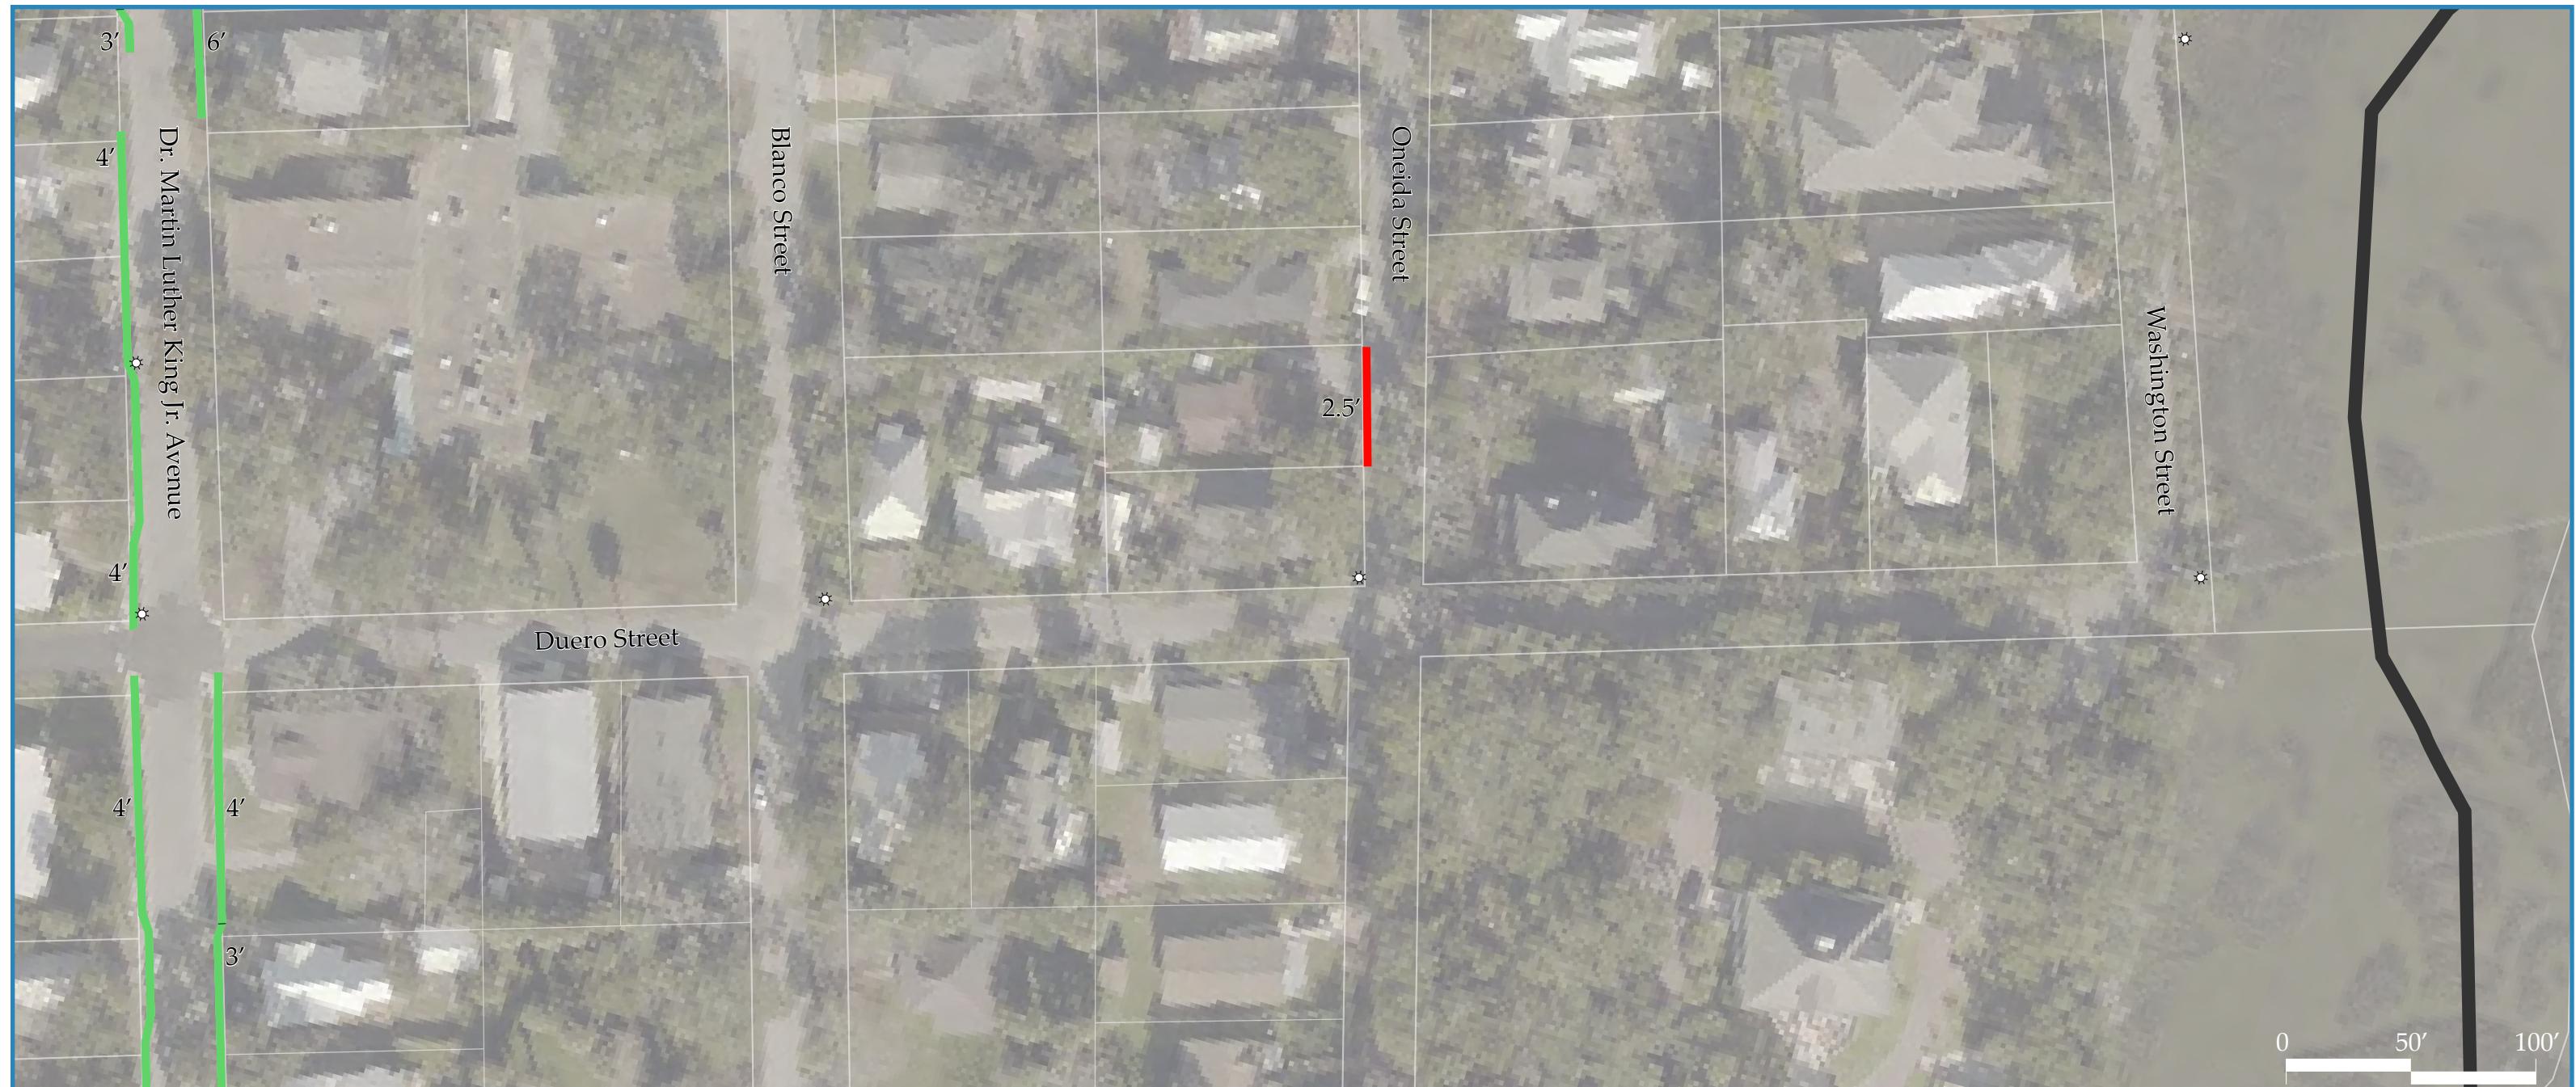
Damaged pavers within a good section of sidewalk.

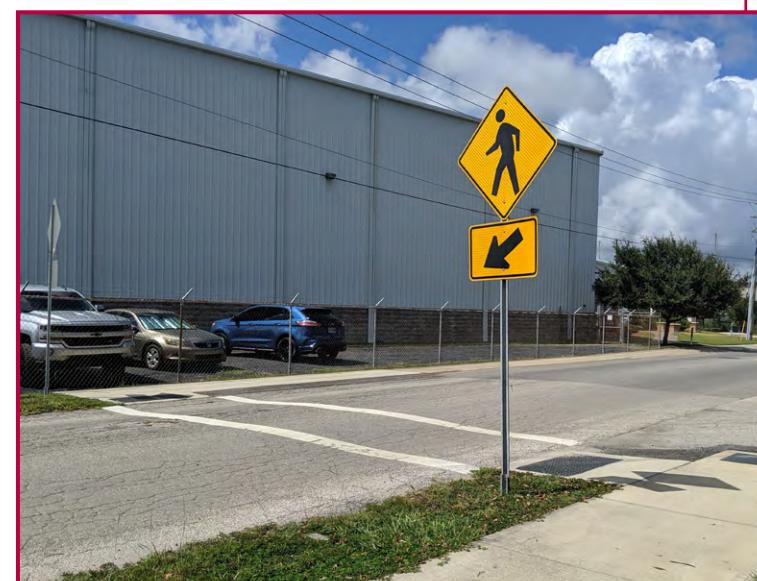
Connection to the Willie Galimore Recreation Center from Cerro St. is broken/missing asphalt.

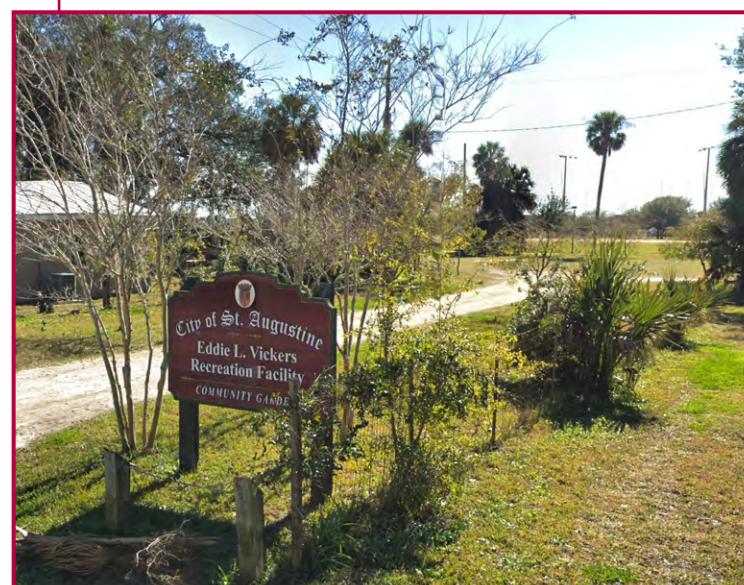
Unpaved entrance to Eddie L. Vickers Recreation Facility/Community Gardens.
